Property and Site

Date: 07-Dec-2015

820 E Auburn Rd., Rochester Hills, Michigan

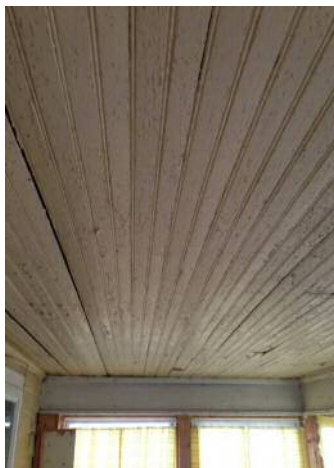
Peeling paint observed throughout house that require immediate attention due to lead risks to health.

Peeling paint throughout home and risks to exposure to lead.

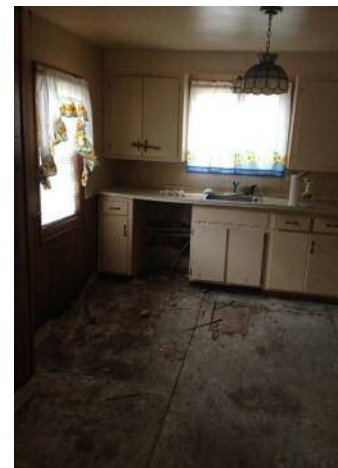
Water damage, mold growth, peeling paint, sagged floors.

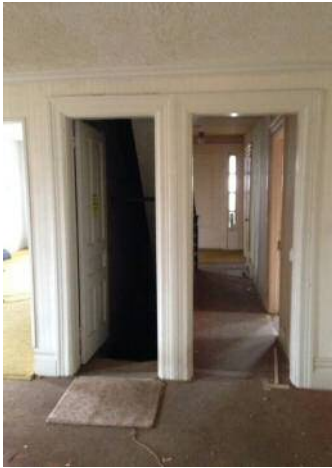
Floors sag throughout home and at ceiling due to instability to structure of home.

Sag at floor and at ceiling.

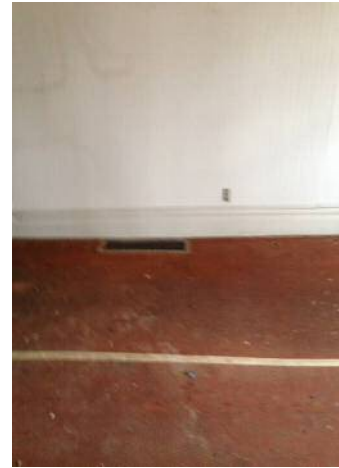
Water damage at subfloor, at wall, and sag at floor.

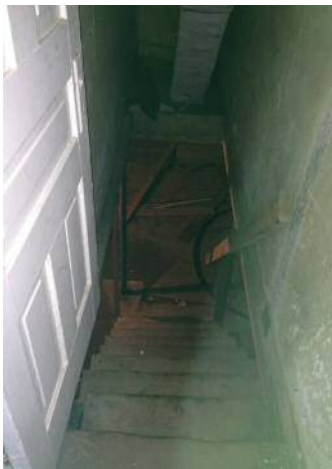
Basement stairs no longer level or structurally sound.

Basement Stairway	Visible Damage Noted
<input type="checkbox"/> Unsecured <input type="checkbox"/> Carpet <input type="checkbox"/> Vinyl <input checked="" type="checkbox"/> Wood <input type="checkbox"/> Worn <input type="checkbox"/> Trip Hazard	
<i>Stairs are no longer level or structurally sound. Stairs require immediate replacement as poses as a safety hazard in current condition.</i>

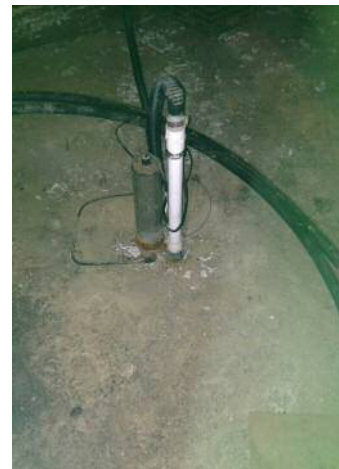
Pump at floor, provides evidence that basement floods.

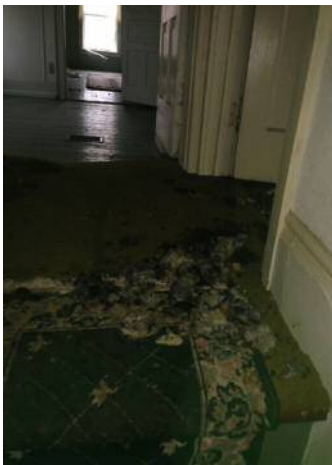
Water damage at second floor hallway and rodent excrement.

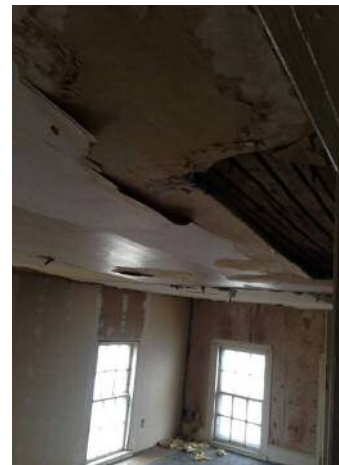
Numerous leaks observed at second story ceiling from roof leaks and requires immediate attention and repairs.

Water damage at ceiling from roof leaks.

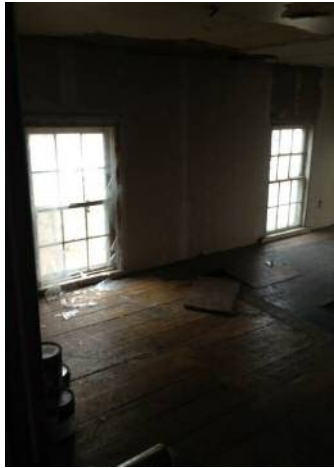
Windows are in poor condition and replacement is advised. Windows at second story are set at ground level which poses as a safety risk. Replace and raise windows to home.

Windows set too closely to floor posing as safety hazards throughout second story of home.

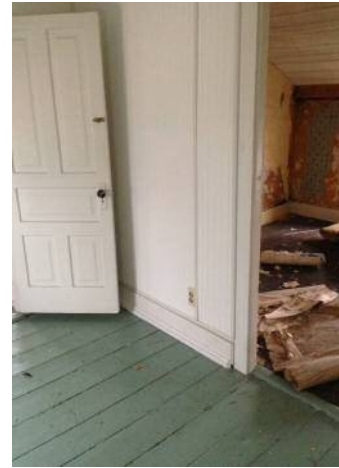
Water damage at walls and sags at floor with water damage.

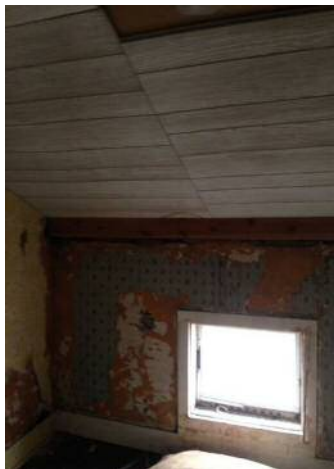
Water damage at ceiling and walls.

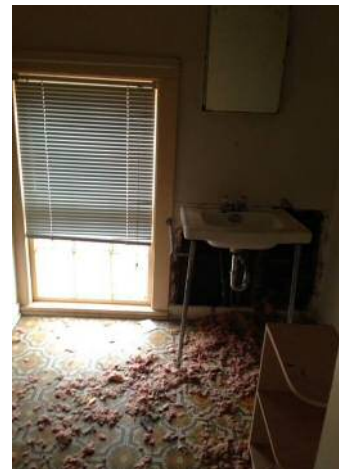
Water damage at second story bathroom.

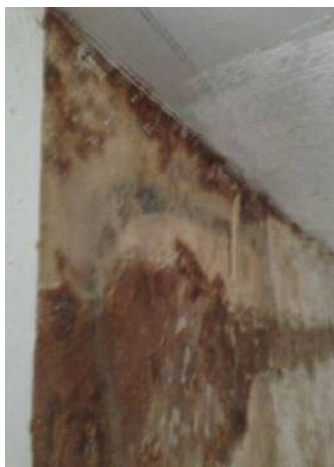
Heavy water damage at second story at rear of home. Mold growth observed.

Due to observed mold growth within home, it is strongly advised to have home tested for mold via indoor air quality test and surface sampling by laboratory.

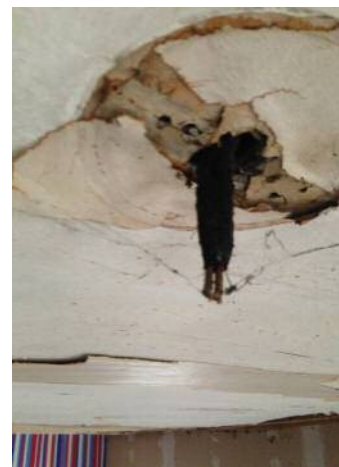
Possible aluminum wires observed from removed light fixtures. Aluminum wires pose as a safety hazard due to known risks with corrosion and overheating. Consult with licensed electrician for further review.

Exposed wires at ceiling, possible aluminum wires.

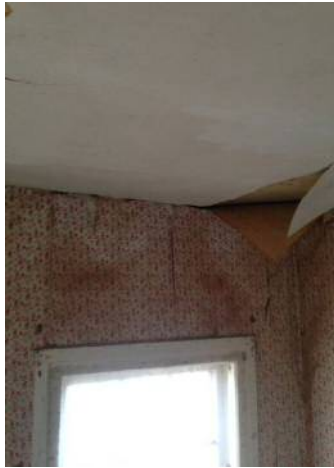
Water damage at ceiling.

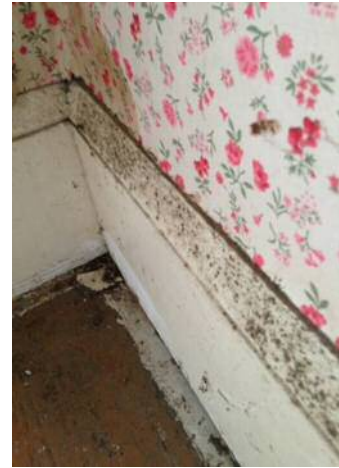
Mold growth.

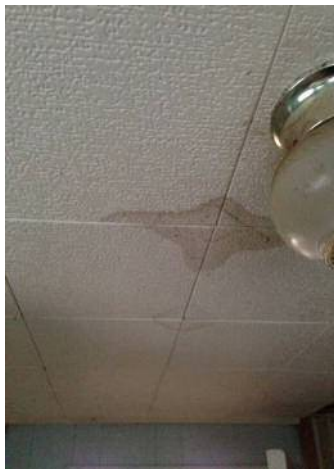
Water damage ceiling tile at rear addition. Possible asbestos tiles.

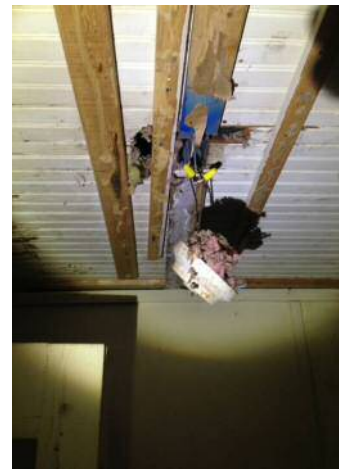
Loose hanging fixture with improper wiring methods.

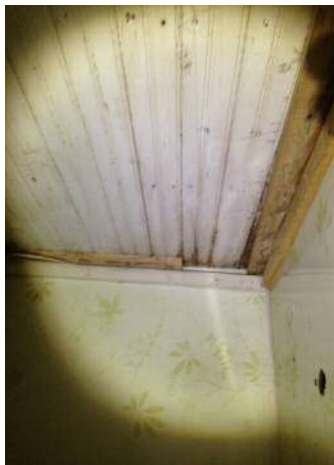
Water damage at lower level bathroom.

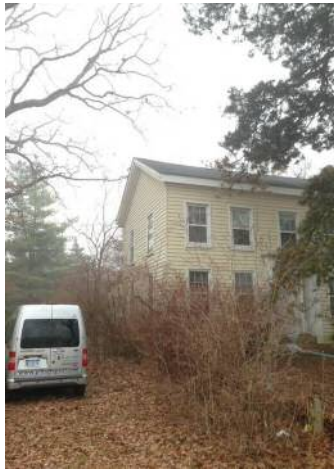
Overgrown landscaping.

Landscape is overgrown and requires major overhaul. Remove overgrowth and trees growing in close proximity of home.

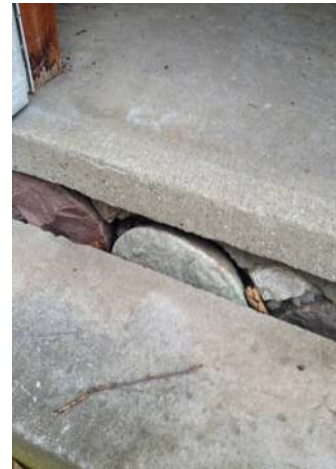
Loose field stone at porch and at rear structure.

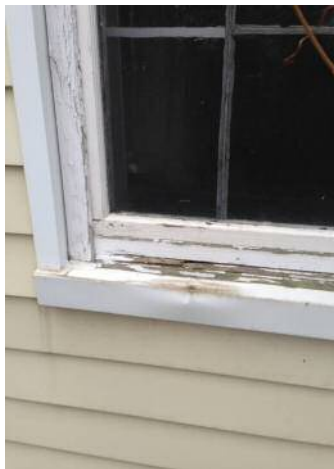
Peeling paint and rot at windows.

Windows are original to home and in poor condition. Recommend replacing windows to promote safety of home and to improve on efficiency on heat loss.

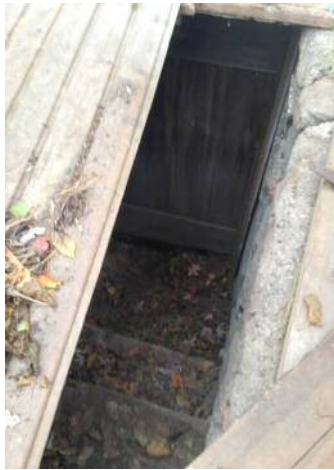
Damaged entry door down to walkout and rot observed at basement doors.

Basement walkout is in poor condition. Frost heave from hydrostatic pressure observed, no drain, entry doors require replacement due to rot. Contact licensed contractor to remove and replace walkout.

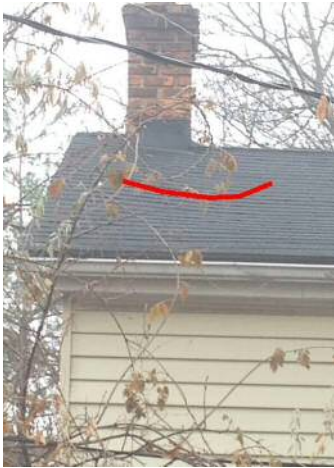
Sag observed at rear roof (requires additional structural support). Numerous shingles are pulling away from roof. Due to age and wear, recommend contacting licensed roofer for roof replacement.

Observed sag at rear roof structure.

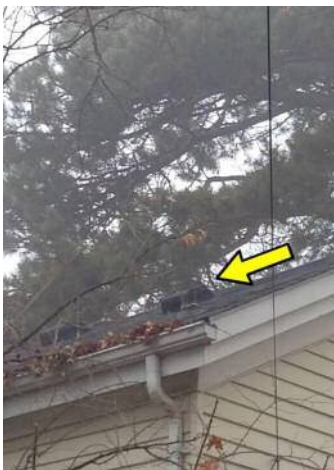
Damaged vent stack.

Replace damaged vent stack at south east corner of home. Contact licensed plumber to have extended minimally 6 inches away from roof.

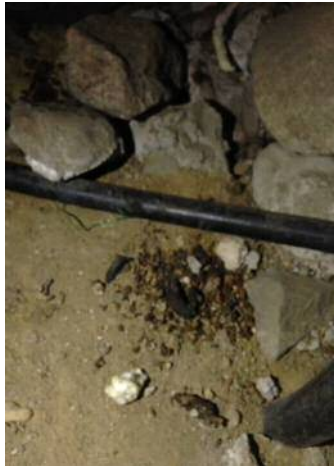
Earth floor and rodent excrement.

Portions of basement concrete floor is missing with exposure to earth floor. Recommend contacting qualified basement contractor to replace floor.

Animal excrement observed at multiple locations through basement. Recommend contacting exterminator for further assessment for removal and to deter from further entry. Multiple possible entry points observed through band joists and at walkout basement door.

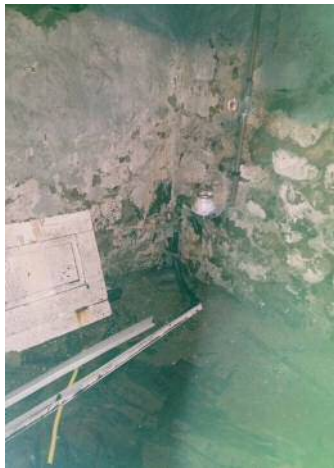
Water penetration and cracks at stone foundation wall.

Water penetration observed at multiple locations throughout basement. Foundation cracks observed which require immediate repairs and pose as a structural concerns to home. Strongly advise having basement further evaluated/assessed by structural engineer for immediate repairs.

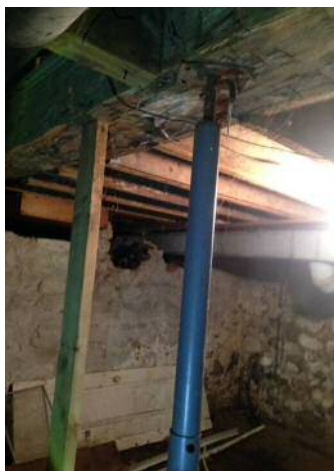
Main support beam is no longer structurally sound. Beam has lean, twist (from torque), and sag. Replace old timber beam to re-support home ASAP by structural contractor.

Improper support posts and torque at support beam.

Numerous posts are no longer level and have moved. Posts do not have appropriate footings and sit on earth floor or broken cement. Contact structural contractor for immediate replacements.

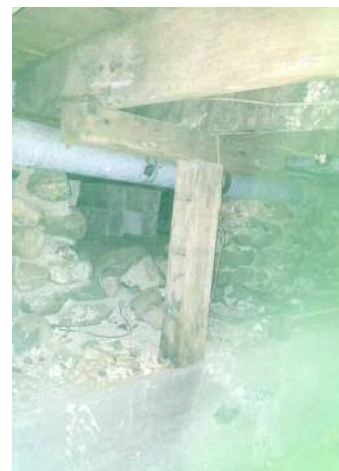
Improper support post at crawlspace.

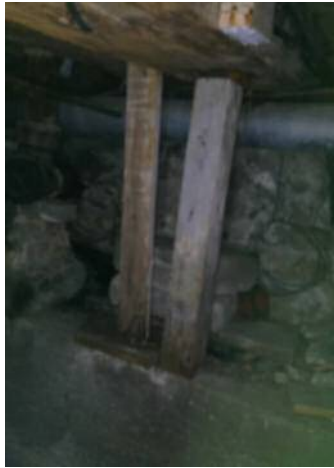
Improper support posts at crawlspace.

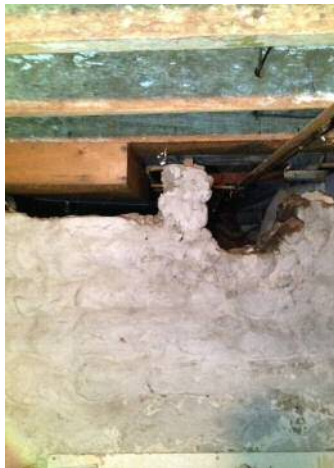
Damaged bearing wall, structurally unsound, and lean at load bearing wall.

Load bearing wall is no longer structurally sound as evident due to northern lean. Portions of wall have been removed or damaged from movement. Contact structural engineer for immediate repairs!

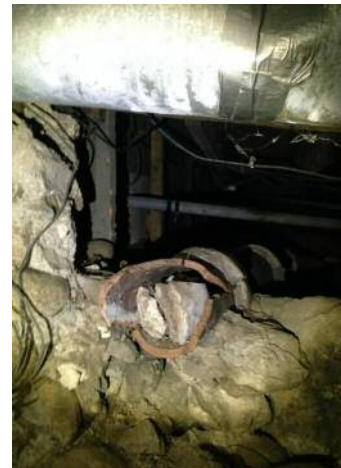
Compromised load bearing wall.

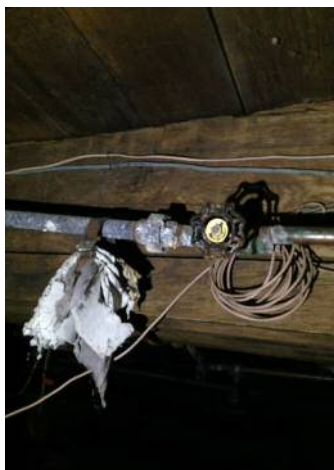
Damaged piping.

Portions of piping are missing from theft and other portions are damaged from frozen temperatures and neglect. Plumbing system will require complete removal and replacement.

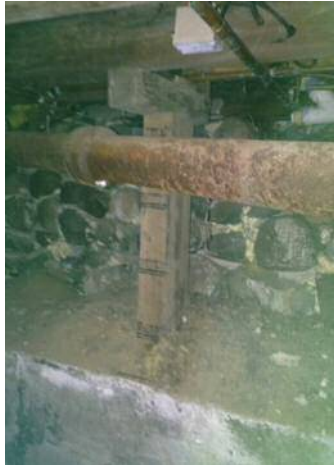
Corroded waste stack requires immediate replacement due to risk for sewage leaks.

Cast iron waste stacks are in poor condition from corrosion and require replacement. Contact licensed plumber for replacement.
