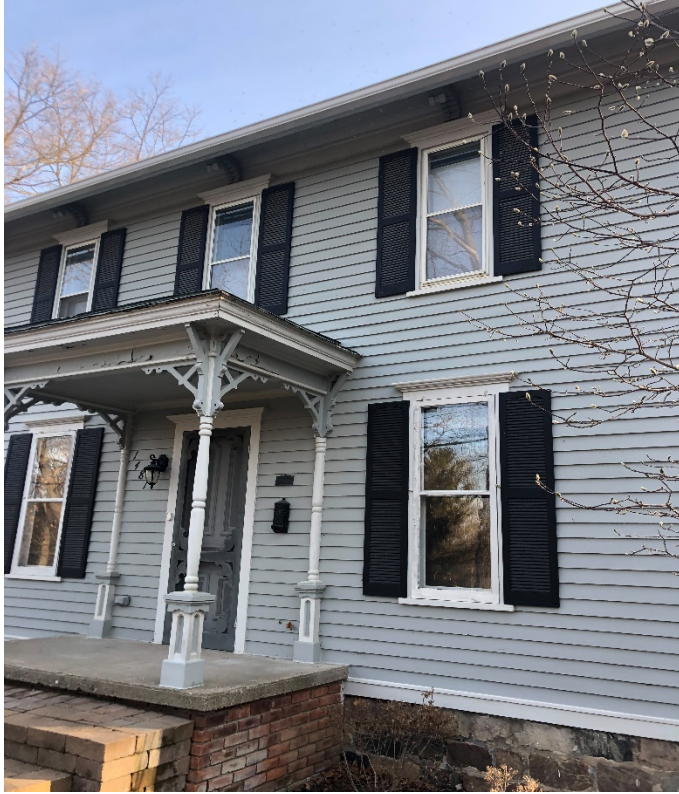
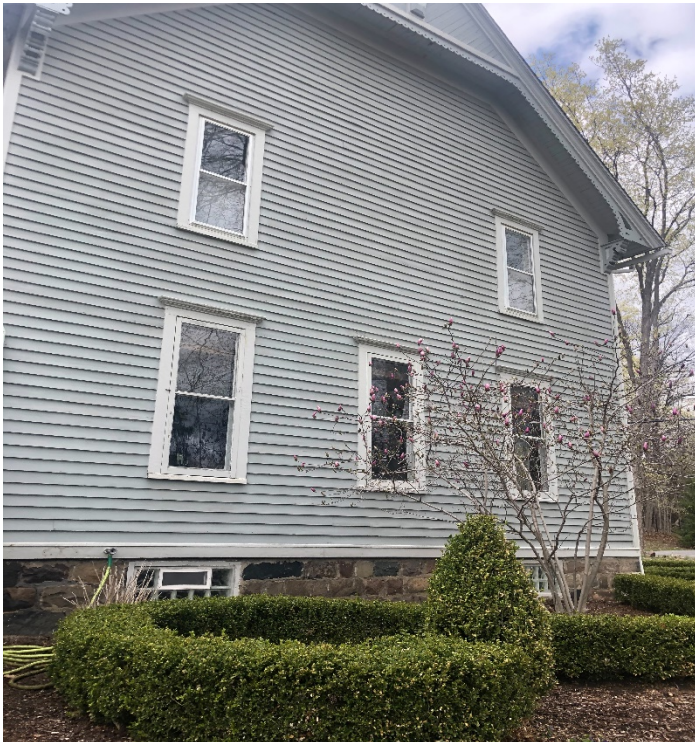
Wood lower storms will be restored and reused. Uppers are metal and broken and will be removed.

Existing windows are not original to the house and are not efficient.

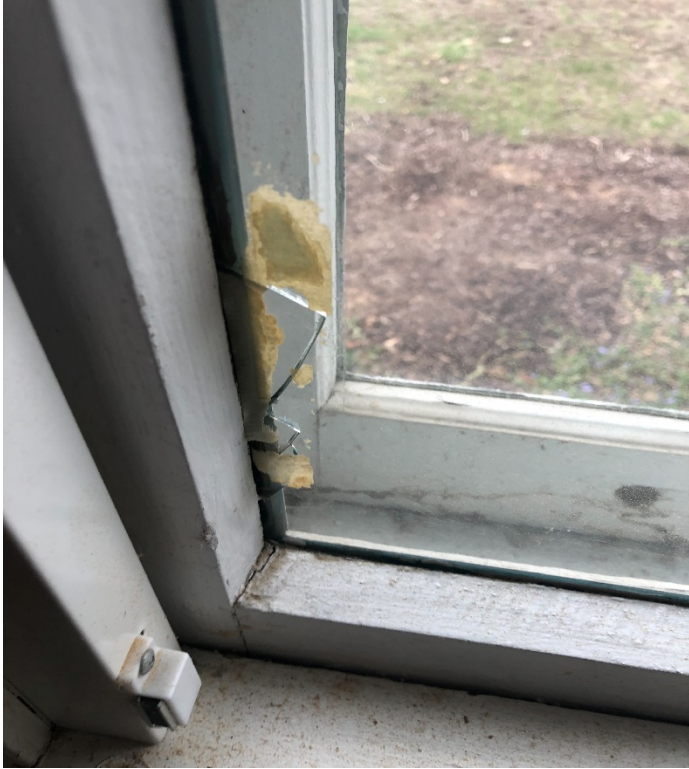
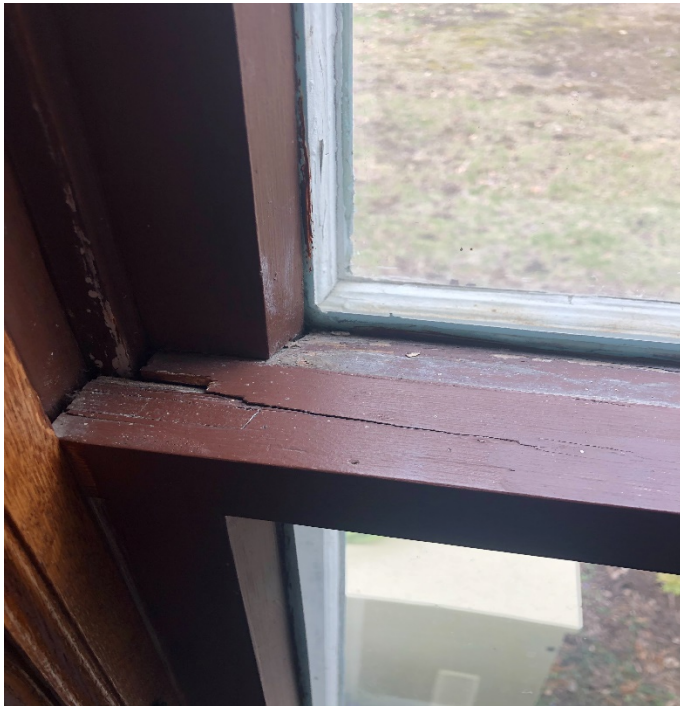
Most of the windows are cracked, warped, broken, and do not open due to many layers of paint.
Replacing just the sashes. Full wood window protected by Fibrex® composite exterior.

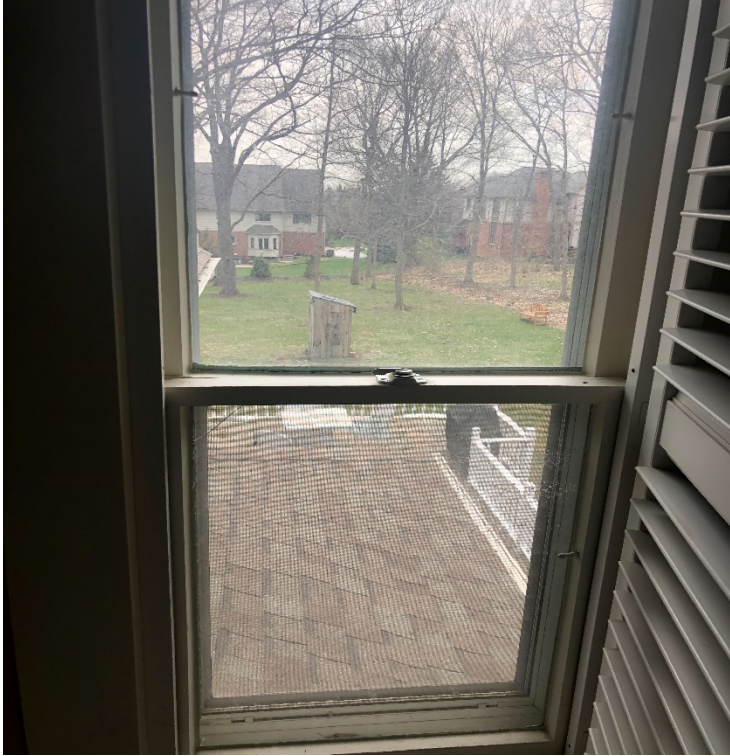
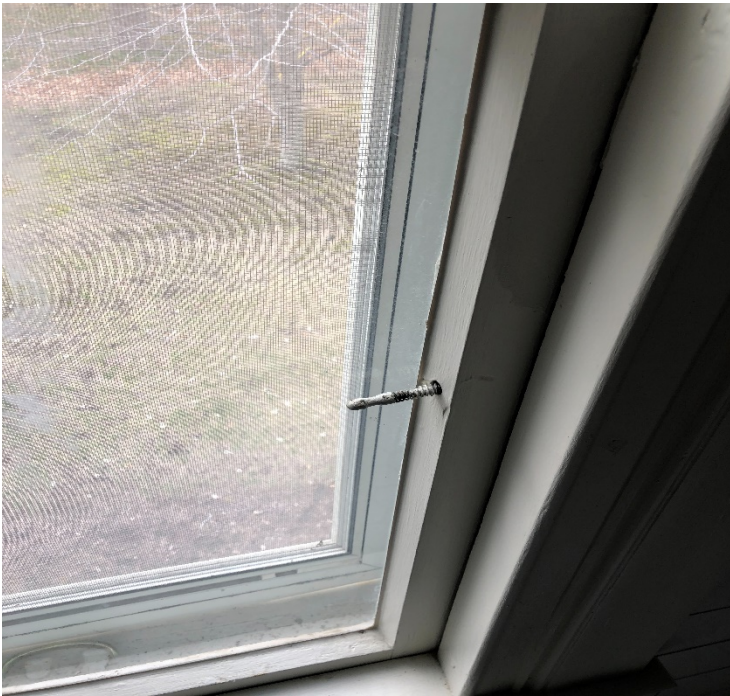
Windows rattle due to proximity to Dutton Road.
