HUBBELL, ROTH & CLARK, INC
Consulting Engineers

Re: 2008 Pedestrian Bridge Inspections

2008 Pedestrian Bridge Inspections,
City of Rochester Hills

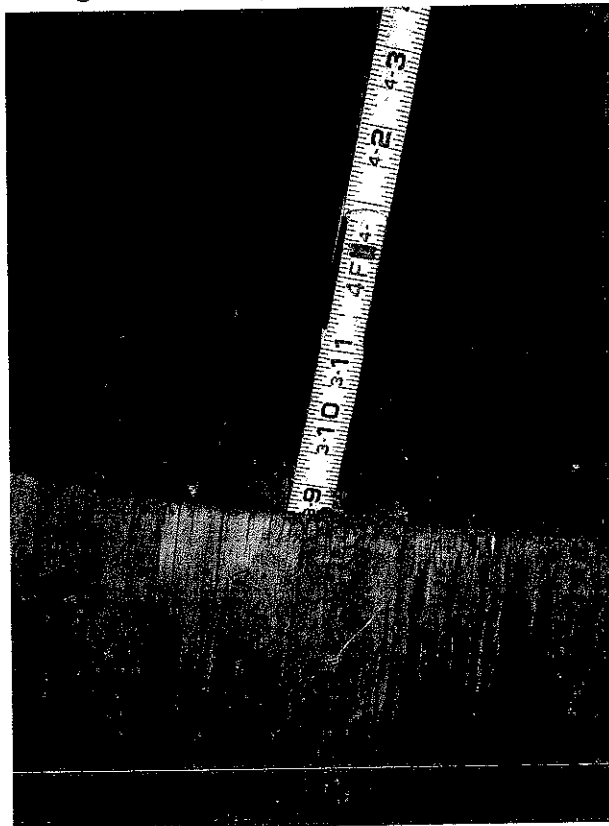
Bridge No. 5: Hollow Timber Piles

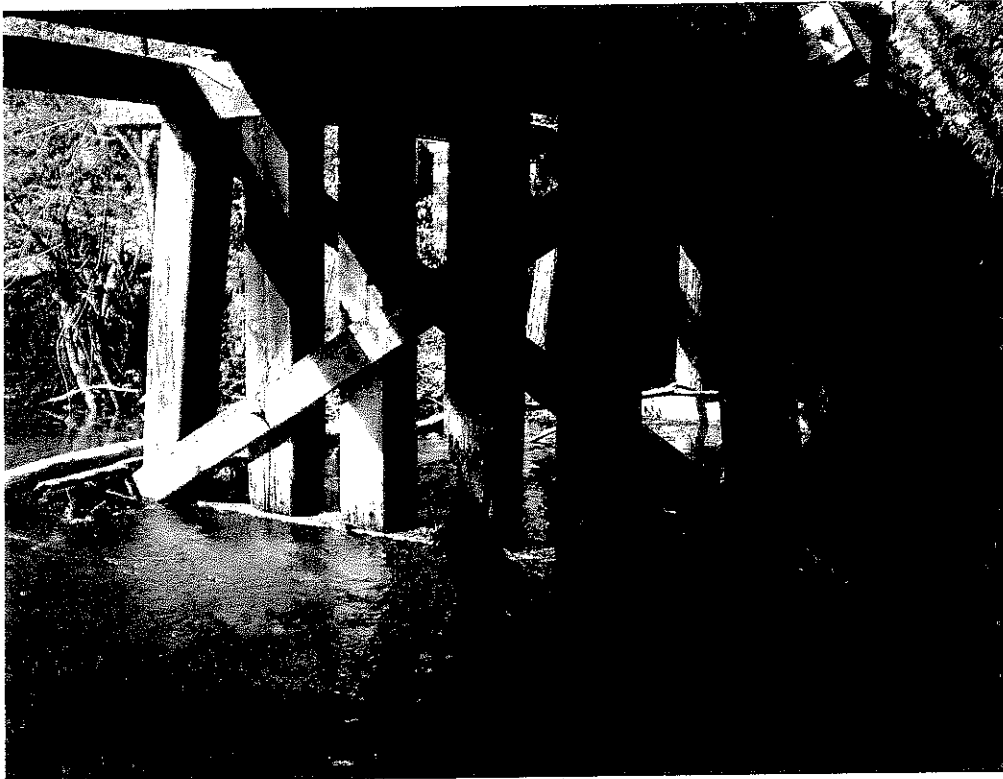
10. FLOOR BEAMS / TIMBER TIES	6				15.) SIGNIFICANT AMOUNT OF STUB COLUMN DECAY OF THE NORTH TIMBER BENT / PIER NEAR WATER SURFACE HAS OCCURRED. ABOUT 50% SECTION LOSS OF TWO STUB COLUMNS AND ABOUT 30% SECTION LOSS OF THE REMAINING STUB COLUMNS NOTED. FURTHER DETAILED TIMBER BENT INSPECTION RECOMMENDED.

Bridge No. 11: Decayed Timber Stub Columns

24. CHANNEL PROTECTION	NA				RECOMMENDATIONS: 2.) REMOVE DEBRIS AND FOLIAGE AND RESEAL TIMBER DECK BOARDS. DETERMINE DECK WIDTH COMPLIANCE W/ AASHTO STANDARDS. 5.) REPAIR LOOSE RAILING CONNECTIONS AND REPAINT RAILING. LOCALLY REPLACE TOP RUB RAILS. 10.) SEAL ENDS OF TIMBER TIES AND REMOVE FOLIAGE. 15, 16.) PERFORM A DETAILED INSPECTION OF THE TIMBER PILES AND BENTS AND PERFORM A LOAD RATING ANALYSIS BASED ON FINDINGS.

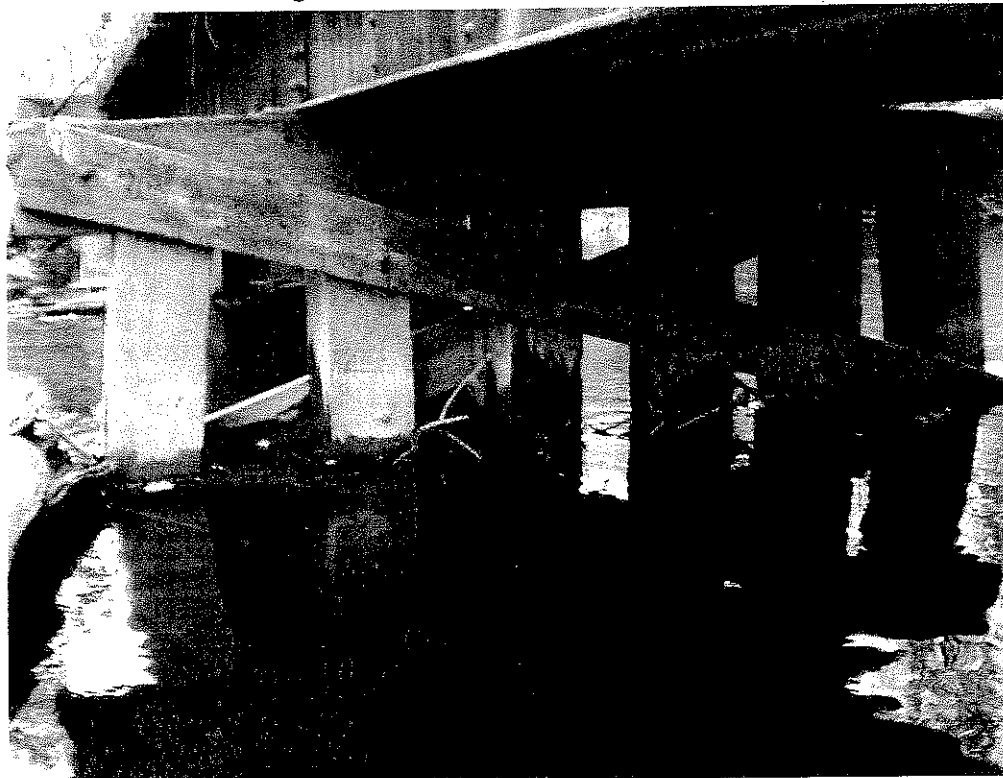
9. STRINGERS	7				15.) 2ND & 3RD BENT FROM THE NORTH - SEVERAL AREAS OF SIGNIFICANT STUB COLUMN DETERIORATION DECAY NOTED, ESPECIALLY NEAR THE WATER SURFACE. ALSO, SOUTH ABUTMENT STUB COLUMN DECAY OBSERVED. FURTHER DETAILED INSPECTION OF STUB COLUMN AND BENTS RECOMMENDED.

Bridge No. 12: Decayed Timber Stub Columns

21. SLOPES	NA				
	22. RAILING	6				
HYDRAULICS	23. SUBSTRUCTURE SCOUR	7				
	24. CHANNEL PROTECTION	NA				RECOMMENDATIONS: 2, 10.) REPLACE TIMBER DECK BOARDS AND FASCIA BOARDS AS REQUIRED. RESEAL DECK. REPLACE DECAYED TIMBER TIES AS REQUIRED. 5.) LOCALLY REPLACE TOP RUB RAIL AND RETIGHTEN CONNECTIONS. 15, 16.) PERFORM A DETAILED INSPECTION OF THE TIMBER PILES AND BENTS AND PERFORM A LOAD RATING ANALYSIS BASED ON FINDINGS.
