## Investigation Report

Carnaghi Structural Consulting Project No: 21056

Report Date: October 19, 2021

Property Name: 1021 Harding Ave.  
Property Address: 1021 Harding Ave.  
Rochester Hills, MI 48307

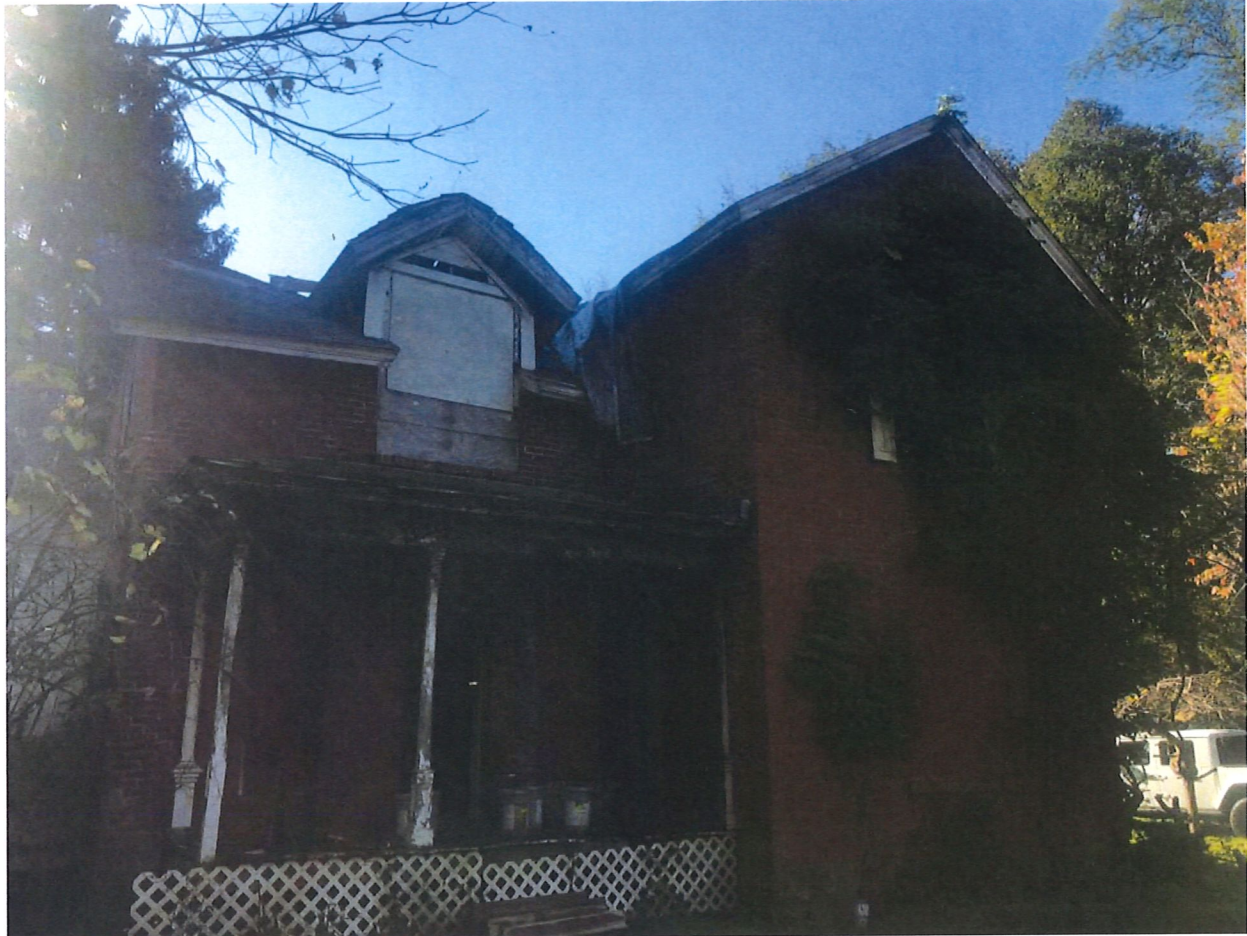
Front of subject structure looking south.

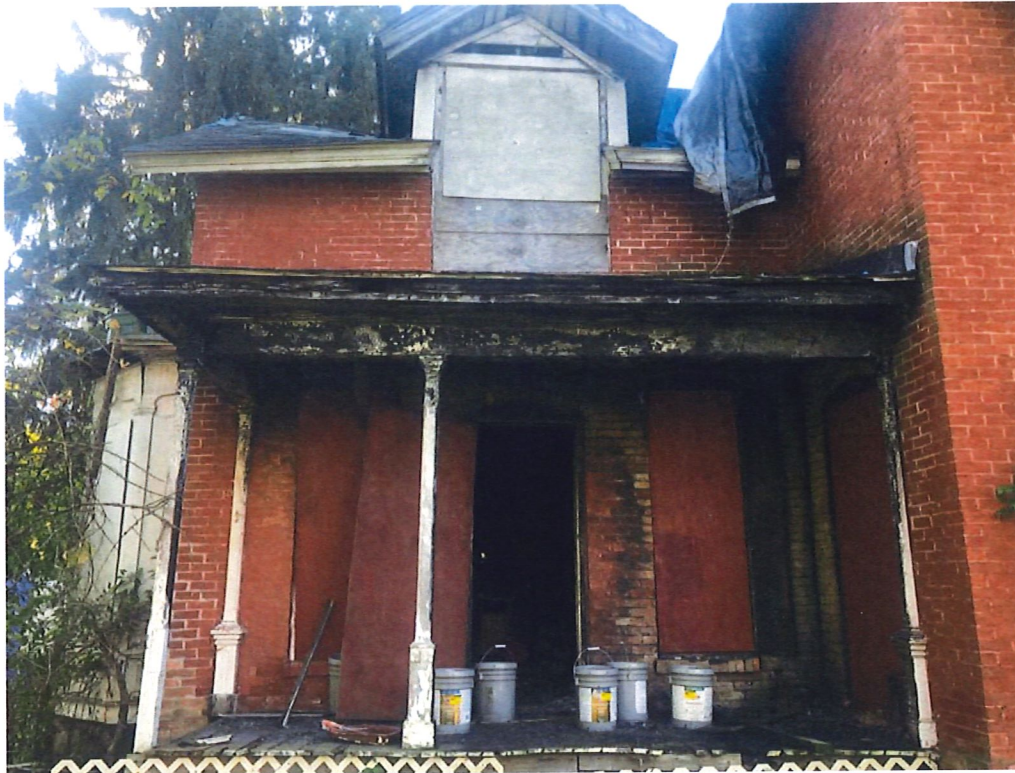
Front porch on north side of structure. Note portion of roof missing behind dormer.

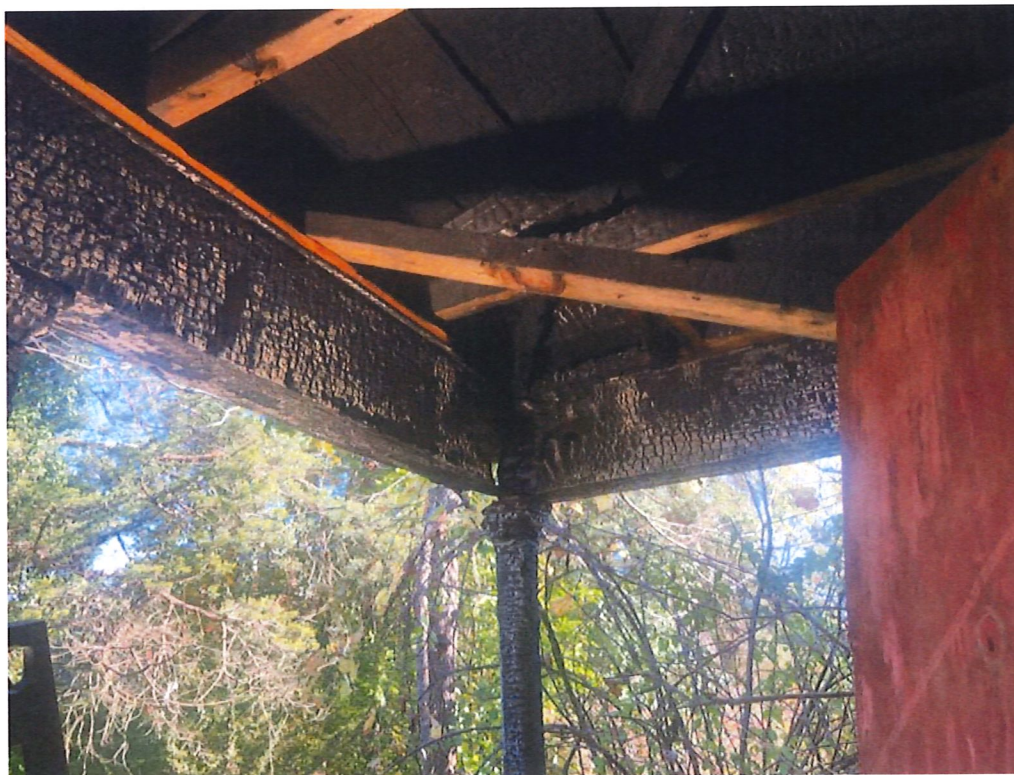
Alternate view of front porch at northeast corner.

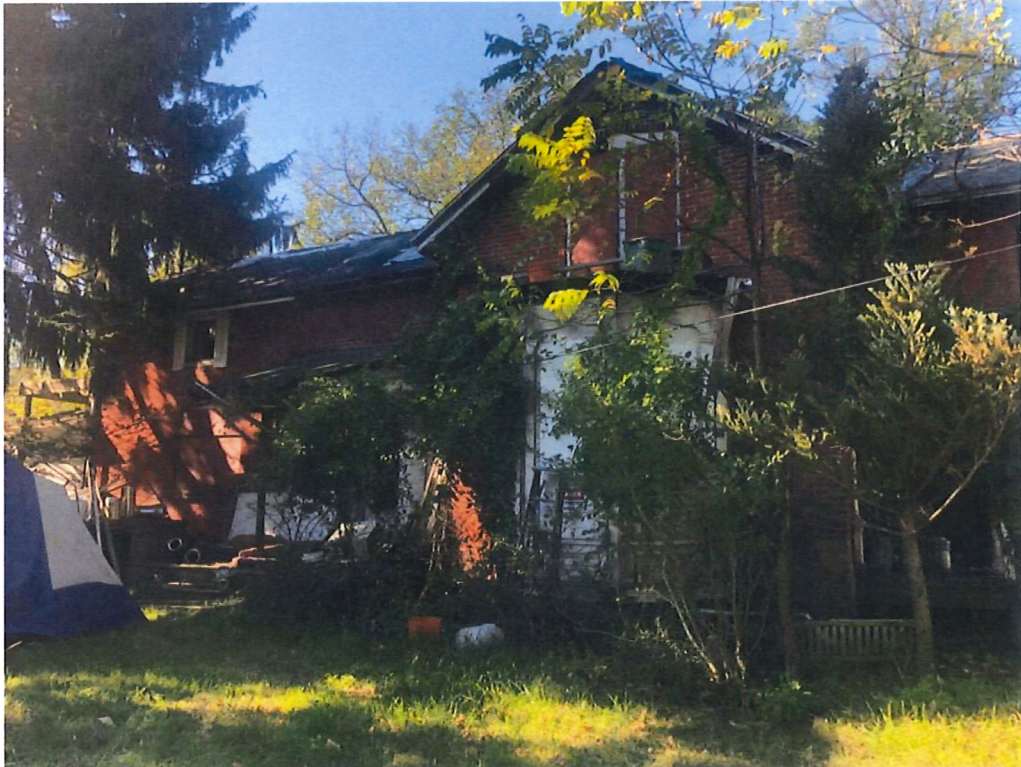
East side of subject structure looking southwest.

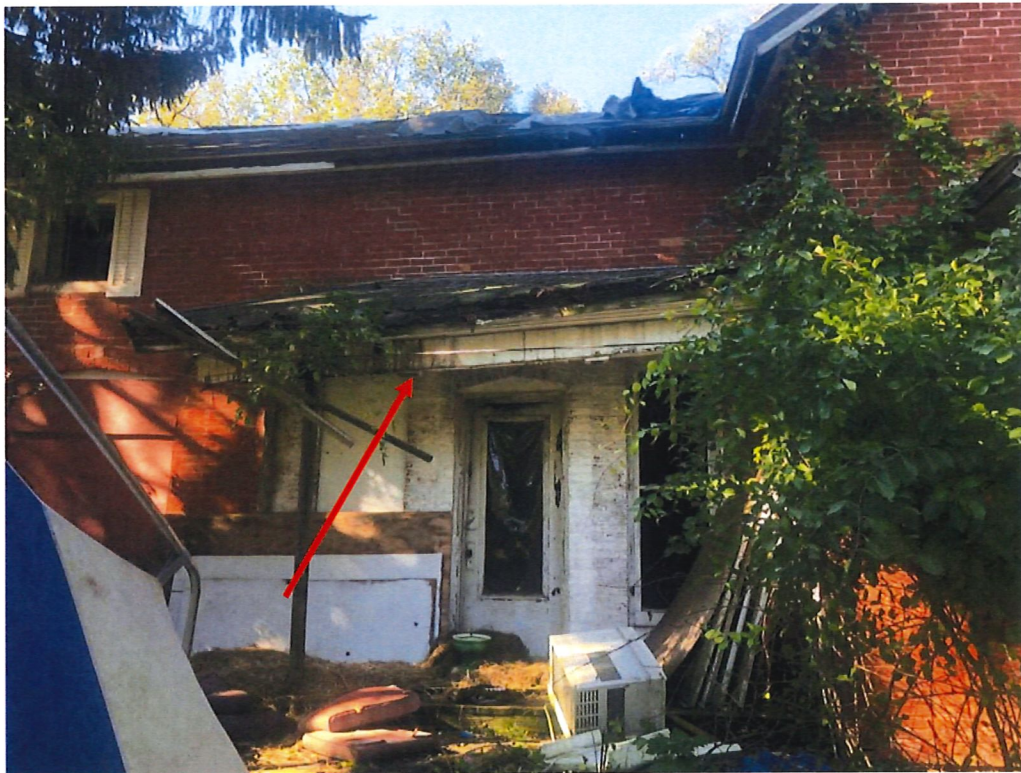
Arrow points to deteriorated roof framing over porch at east entry.

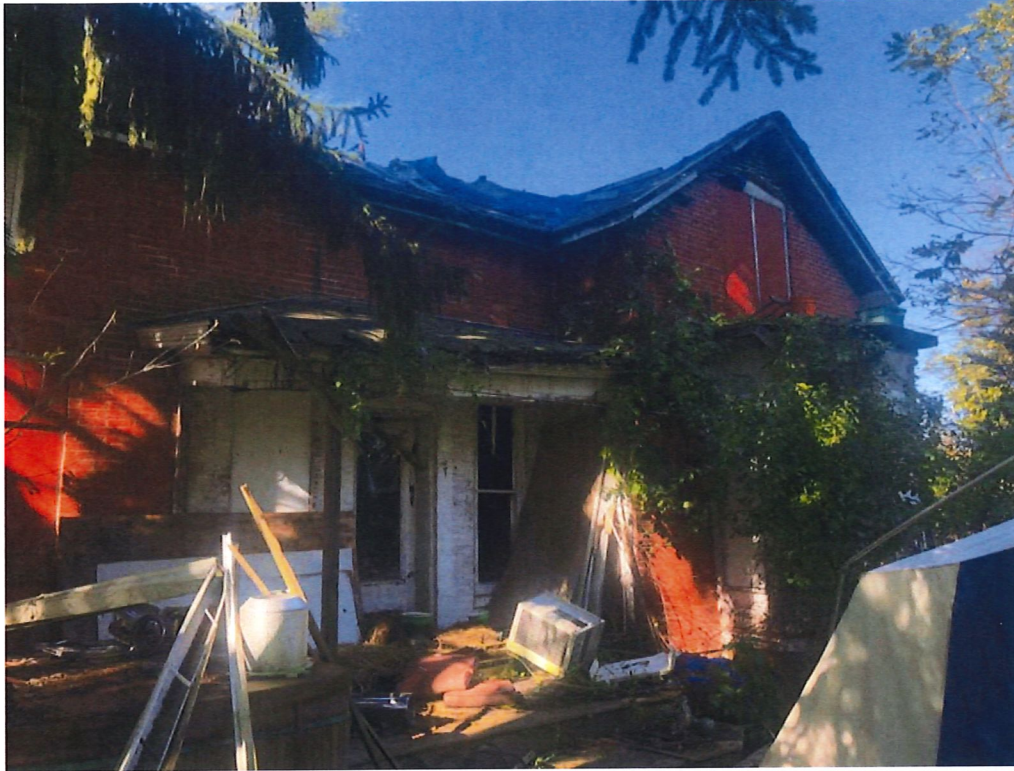
Alternate photograph of east side of structure looking northwest. Note missing roof area.

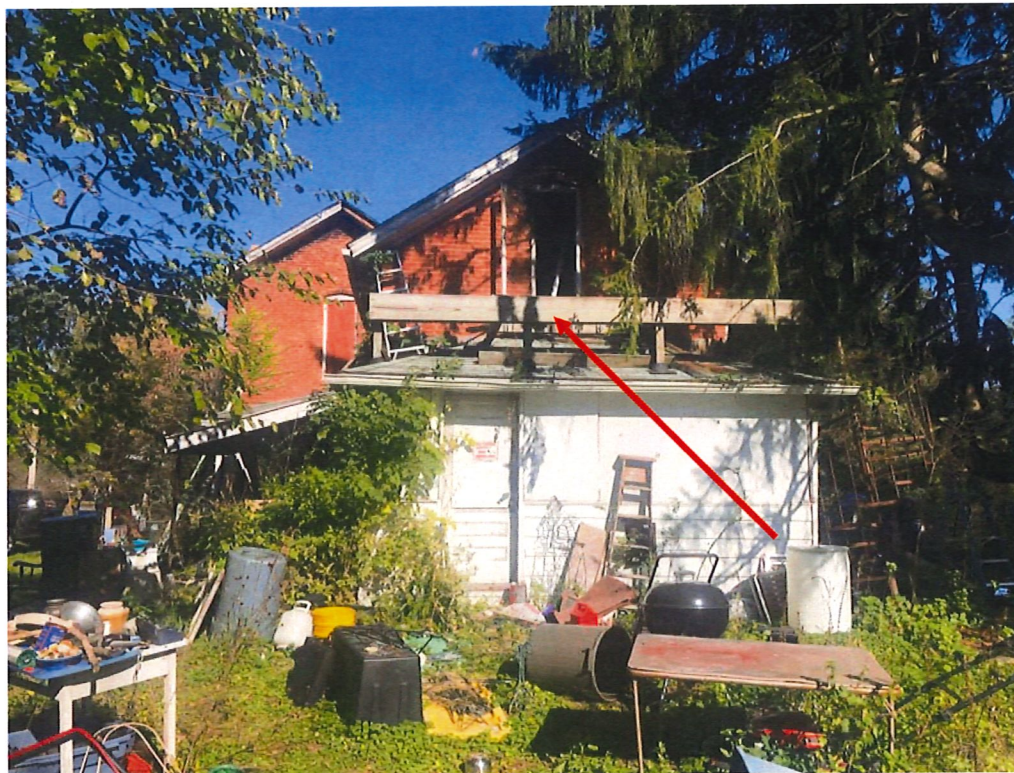
Rear, south side of structure looking north. Note unconventional framing over one-story portion.

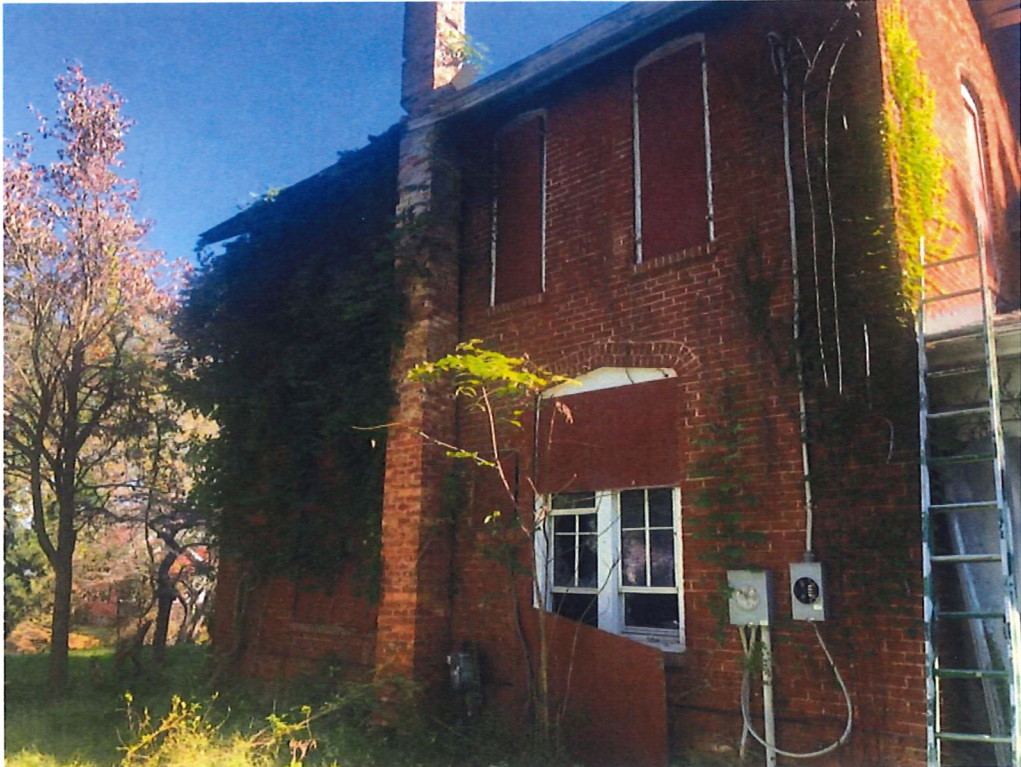
West side of structure looking northeast. Note chimney displaced away from structure.

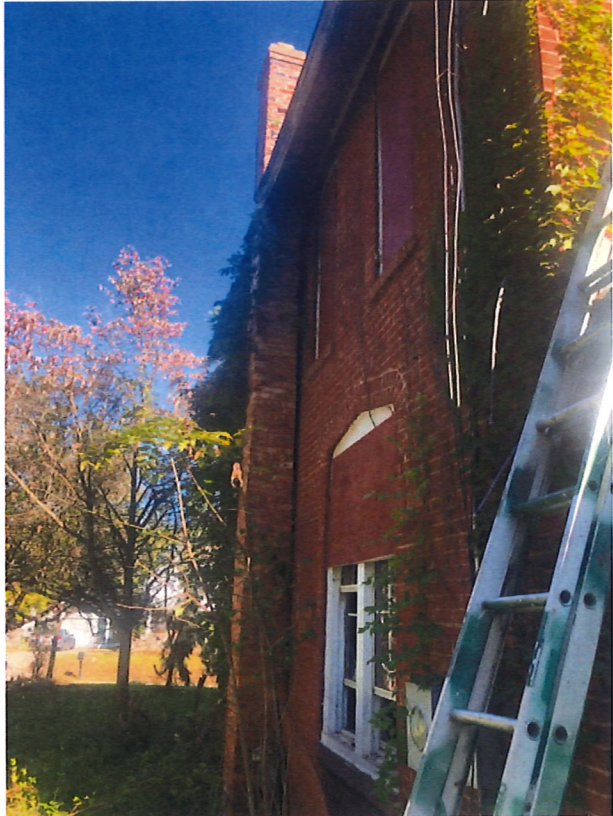
Alternate view of chimney displaced away from structure.

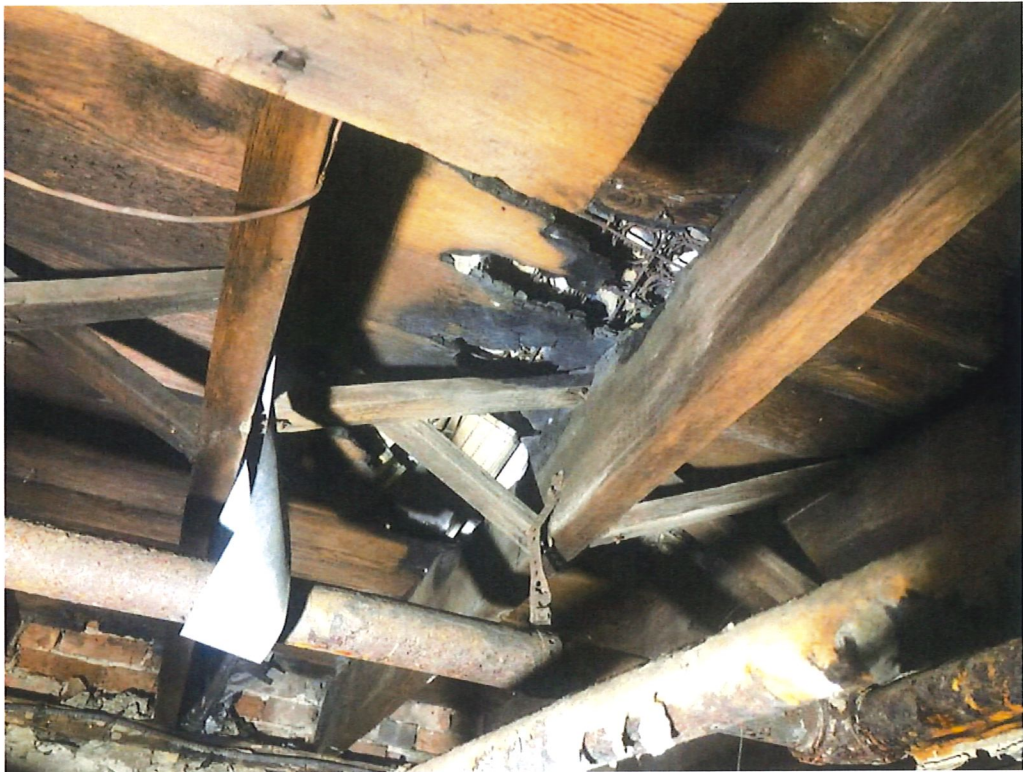
Portion of first floor framing with fire damage.

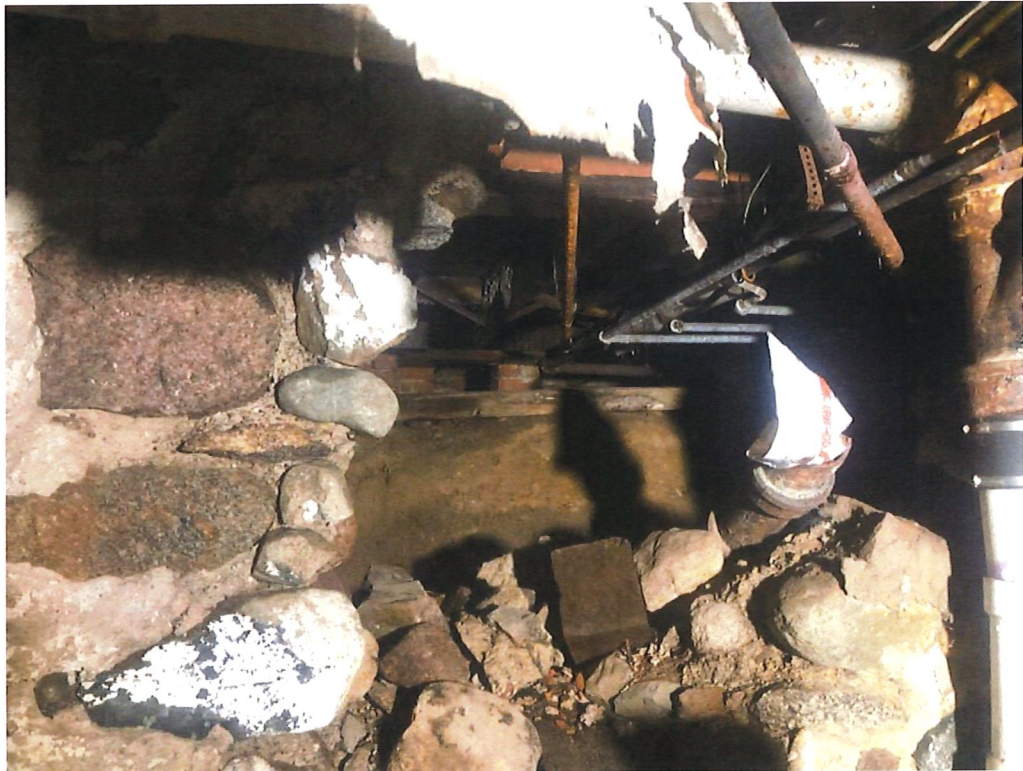
View into crawl space.

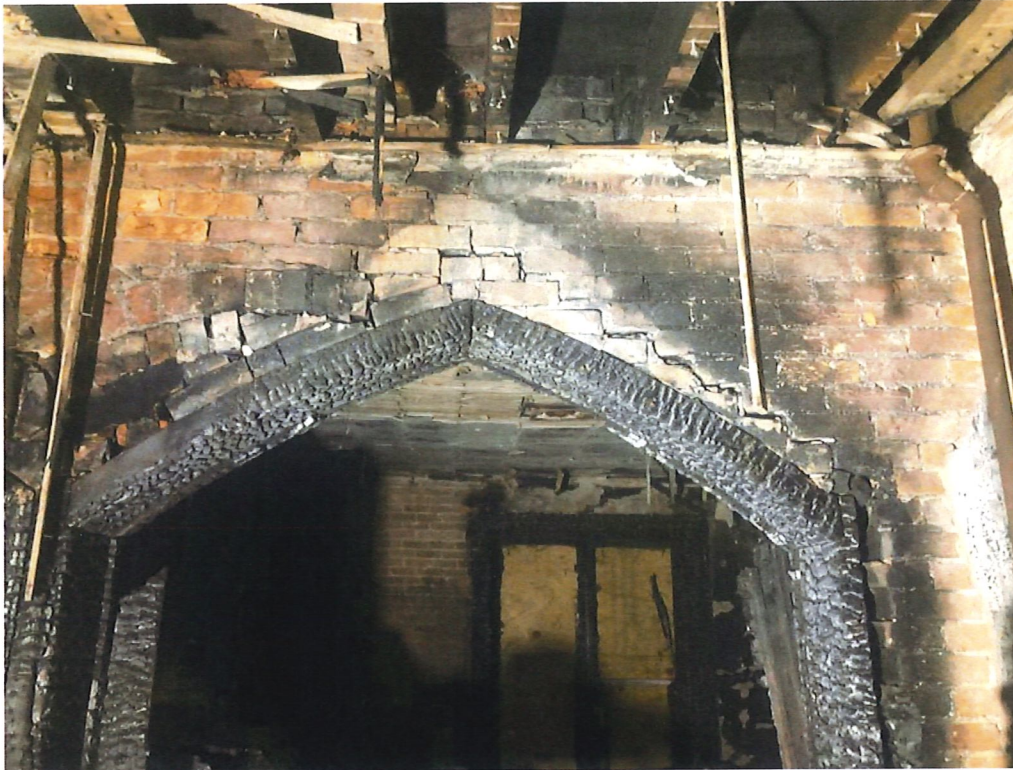
Interior structural brick wall damaged at opening on first floor.

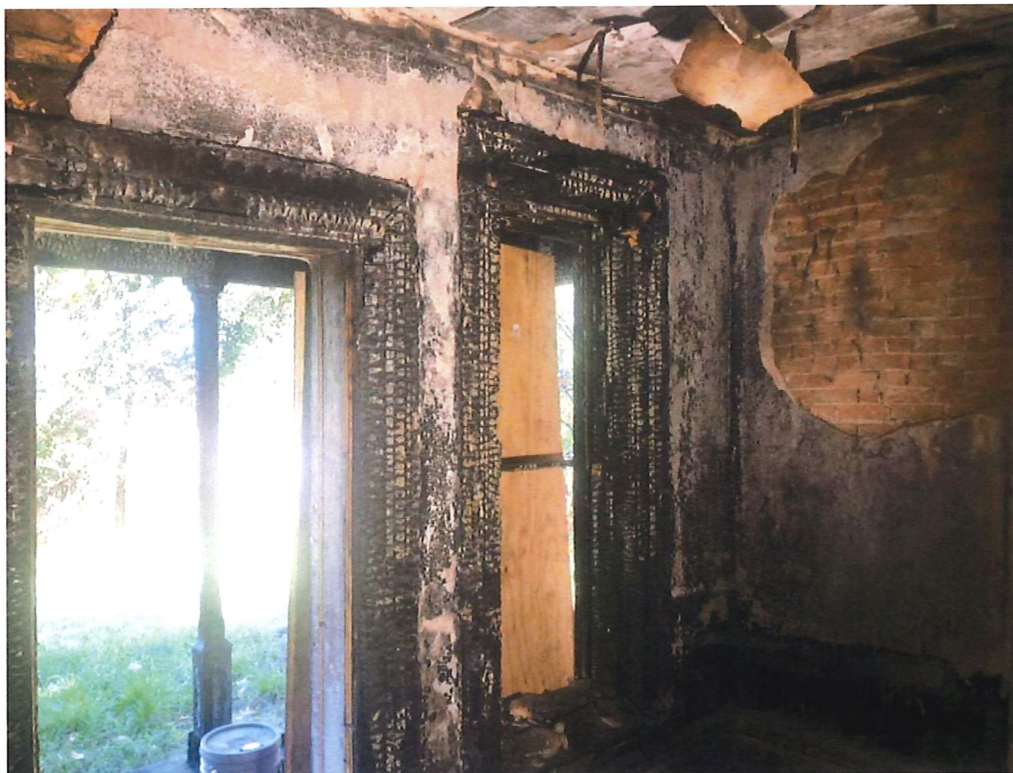
Exterior brick wall. Note that there were no wall studs against the brick.

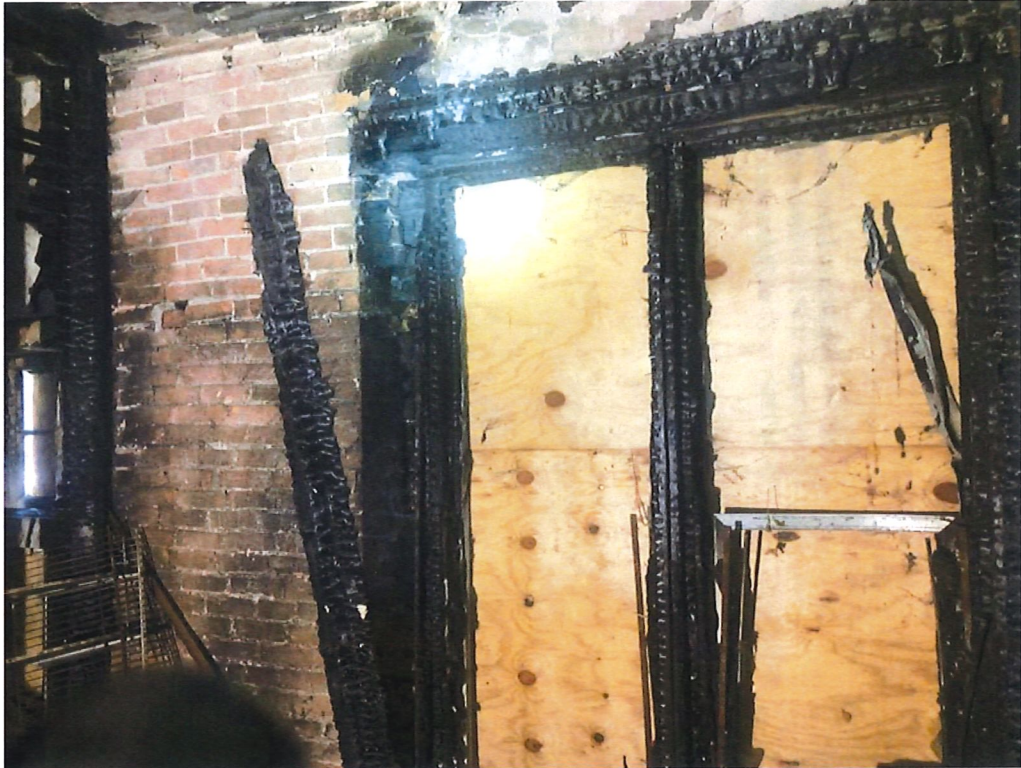
Another example where there were no interior wall studs against the exterior brick.

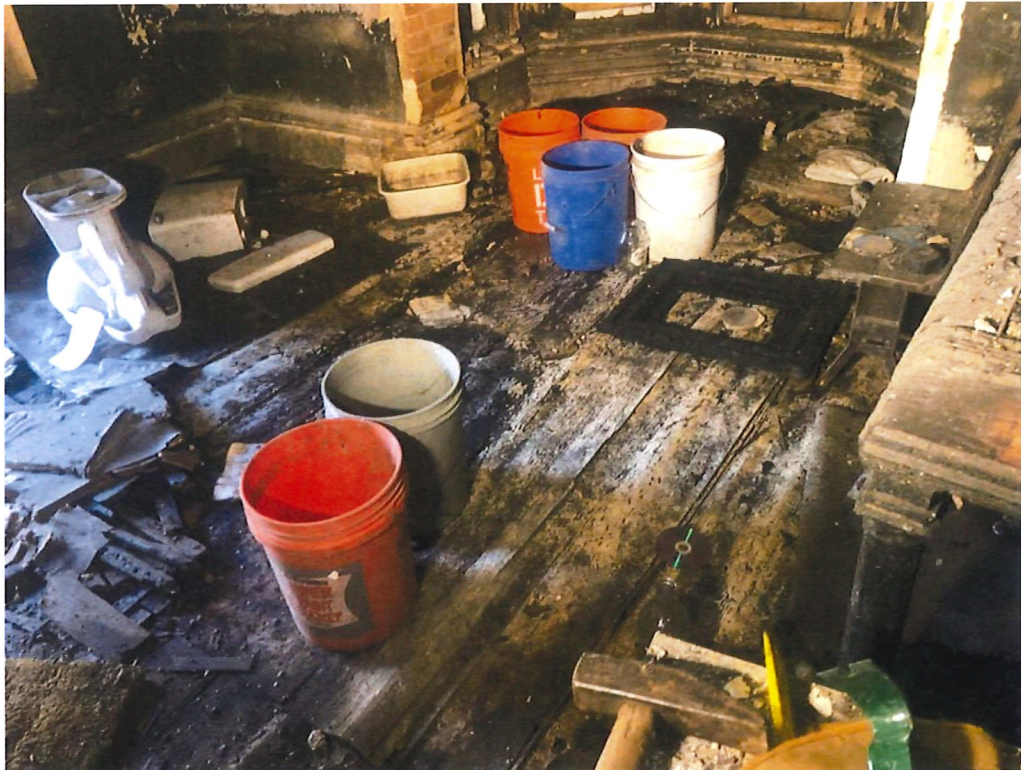
Delaminated flooring at first floor. Note buckets to collect water.

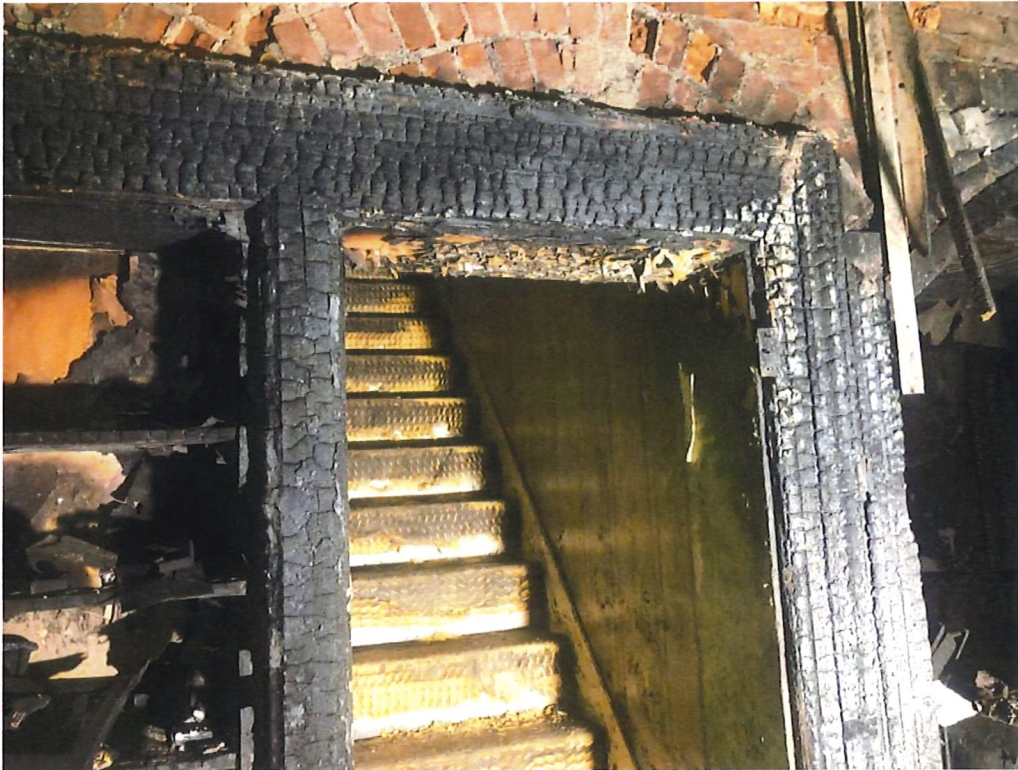
Access stair to second floor with limited head room.

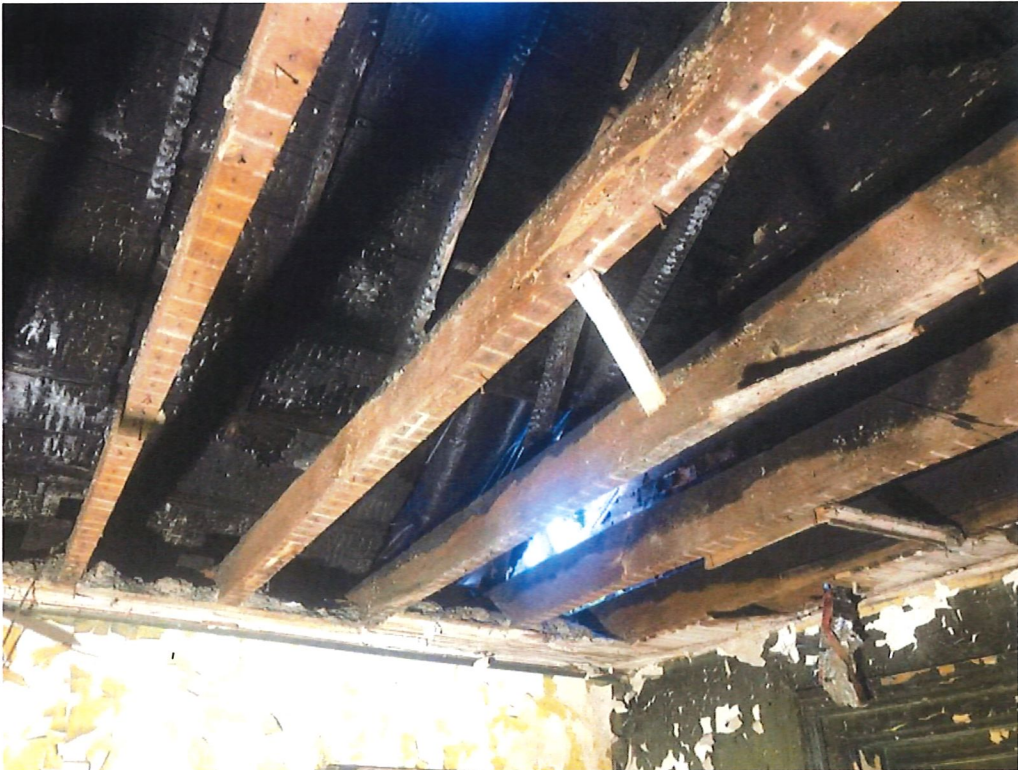
Roof and ceiling framing over second floor.

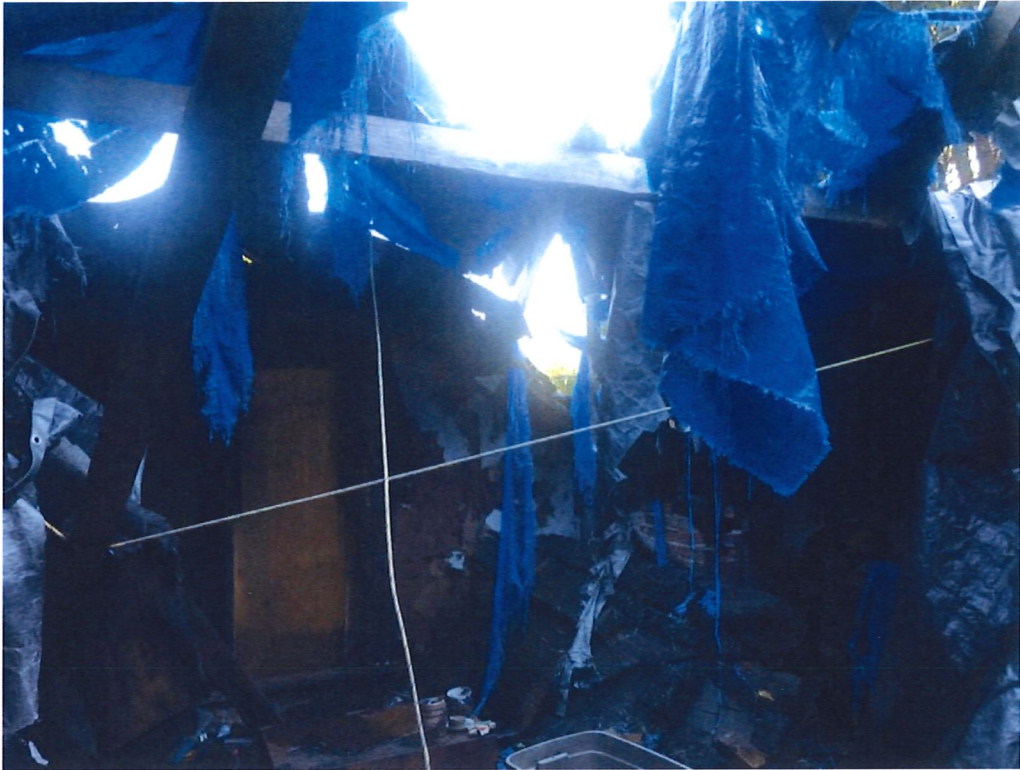
Roof and ceiling framing missing over portion of second floor.

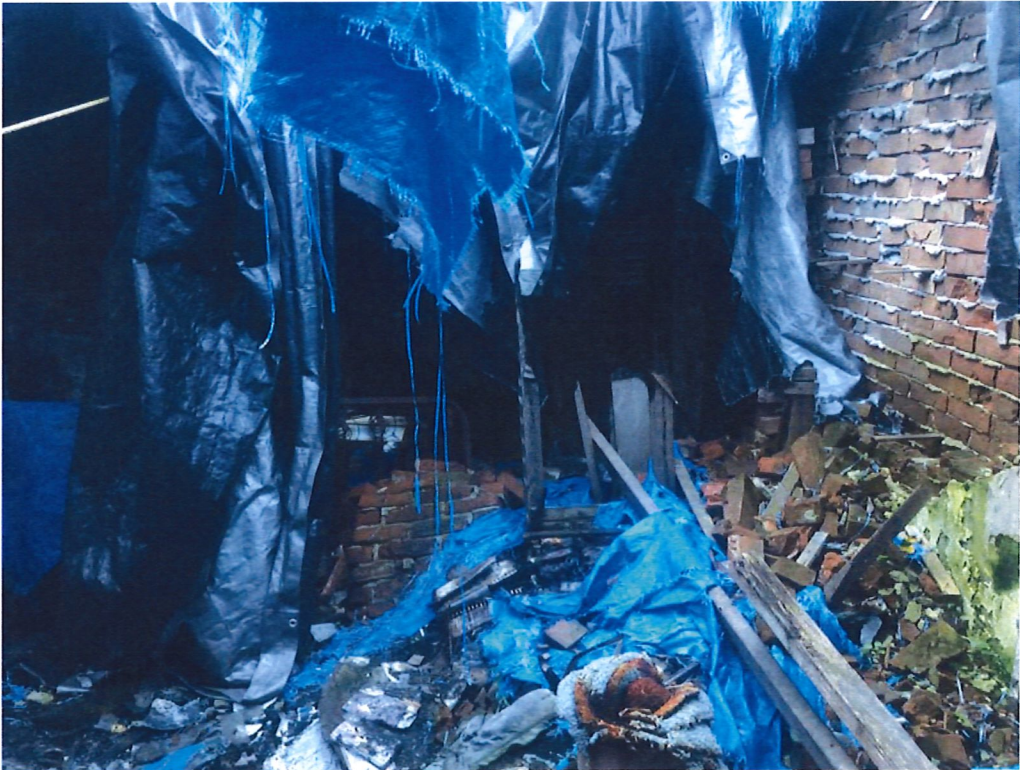
Failed load bearing brick wall at second floor.

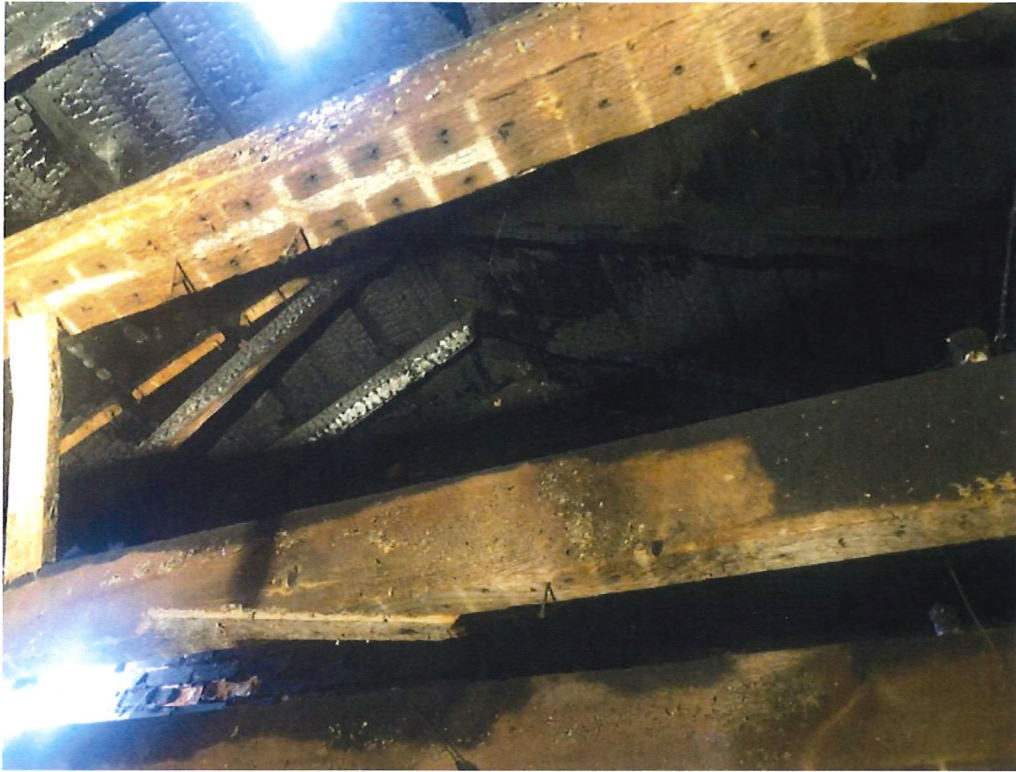
Alternate photograph of roof and ceiling framing over second floor.

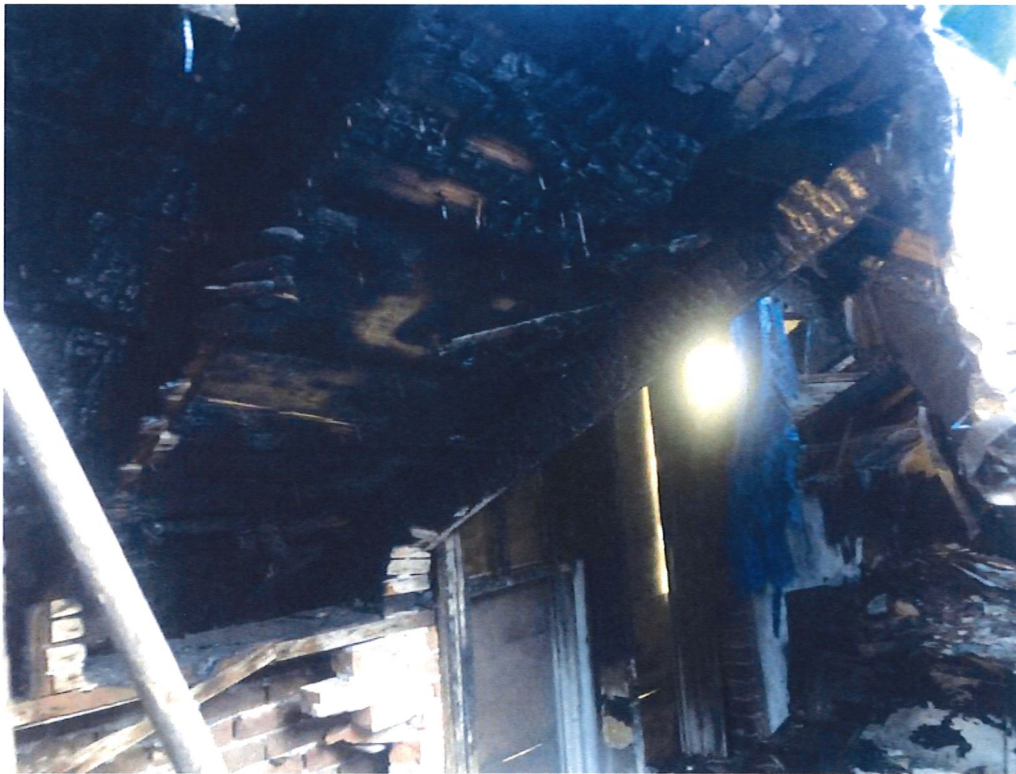
Alternate photograph of roof and ceiling framing over second floor.
