## PRE-DEMOLITION ASBESTOS CONTAINING MATERIALS SURVEY

### **Gasoline Dispensing Station and Canopy**

975 South Rochester Road | Rochester Hills, MI  
PM Project Number 01-11390-0-0004

June 9, 2021

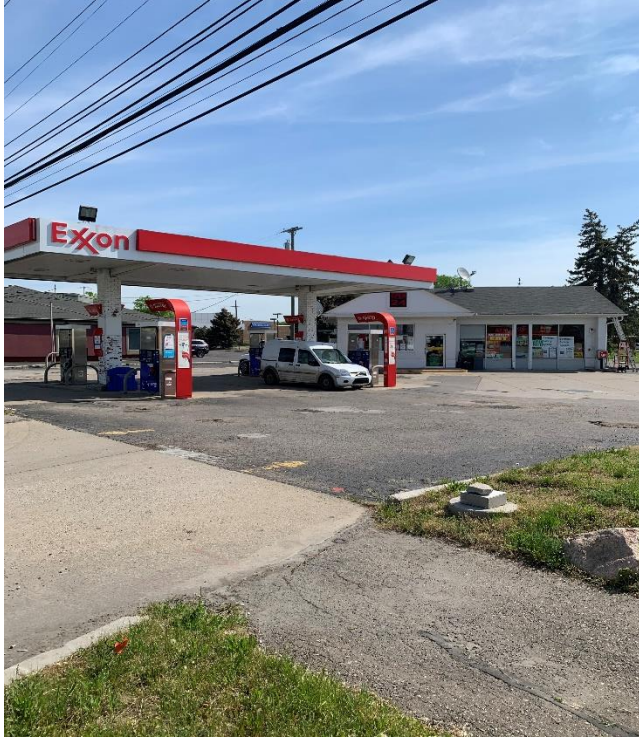
### Photograph 1

View of Subject Property

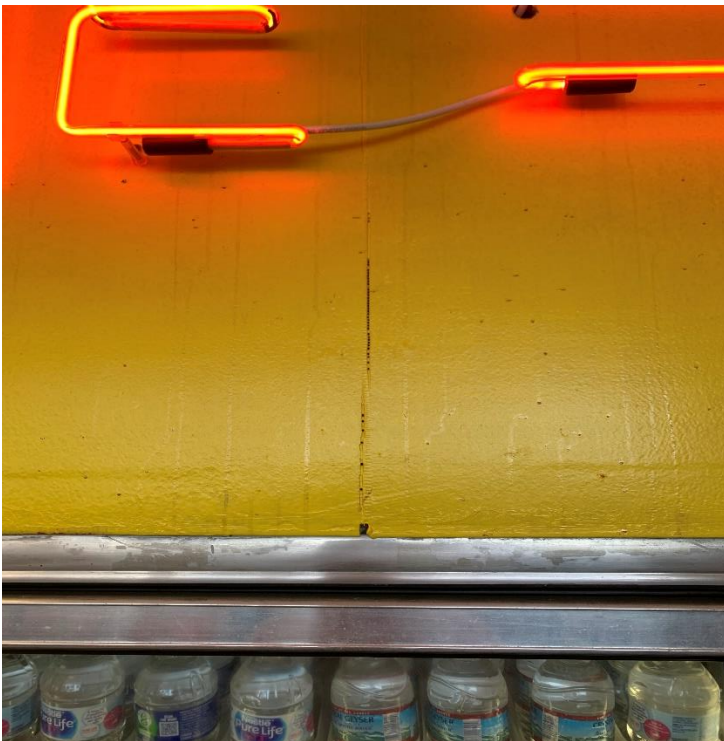
### Photograph 2

View of Drywall and Joint Compound  
(HA1)

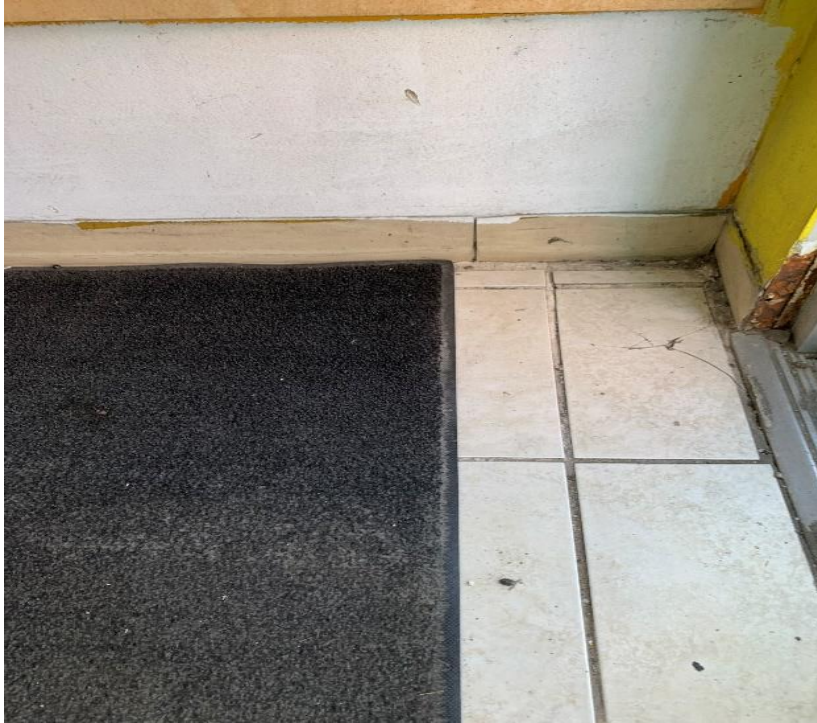
### Photograph 3

View of Tan Cove Base and Adhesive  
(HA2)

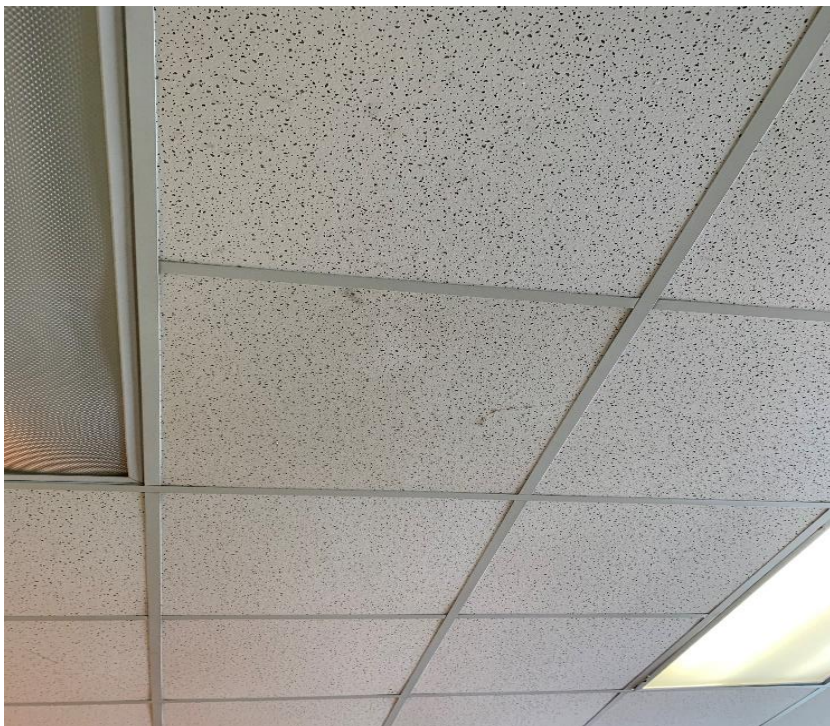
### Photograph 4

View of 2' X 2' Suspended Ceiling Tile – Pin  
Holes  
(HA3)

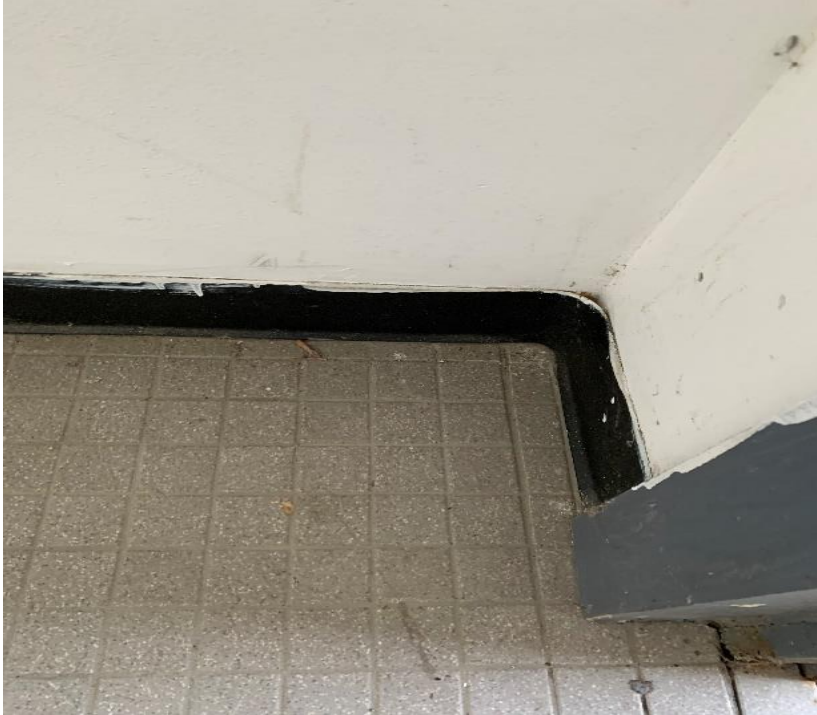
### Photograph 5

View of Black Cove Base and Adhesive  
(HA4)

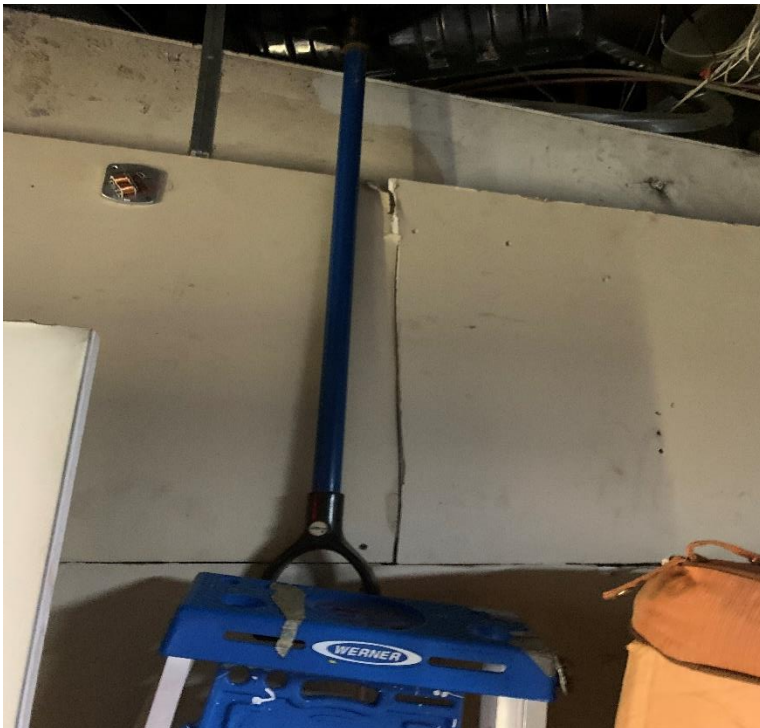
### Photograph 6

View of View of Unfinished Drywall  
(HA5)

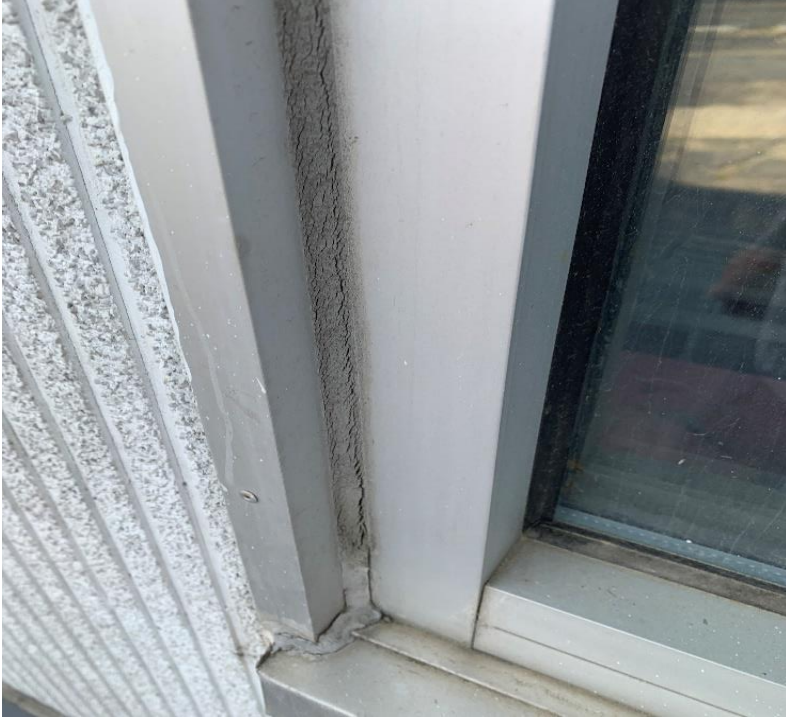
### Photograph 7

View of Exterior Door and Window Caulking  
(HA6)

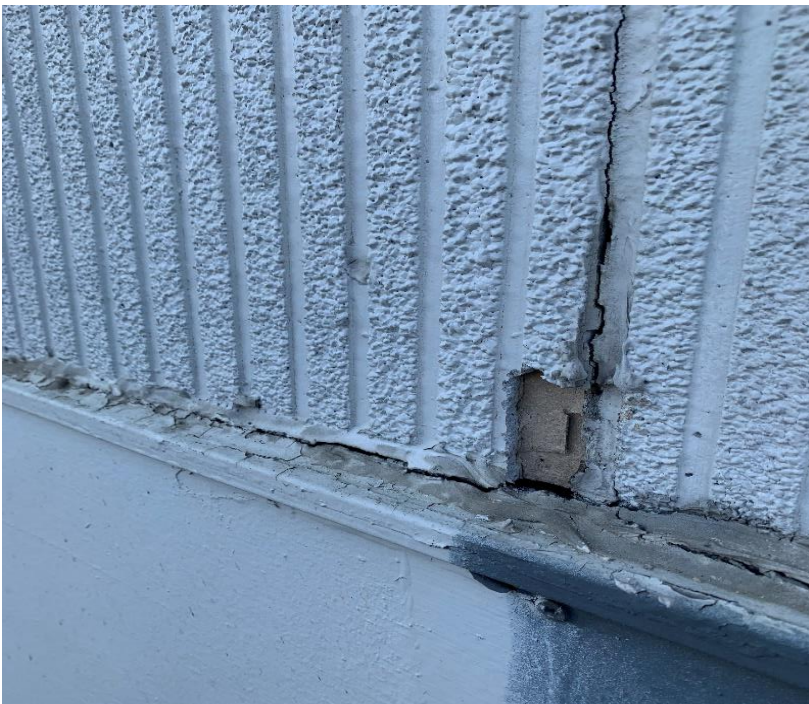
### Photograph 8

View of Exterior Cement-like Siding  
(HA7)

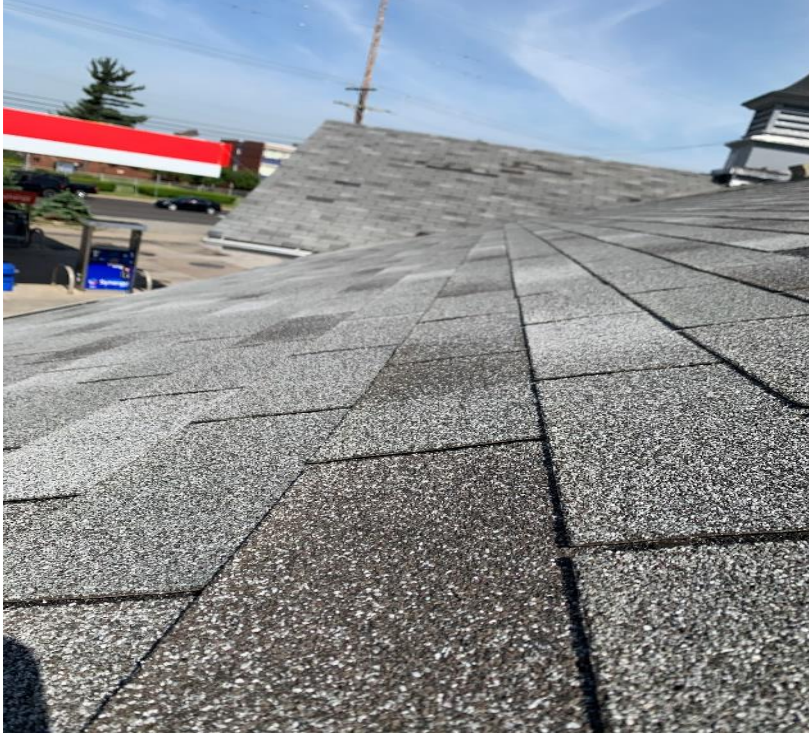
### Photograph 9

View of Roofing Shingles and Underlayment  
(HA8)
