Several months ago, at your meeting, I said I would come up with a plan to present to the RHC. Today, I am asking for a Notice to Proceed with the demolition of the house at 1841 Crooks Rd.

From: Kelly Winters <wintersk@rochesterhills.org>
Sent: Thursday, April 20, 2017 9:17 AM
To: kathrynDunn@live.com
Cc: Scott Cope; Sara Roediger
Subject: 1841 Crooks Building Department Findings

Regarding: 1841 Crooks Road
Rochester Hills, Michigan
Existing Conditions

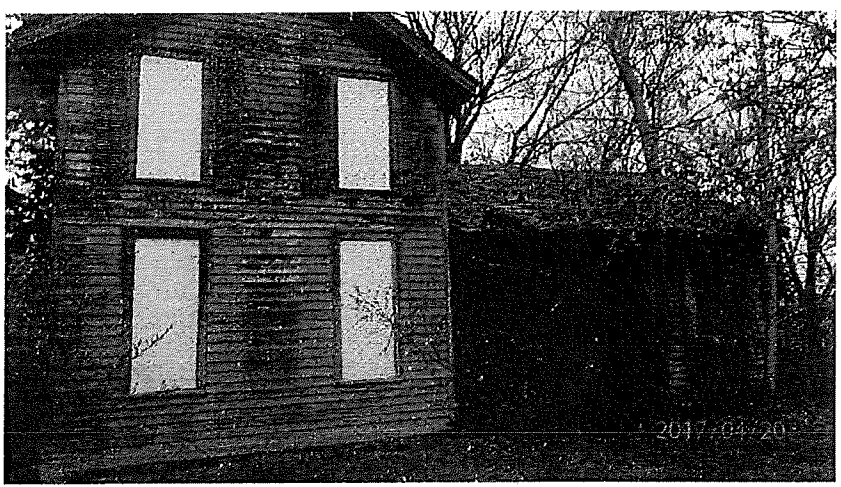
Front Elevation

The roof is in very poor condition with asphalt or similar shingles, possibly over cedar shingles on the original wide board sheathing. Severe roof damage was observed in numerous locations. The roof framing itself did not appear to have significant water damage or rot but the members sizes would not be adequate for current building code requirements and would therefore all require reinforcing or replacement. Due to the condition of the roofing material and long term water intrusion, it is expected that damage does exist to the members and connections.

- A complete new roof is required which will probably require new roof sheathing.
- The existing roof framing members are not adequate for current building code requirements.

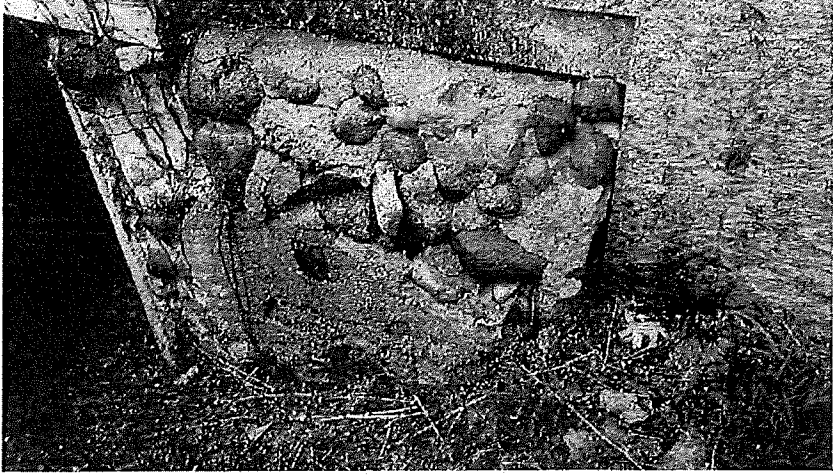
Foundation at South Elevation

The exterior wall is a typical timber sill on a stone foundation. Signs of rot were evident in the sill and may be repairable but the extent of repair needed could not be evaluated at this time. The stone foundations were also in poor condition with loose stones. It appears that some grouting and tuck pointing has been done in the past but at a minimum, is needed again. Stone foundations such as this are notoriously unstable and problematic to work on. The current building code requirements for anchoring the structure to the foundation can also be a problem with this type of construction and it is not known what if anything currently exists.

- Stone foundation walls need stabilizing
- As with all structures of this age and type that are in need of extensive repair and maintenance, it is very common to find even more issues once demolition and construction is started and other areas are exposed to view.
