820 E. Auburn Rd

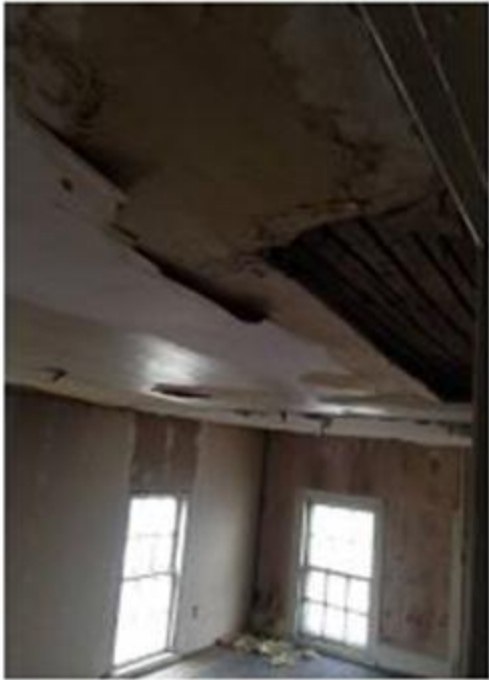
Water damage at ceiling from roof leaks.

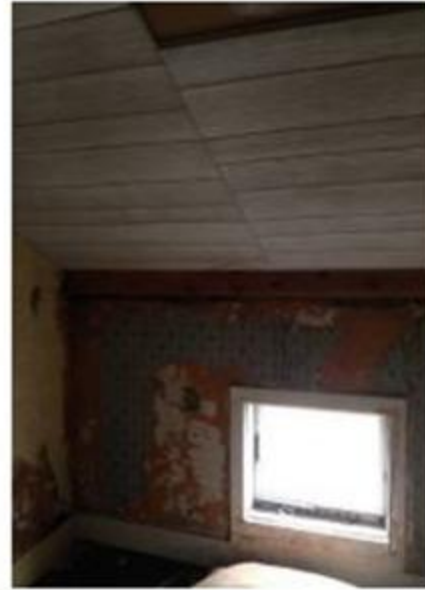
Water damage at ceiling and walls.

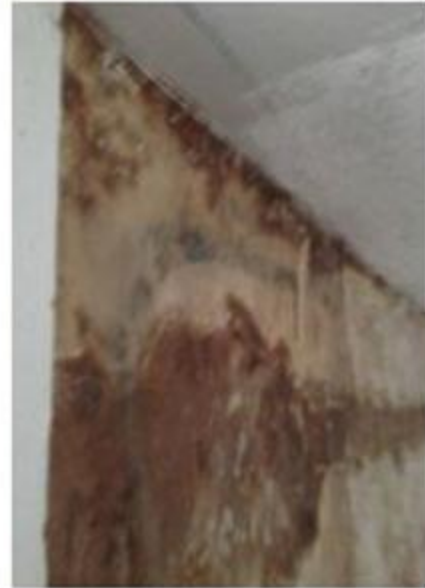
Heavy water damage at second story at rear of home.
Mold growth observed.

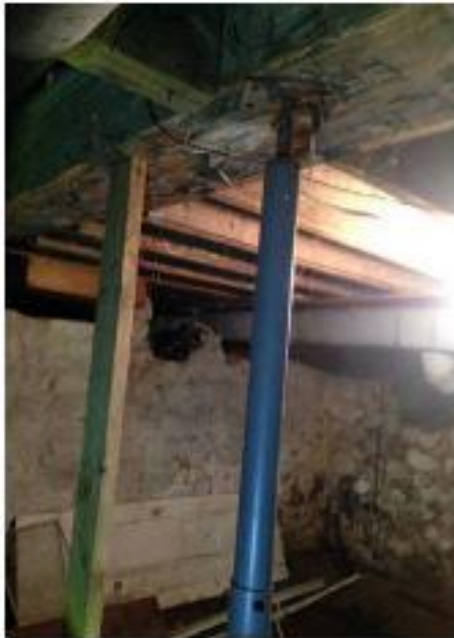
Numerous posts are no longer level and have moved. Posts do not have appropriate footings and sit on earth floor or broken cement. Contact structural contractor for immediate replacements.

Improper support posts and torque at support beam.

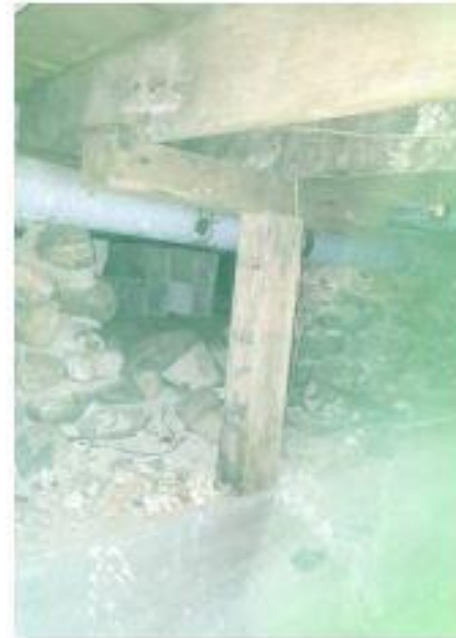
Improper support post at crawlspace.
