Avon Rd. & Livernois Rd. Bridges

Rochester Hills City Council

February 28, 2011

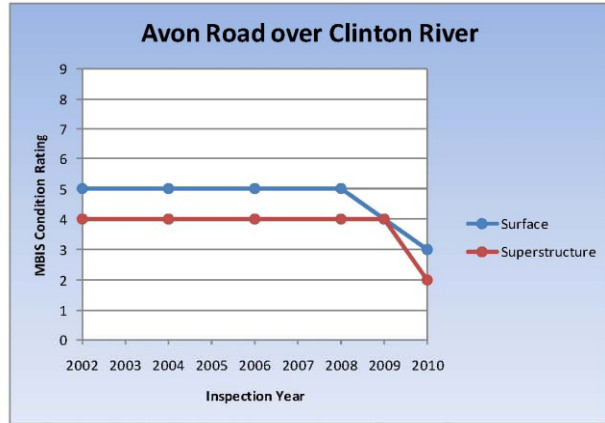
AVON ROAD OVER CLINTON RIVER (0209A)

Inspection Year	02	04	06	08	09	10
Surface Rating	5	5	5	5	4	3
Superstructure Rating	4	4	4	4	4	2

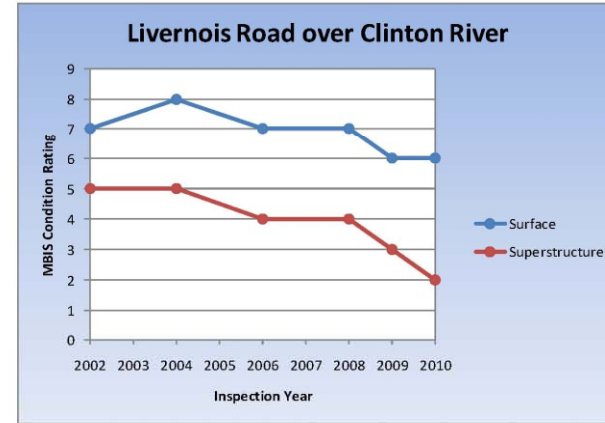
LIVERNOIS ROAD OVER CLINTON RIVER (0210A)

Inspection Year	02	04	06	08	09	10
Surface Rating	7	8	7	7	6	6
Superstructure Rating	5	5	4	4	3	2

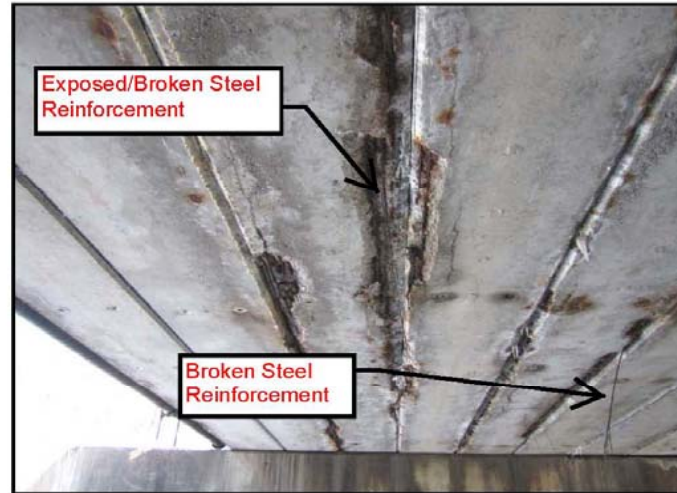
*Exposed/
broken strand
in northside
beams*

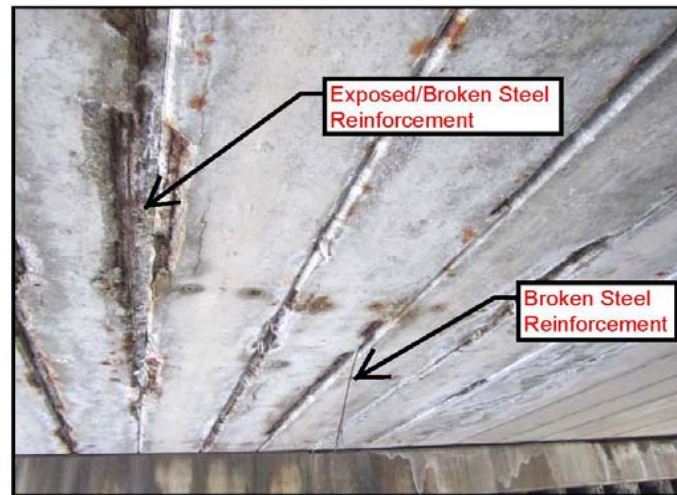
*Exposed/
broken strand
in northside
beams*

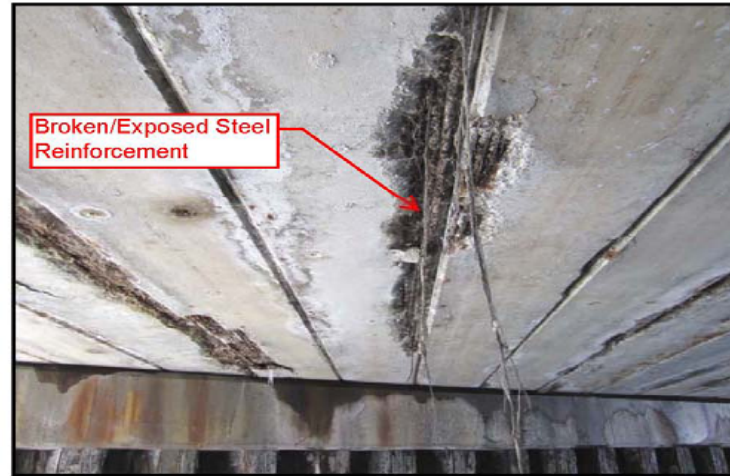
*Broken strands
hanging from
bottom of box
beam*

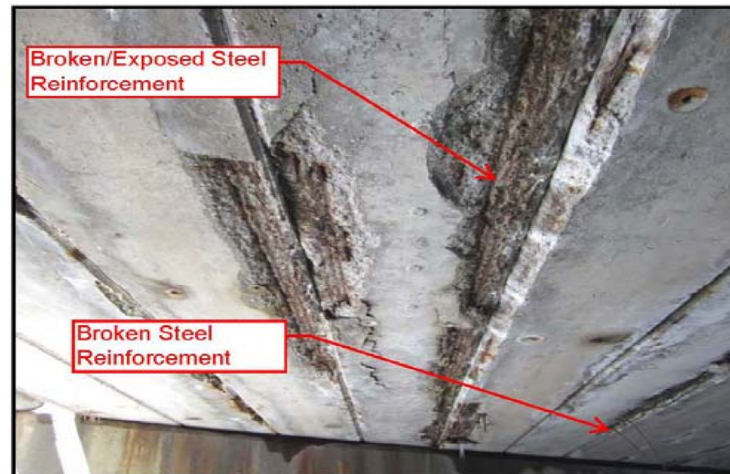
*Exposed/
broken strands
in beams 2W-
4W*
