ROCHESTER HILLS
DESIGNATED HISTORIC SITE

RESIDENCE: Eddy Farm (c. 1902)
STYLE OF BUILDING: Classic Greek Revival
TYPE OF CONSTRUCTION: Wood Frame
LOCATION: 1585 Rochester Road - South
CURRENT OWNER'S NAME: 1001 Services Inc.
ADDRESS: 1001 Woodward Ave Detroit, MI 48226

**State of Michigan Historic Preservation Office
Intensive Level Survey
Rochester Hills Historic Districts Survey**

MICHIGAN ABOVE-GROUND SURVEY FIELD FORM

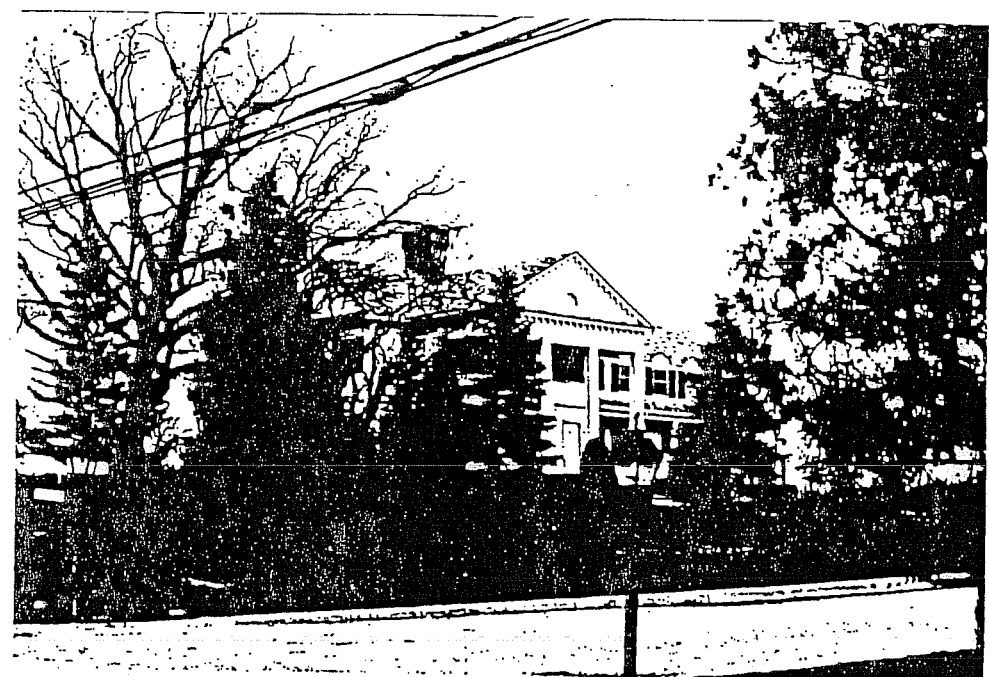
Good exterior condition. Historically significant.

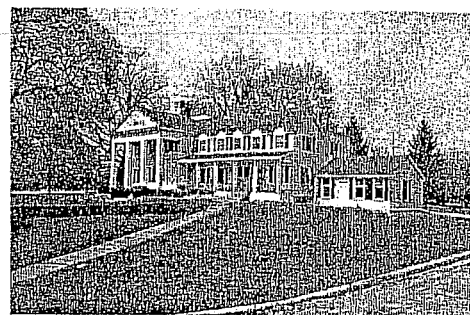
Filename: My Pictures\By Street\Rochester\S Rochester\1585 S
 Roll: Frame:
 View: Northwest
 Credit: Burke Jenkins
 Caption: Fairview Farm House, 1585 S. Rochester Rd.,
 Rochester Hills, MI

Two story frame house of irregular plan. Gable roof on main house and 1 1/2 story east wing. Stone foundation. Ornate brick chimney and corner pilasters on main block. Full height front porch has pediment with dentils, square columns, brick foundation. Lunette window in pediment. Front door surround with pilasters, architrave, frieze, and dentillated cornice. One story porch on wing with square columns. Pediments above second floor windows. One story gable roof east side addition to east wing has concrete foundation, two car garage. Flat roof rear addition to wing has brick chimney with decorative stonework.
