| Subject | Rochester Hills Historic Districts Commission Submittal - East Avon Road/Dequindre Road Improvements | Project Name | 96-inch Water Transmission Main Relocation Project |
| Attention | Rochester Hills Historic Districts Commission | Project Number | GLWA-1900741 |

Culvert Safety Inspection Report

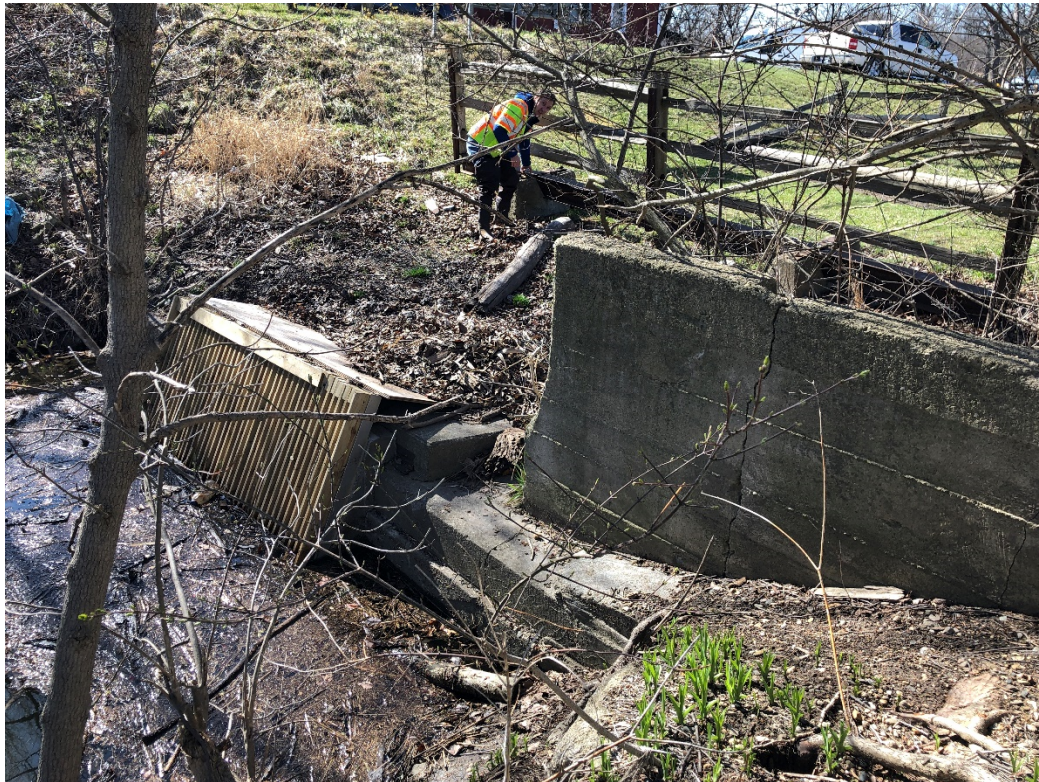
Figure 2: Existing millrace culvert inlet and headwall

In July 2020, Great Lakes Engineering Group, LLC completed a culvert condition assessment inspection of the Mill Race Culvert for the RCOC. The Mill Race Culvert Condition Assessment, included as Attachment A, found the concrete headwalls to be in generally good condition, but the corrugated metal pipe was generally described as being in poor condition, with heavy rust and scale along the sides for the full length of the pipe. The assessment report states no leakage was visible nor any holes observed in the existing corrugated metal pipe. A photo of the existing millrace culvert inlet and headwall is presented in Figure 2.

A majority of the Mill Race Culvert and existing headwall will be removed and replaced in kind. The total proposed replacement length is 128 feet. The existing culvert will be replaced with a new 61-inch-high x 84-inch-wide CMP structural plate arch to match the existing. A custom trash and debris rack will be installed at the entrance to the culvert. The new culvert will follow the same alignment, will be set at the same inverts, and have the same slope as the existing culvert.

The last 15 feet of the existing culvert will remain in place to protect the existing concrete chamber from being damaged during construction. This remaining section of culvert will be sprayed with a polymer liner due to the culvert's age and condition. The spray-on polymer liner will also be applied to the new culvert to increase its life expectancy.

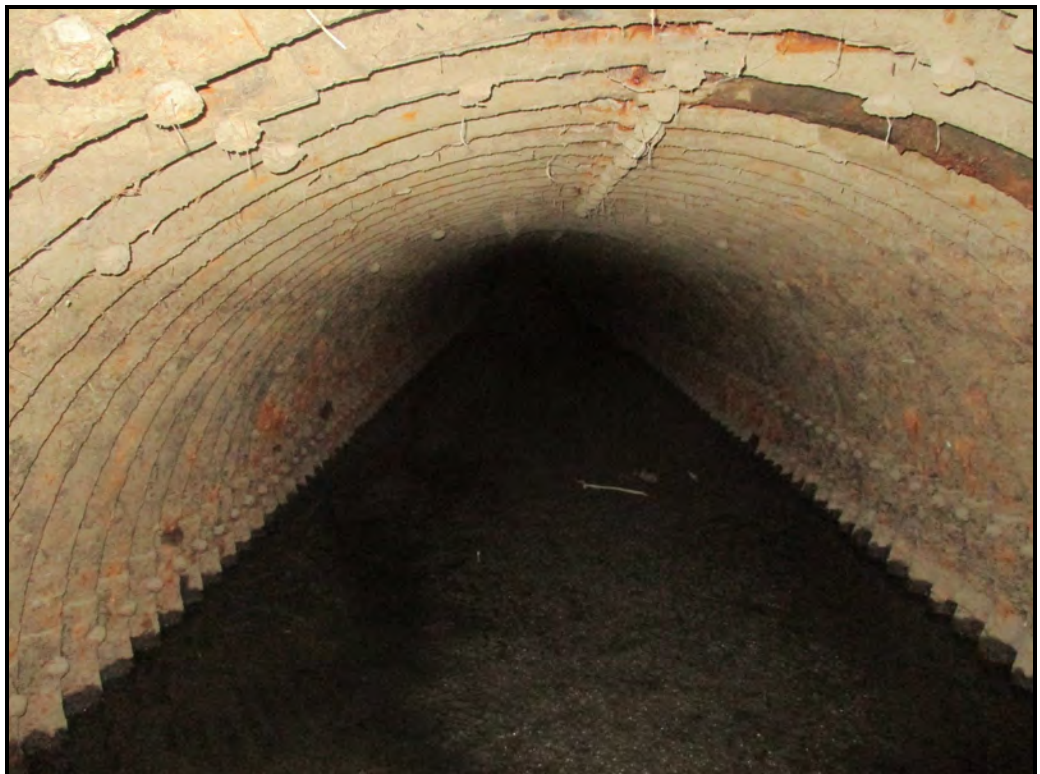
*View through
culvert facing
north*

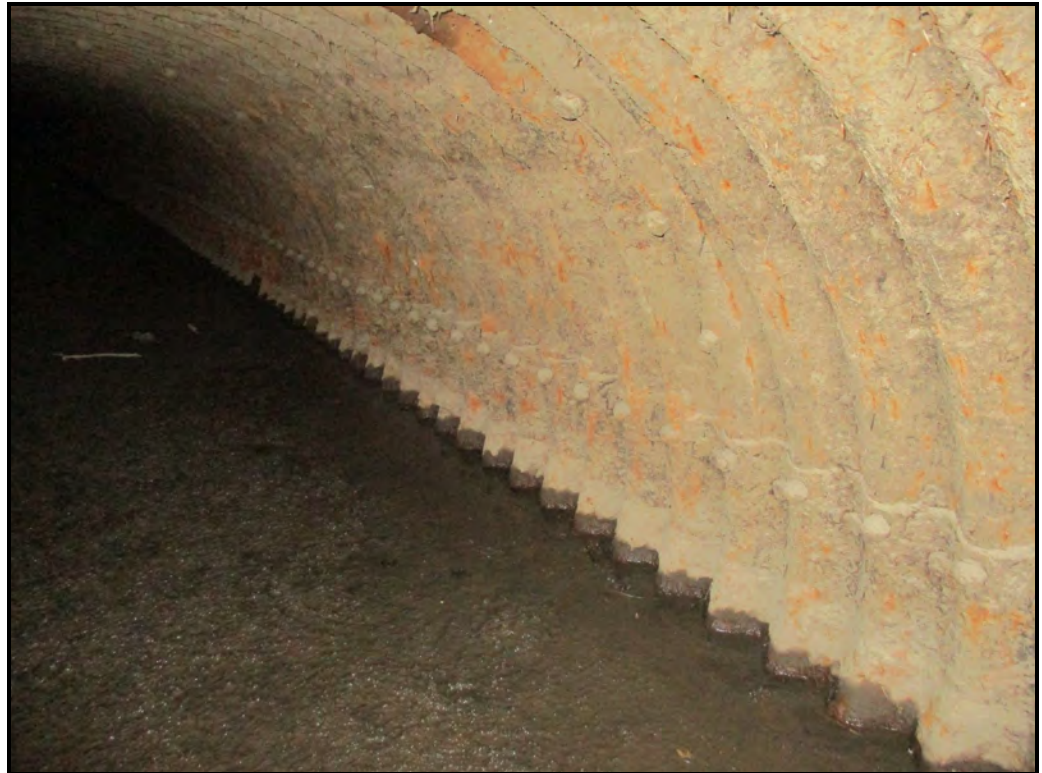
| 11. Pipe | <input type="checkbox"/> | <input type="checkbox"/> | <input type="checkbox"/> 4 | 7' diameter CMP pipe arch with 6"x2" corrugations. Bend in culvert near inlet. 12"-18" of very soft muck in bottom of culvert, difficult to inspect. CMP has heavy rust and scale at the mudline along both sides for the full length of the CMP. No holes through CMP. |

*Rust and scale
on CMP*

| L Budget replacement | | | | | | | | | | | | | | | | | | | | | | | | | | |
| H Clean muck out of culvert bottom | | | | | | | | | | | | | | | | | | | | | | | | | | |

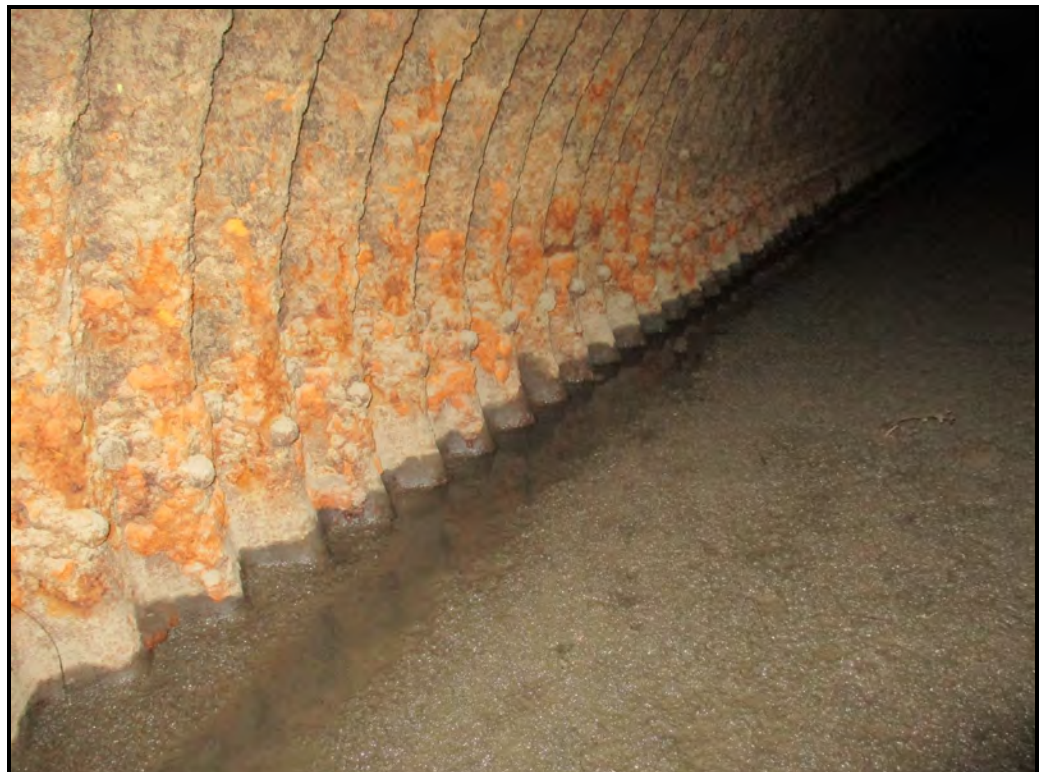
*Rust and scale
on CMP*

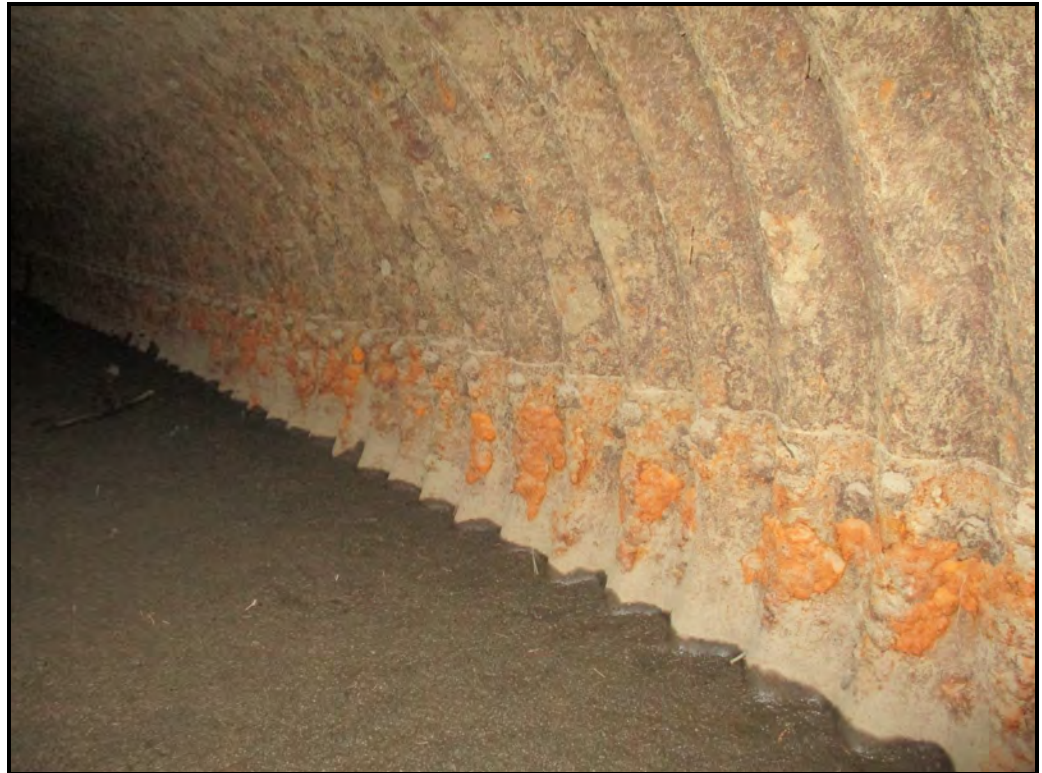
Heavy rust and scale on CMP

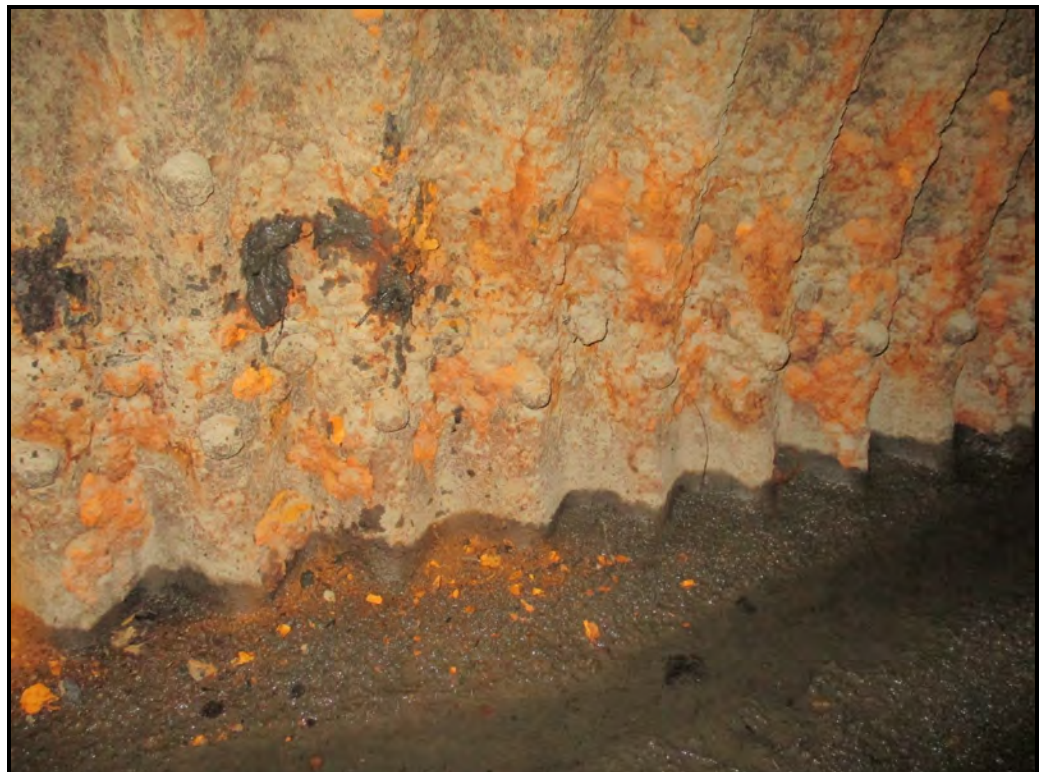
Heavy rust and scale on CMP

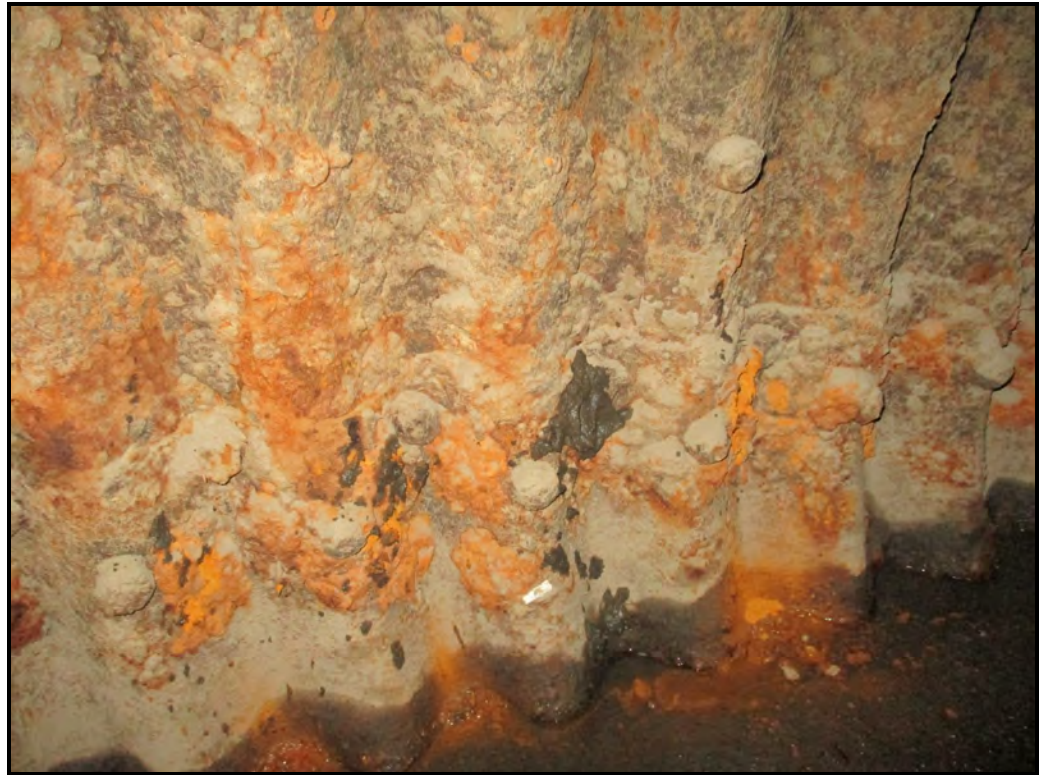
*Heavy rust and
scale on CMP*
