**PRELIMINARY REPORT**  
**ROCHESTER HILLS HISTORIC DISTRICTS STUDY COMMITTEE**  
**EUREKA FRUIT FARM, 1021 HARDING ROAD**  
**ROCHESTER HILLS, MICHIGAN**  
**Adopted February 11, 2021**

**CHARGE OF THE HISTORIC DISTRICTS STUDY COMMITTEE**

## **DESCRIPTION OF THE DISTRICT**

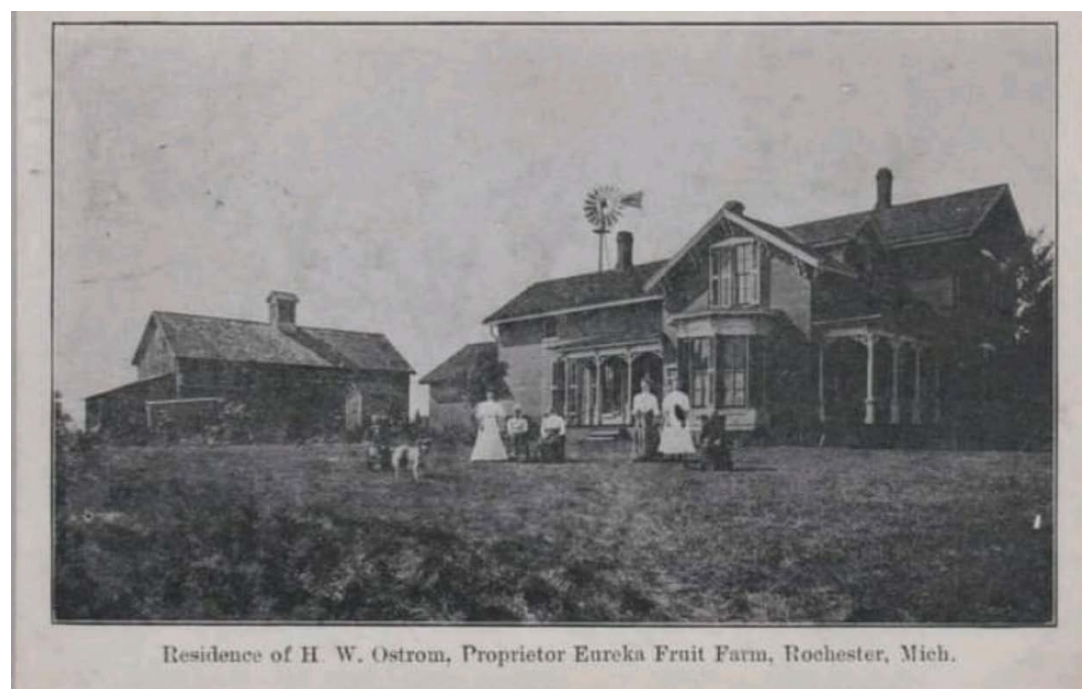
**Photo 1** Photo of H.W. Ostrom house, Eureka Fruit Farm, unknown date, courtesy property owner.

A historic photograph of an unknown date shows the house with a two-story barn in the background. The house shows more of its original elements such as cornice brackets and decorative porch posts and brackets.

Residence of H. W. Ostrom, Proprietor Eureka Fruit Farm, Rochester, Mich.

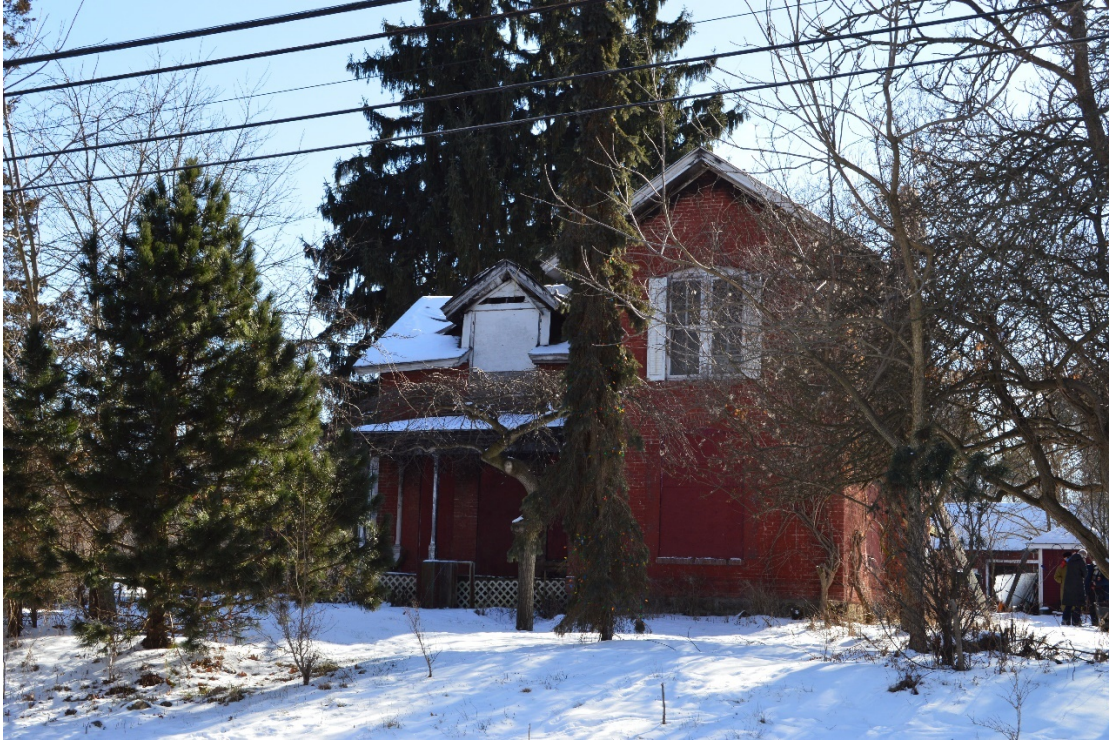
**Photo 3** Photo of 1021 Harding, January 2021.

Other than windows and portions of the roof all damaged by fire the district has not lost its original physical characteristics from when it was designated.

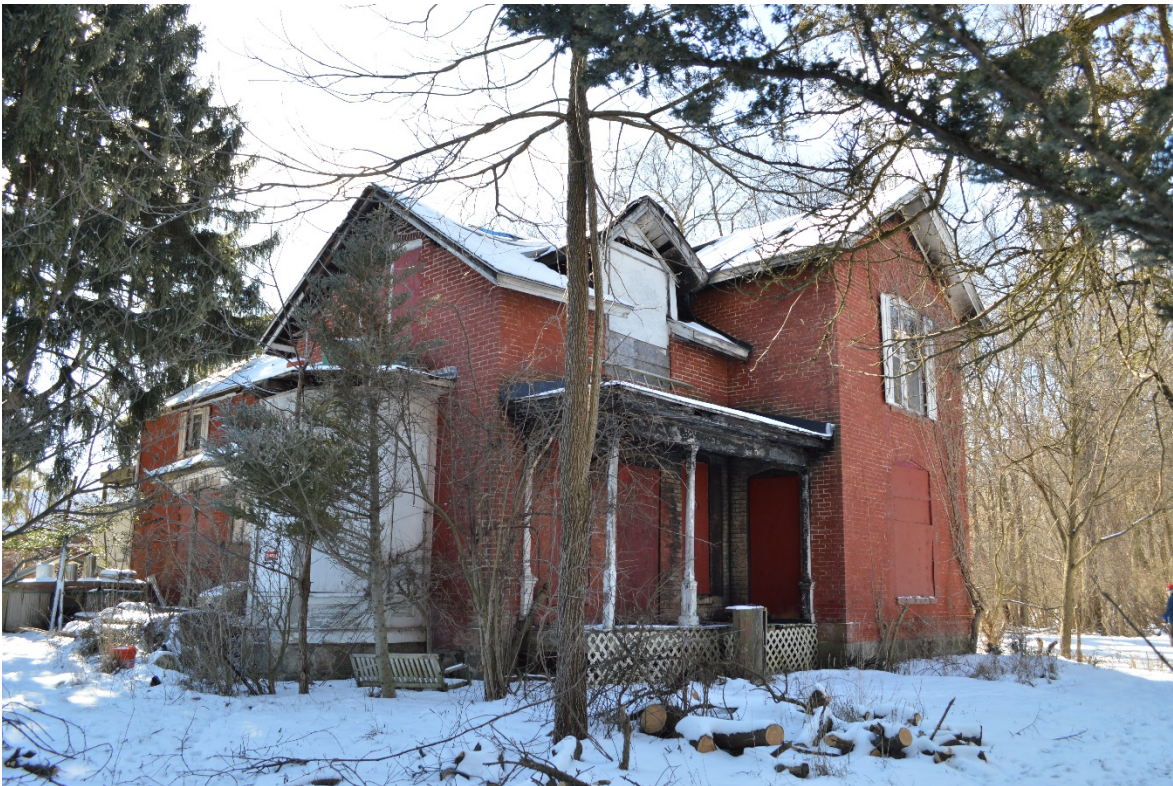
2-Looking southwest at front and east side of house, January 2021

The north façade of the upright has flat arched window openings at the first and second floor. The first-floor opening has a limestone sill and is boarded, the second floor contains a pair of two-over-two double-hung windows with narrow louvered shutters. The north façade of the wing has a central door opening flanked by tall narrow window openings at the first floor that are all boarded closed. At the second floor there is a gable-front wall dormer with a boarded window opening. A shed roof porch supported by turned posts which appear to be original runs the full width of the wing. A second boarded door opening enters the east side of the upright from the porch.

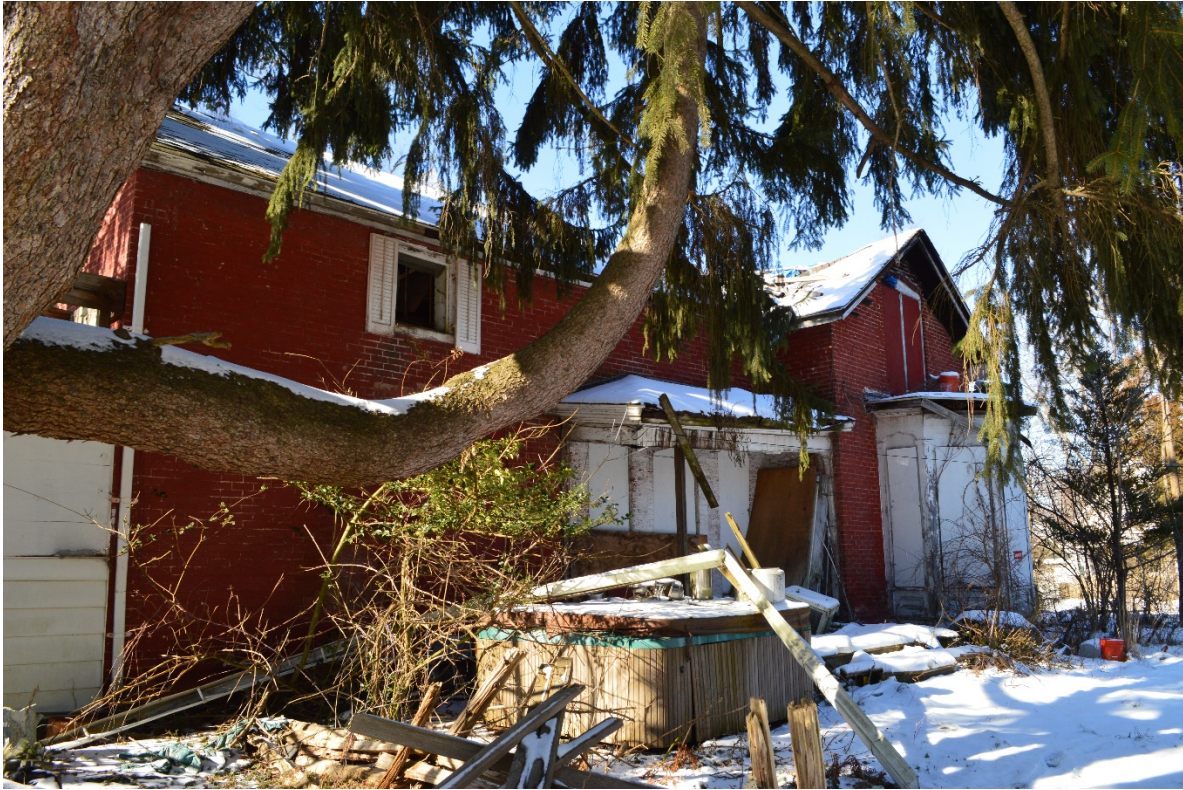
3-Looking northwest at east side of house, January 2021

The house's east elevation is comprised of the gable end of the wing, and the side of the rear ell. The gable end of the wing has a five-sided projecting one-story tall bay with a stone foundation, wood walls, and a hipped roof. The window openings are boarded. Above the bay, in the gable end, is a window opening with a shallow-arch lintel. The window opening is boarded. The east elevation of the rear wing has the remains of a hipped roof porch at the first floor and a shallow arched window opening. Behind the porch there is a door flanked by two window openings that are boarded over. There is one square window opening at the second floor with no window sash and small louvered shutters.

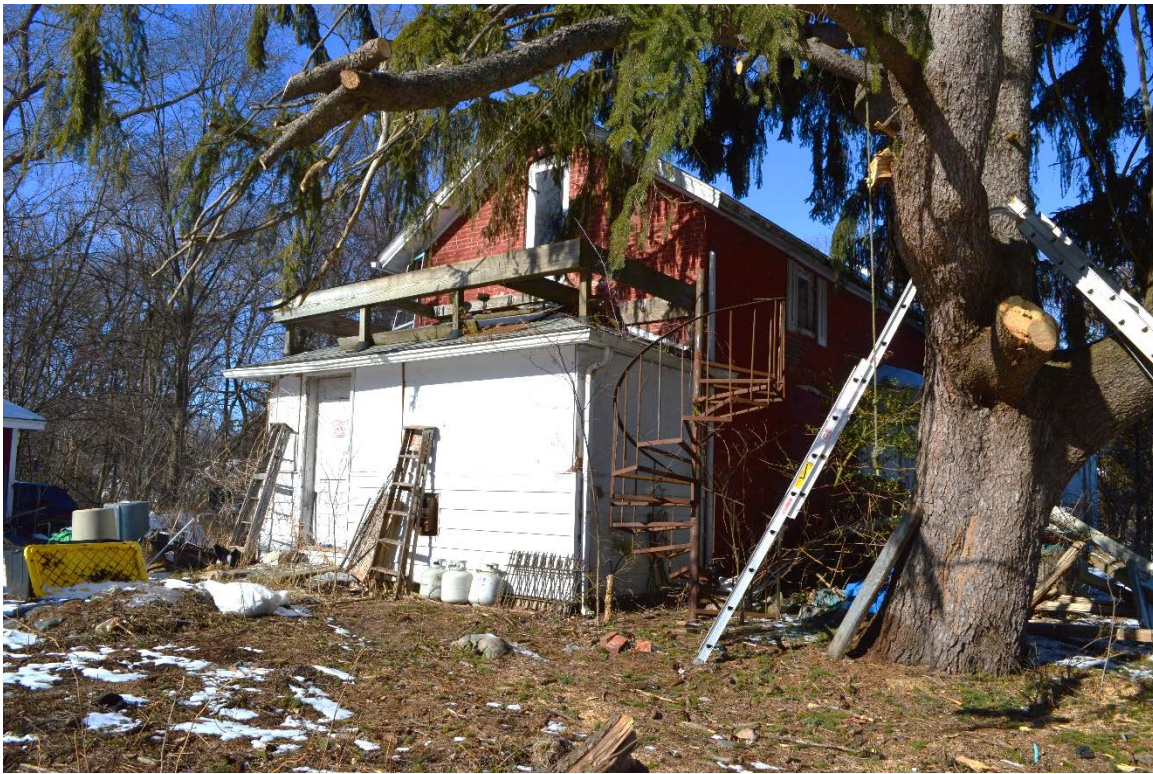
4-Looking northwest at rear of house, January 2021

At the rear of the house there is a one-story tall hip roof enclosed porch with wide siding on the lower half and boarded window openings in the upper half. A single door is located near the west side. The second floor of the rear ell has a single tall opening in the center. The rear elevation of the upright has a one-story hip roof addition that is clad in wood clapboard siding. A door and window opening in the addition are both boarded over. In the second floor of the upright there is a tall narrow window opening with a shallow arch lintel that is boarded over.

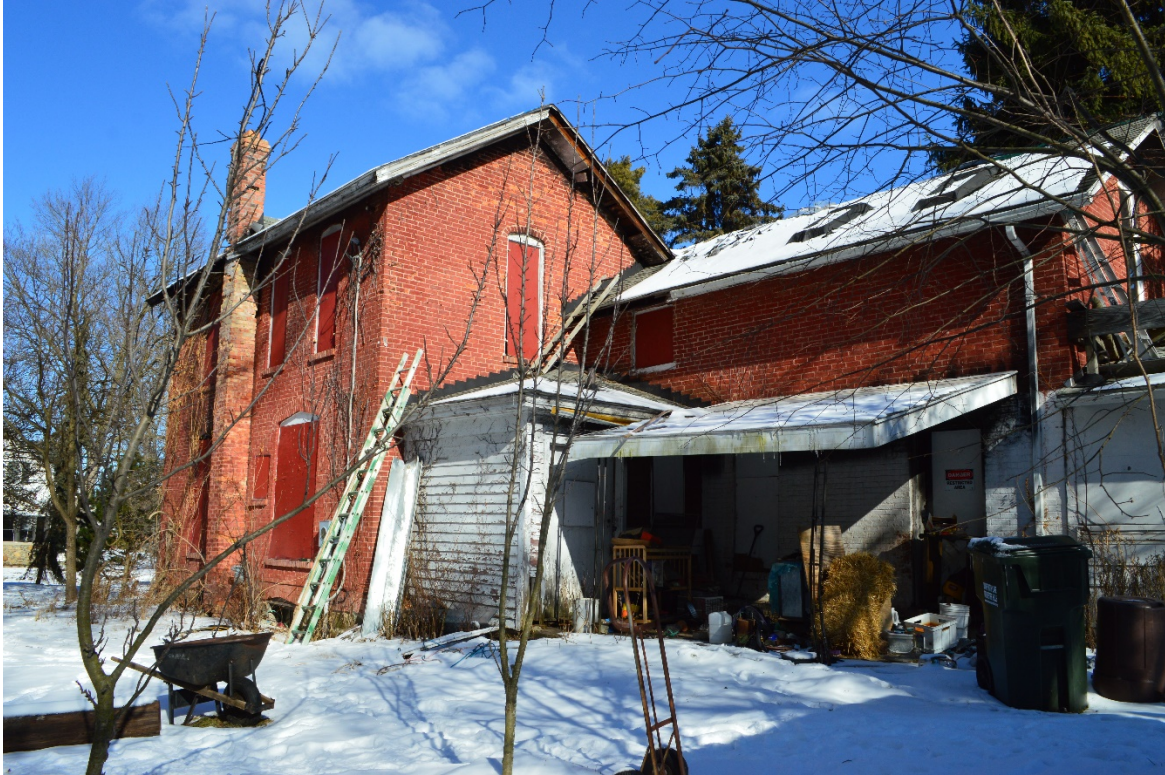
5-Looking northeast at west side and rear of house, January 2021

The west elevation of the house consists of the two-story tall upright, the side of the one-and-a-half-story tall rear ell, and the side of the small one-story addition to the rear of the upright. The upright has a non-original exterior brick chimney in the center of the wall. To the north of the chimney are wide shallow-arched window openings at the first and second floor that are boarded over. To the south of the chimney at the first floor there is a small window opening, and a larger shallow arched window opening. Both are boarded over. At the second floor there are two narrow window openings with shallow arched lintels. The side of the rear ell consists of the clapboard sided addition to the upright. The remains of a shed roof porch extends along the remainder of the side of the rear ell. There are two boarded window openings at the first floor. At the second floor there is one boarded window opening near the rear wall of the upright. There are two skylights in the gable roof of the rear ell.

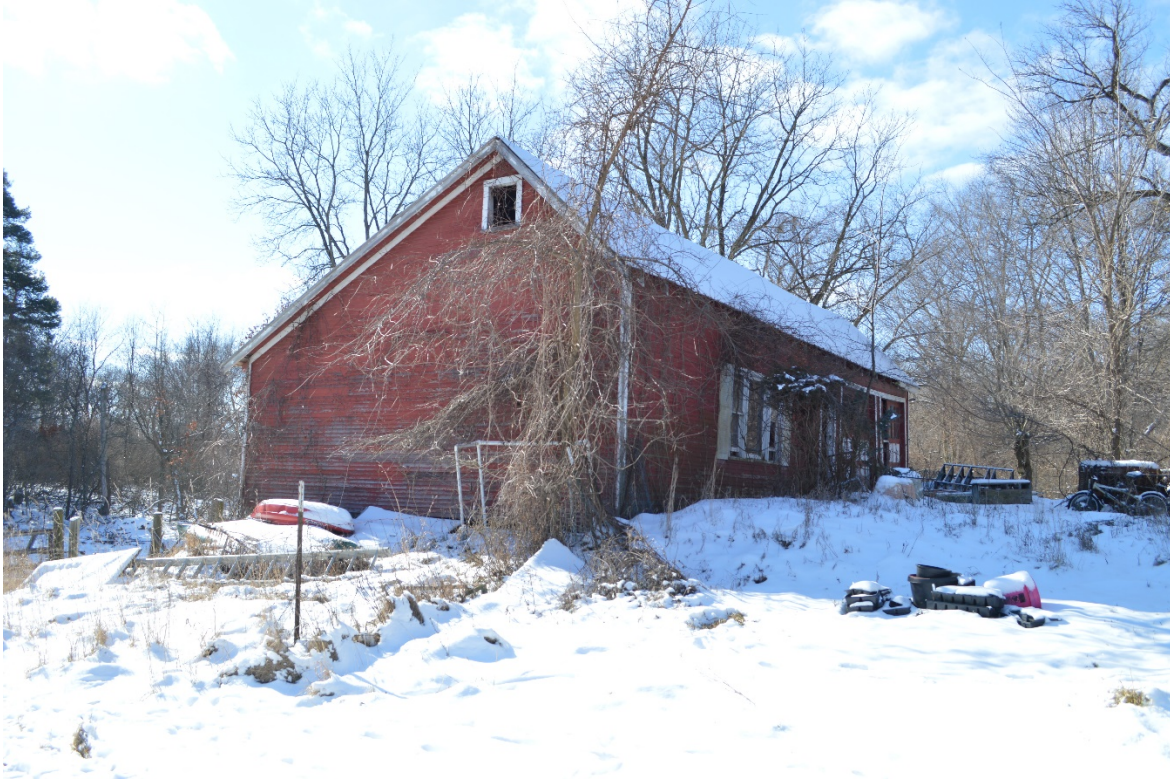
7-Looking southwest at barn north and east elevations, January 2021

The north elevation has two wide door openings with paneled wood sliding doors with windows in the upper third of each door. There is a wood panel pedestrian door. A wide opening in the east half of the elevation contains a

combination of double-hung windows with a wider fixed sash window in between. The east elevation has a small square opening in the top of the gable, the ground slopes away sharply toward the south. The west elevation is identical with a more gradual slope toward the south. The south elevation has wide openings at both ends of the lower level that have half-high wood gates across the bottom. The wall in between the openings has seven four-over-four windows that alternate with sections of wall clad with wood louvers. In the upper level at the east end there is a wide window opening containing two one-over-one double hung windows flanking a large, fixed center sash. In the west end there are three four-over-four double hung windows.

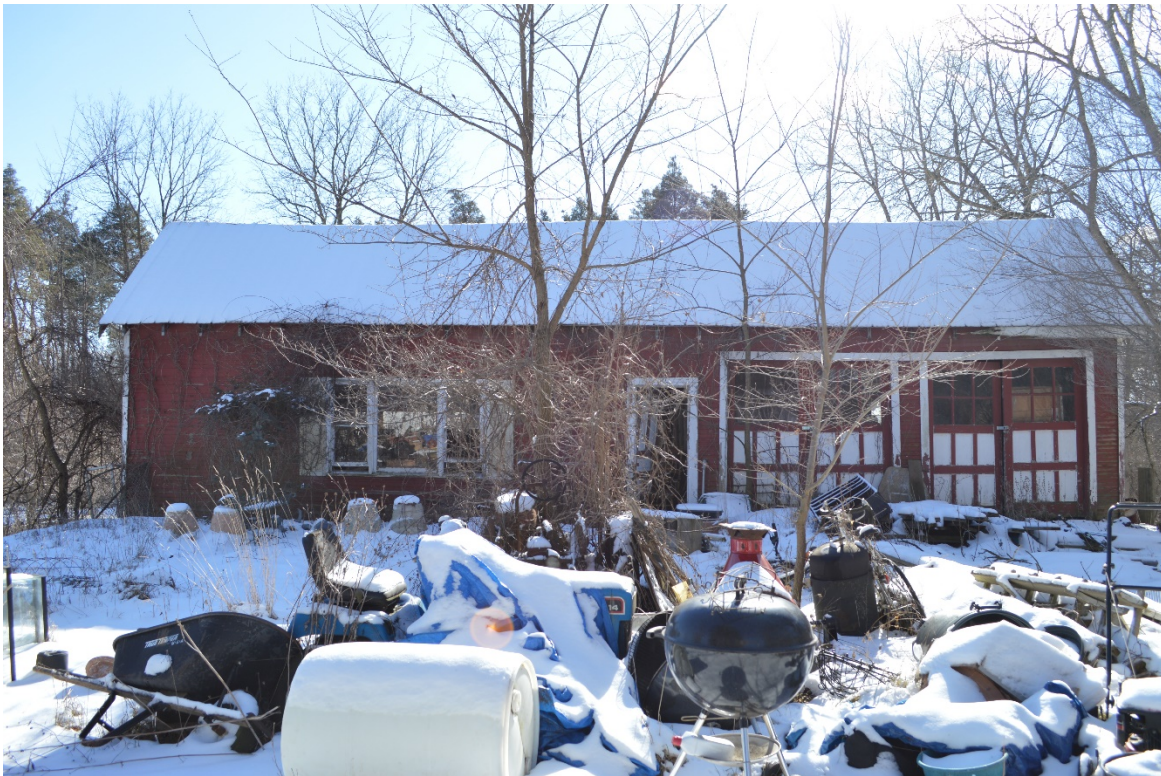
8-Looking south at north elevation of barn, January 2021

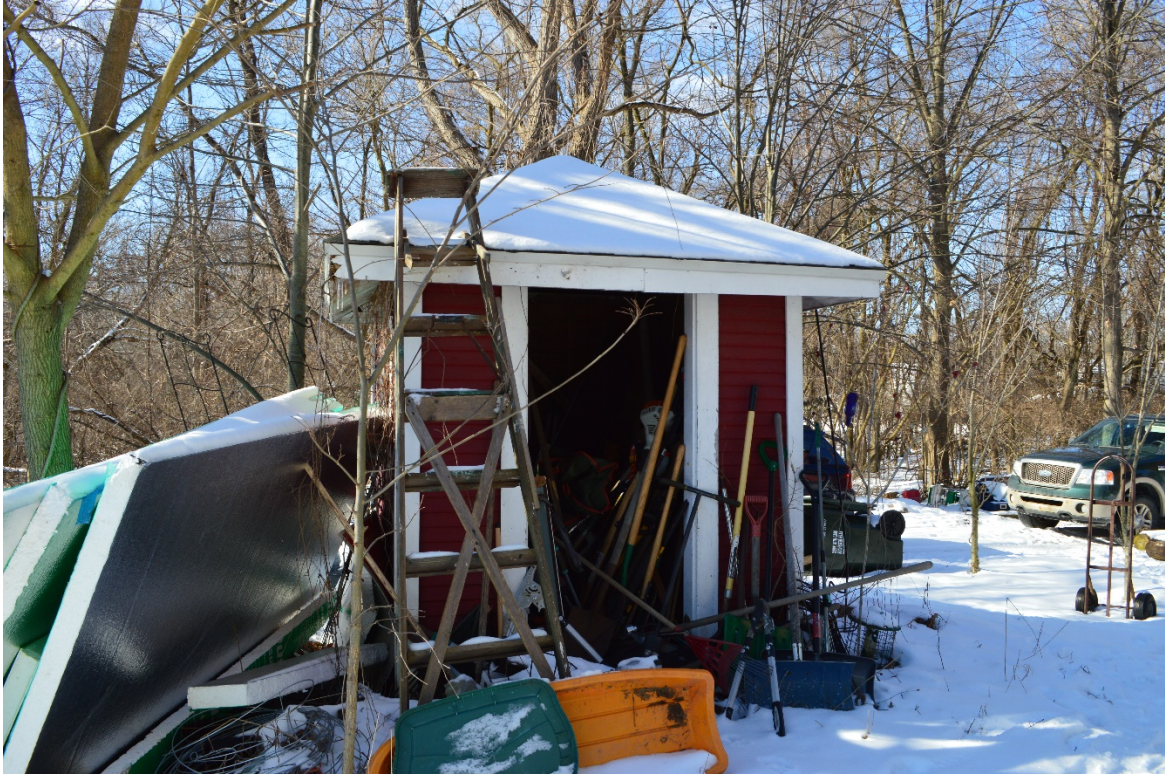
11-Looking west at pumphouse, January 2021

To the southwest of the house is a one-story tall pumphouse with a square footprint and pyramidal roof. The walls are clad in narrow wood clapboard with wood trim. The west and north elevations have no openings. The east elevation has a single door opening with no door. The south elevation has a small window opening with a casement window.

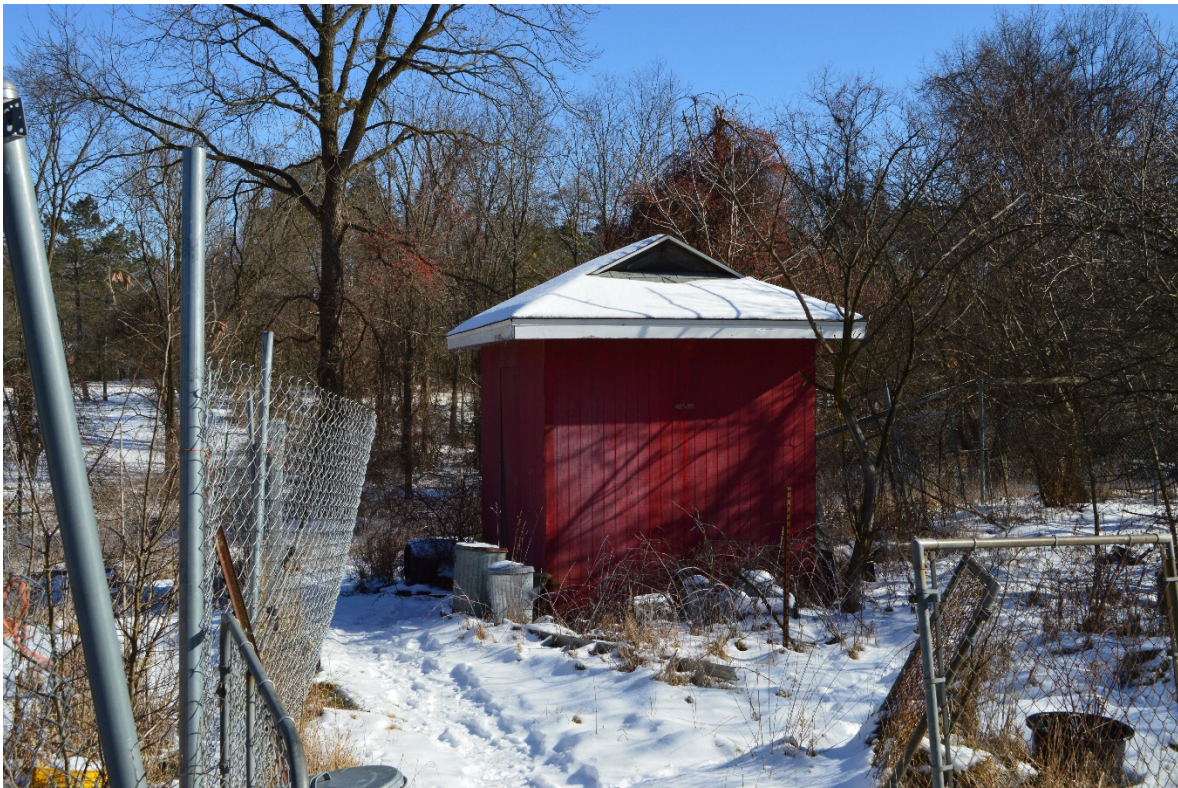
12-Looking east at storage shed, January 2021

The shed is one-story tall with a gable hip roof and deep eaves. It is clad in modern vertical wood siding. The hinged door matches the siding and makes the building appear that there are no openings.

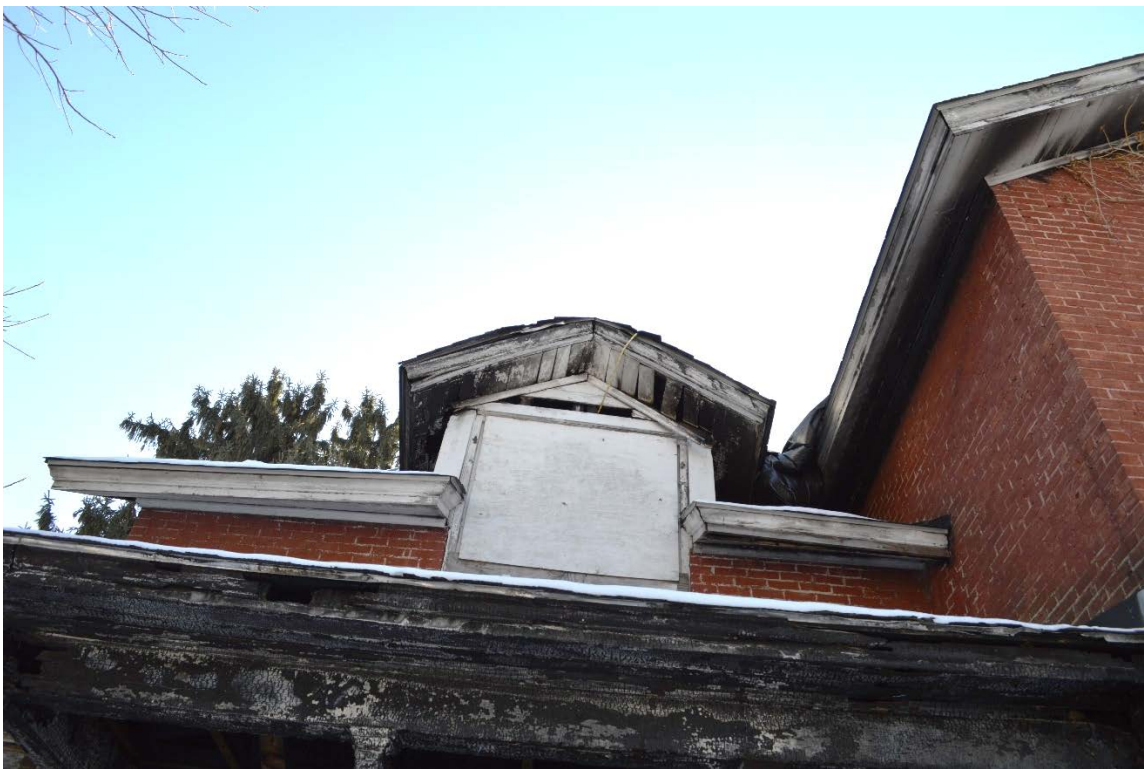
Note that the house suffered an extensive fire in November 2017. As a result many window and door openings are boarded over, there are tarps on the roof, and there is evidence of fire damage on some areas of the brick walls and the roof.

16 – North dormer showing fire damage, January 2021

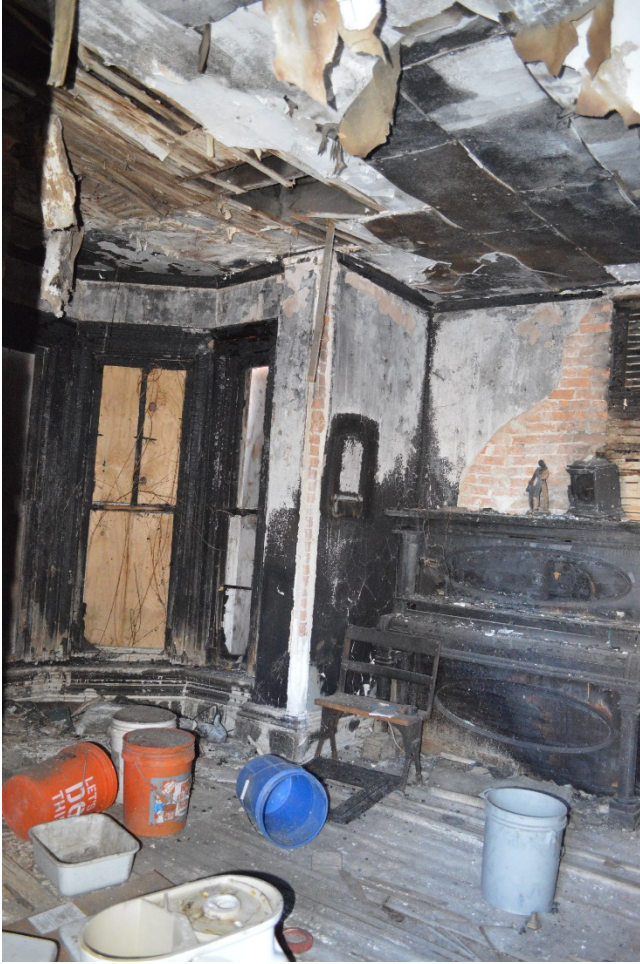
17 – Looking at fire damaged interior, damaged east bay window to left, January 2021
