BASELINE ENVIRONMENTAL ASSESSMENT SUBMITTAL FORM

Name of Property: Approximate 32.49-Acre Parcel County: Oakland

Street Address(es) of Property: 1406 East Avon Road

Phase I Environmental Site Assessment

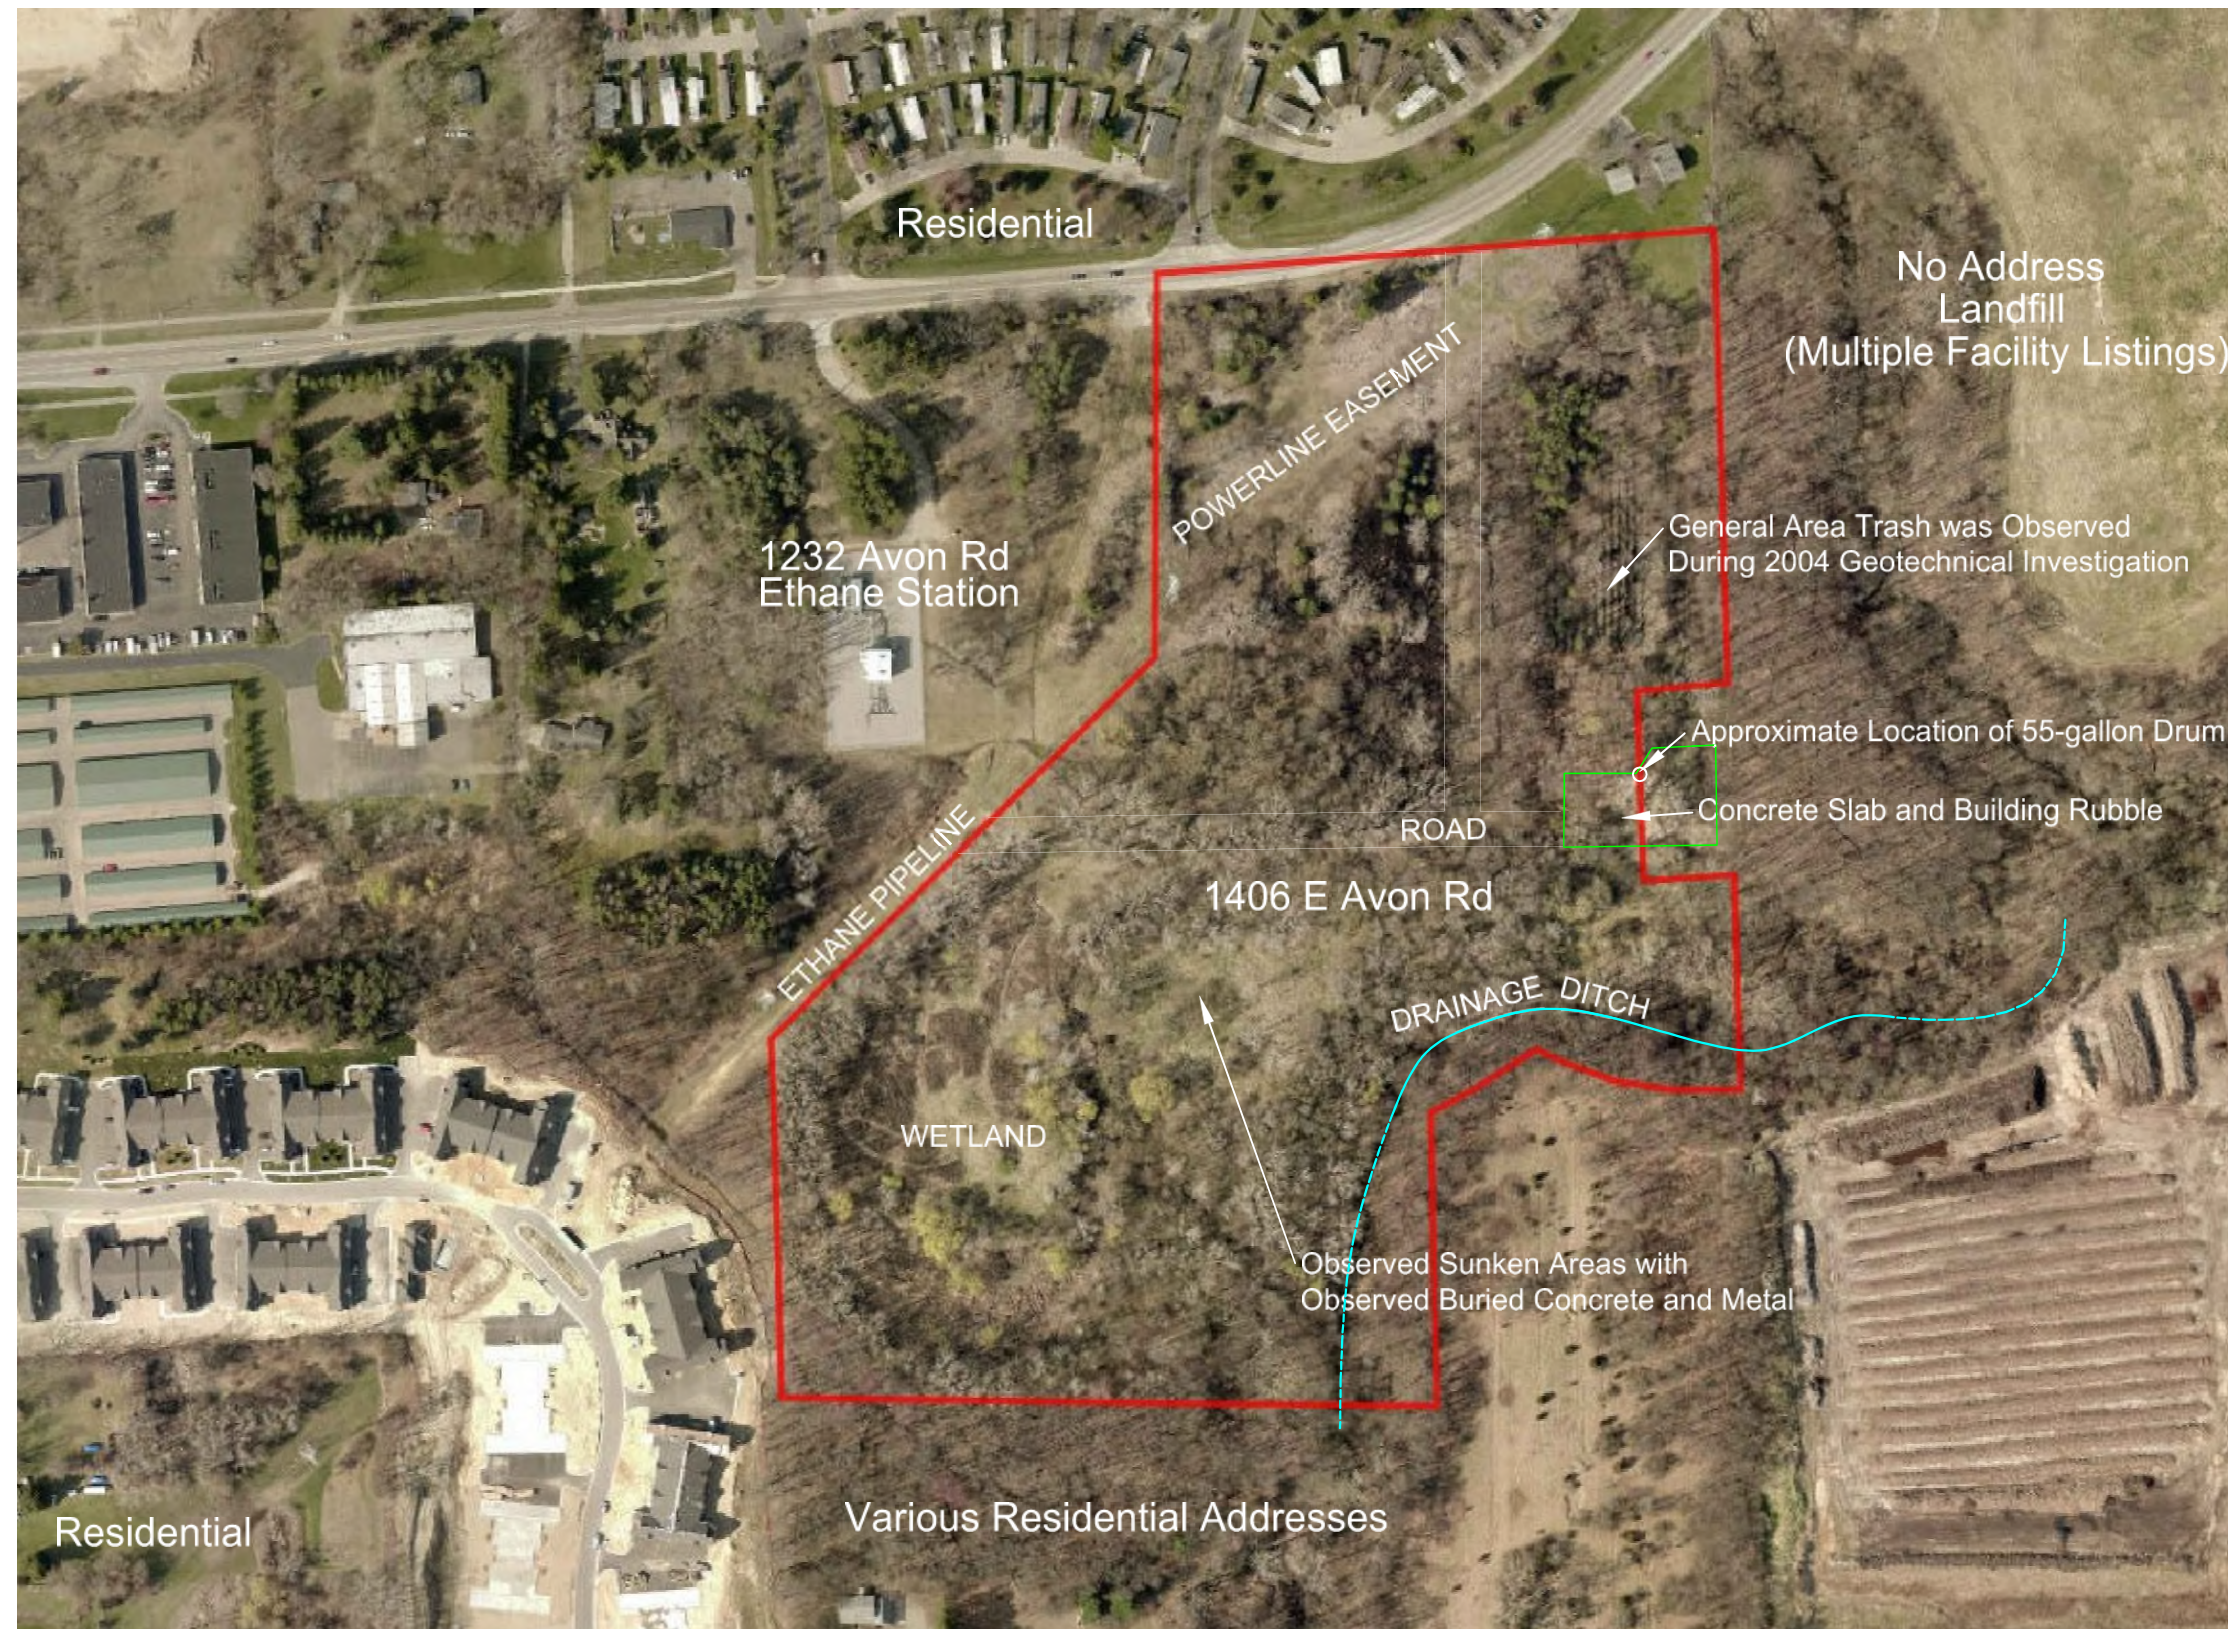
Site Map	
	Location: Vacant Land 1406 East Avon Road Rochester Hills, MI 48307
Figure 2	Drawing Date: 12-15-22 Project Number: 70024
<p>Approximate scale in feet</p>	Project Manager: JMD CAD File: 70024-1-2 Drawn by: JMD

The Property inspection was performed on December 12, 2022, by Mr. Raymond Brege of MCE. The Owners, Mr. Elvis Logu and Ms. Bukurise Logu, accompanied MCE during the site reconnaissance. The Property was inspected for the presence of hazardous or toxic substances, hazardous wastes or petroleum products, and other evidence of potential RECs that may have been visually and physically observable. Items that typically represent the potential for environmental impairment include, but are not limited to, flammable substances, spills, leaks, ground discoloration and disturbances, unusual odors, dead or dying foliage and electrical equipment that uses polychlorinated biphenyls (PCBs) containing oil. The adjacent parcels were also visually inspected from the Property at the time of the reconnaissance. Property reconnaissance was accomplished by a systematic walking of the Property, photographic documentation of the site reconnaissance is included in **Appendix E**. A map showing the general location of the Property and surrounding features is included as **Figure 1**. An aerial site map, obtained from an online source, showing the Property, observed RECs and other site features, and adjacent parcel features is included as **Figure 2**.

A large drainage ditch, the Honeywell Ditch, runs on the southern portion of the Property. The ground elevation drops severely (approximately 40-50 feet) around the ditch. No staining or odors were noted on the water. Several ceramic/ clay drain lines were lying in the water and were broken and found in several different areas however, no connection of the pipes to the Property or adjacent parcels upland was observed. Property layout can be seen on **Figure 2**.

The table below contains information regarding the site features located on the Property. See **Figure 2** for a diagram depicting the location of the Property relative to site features and adjoining parcels in **Figures**.

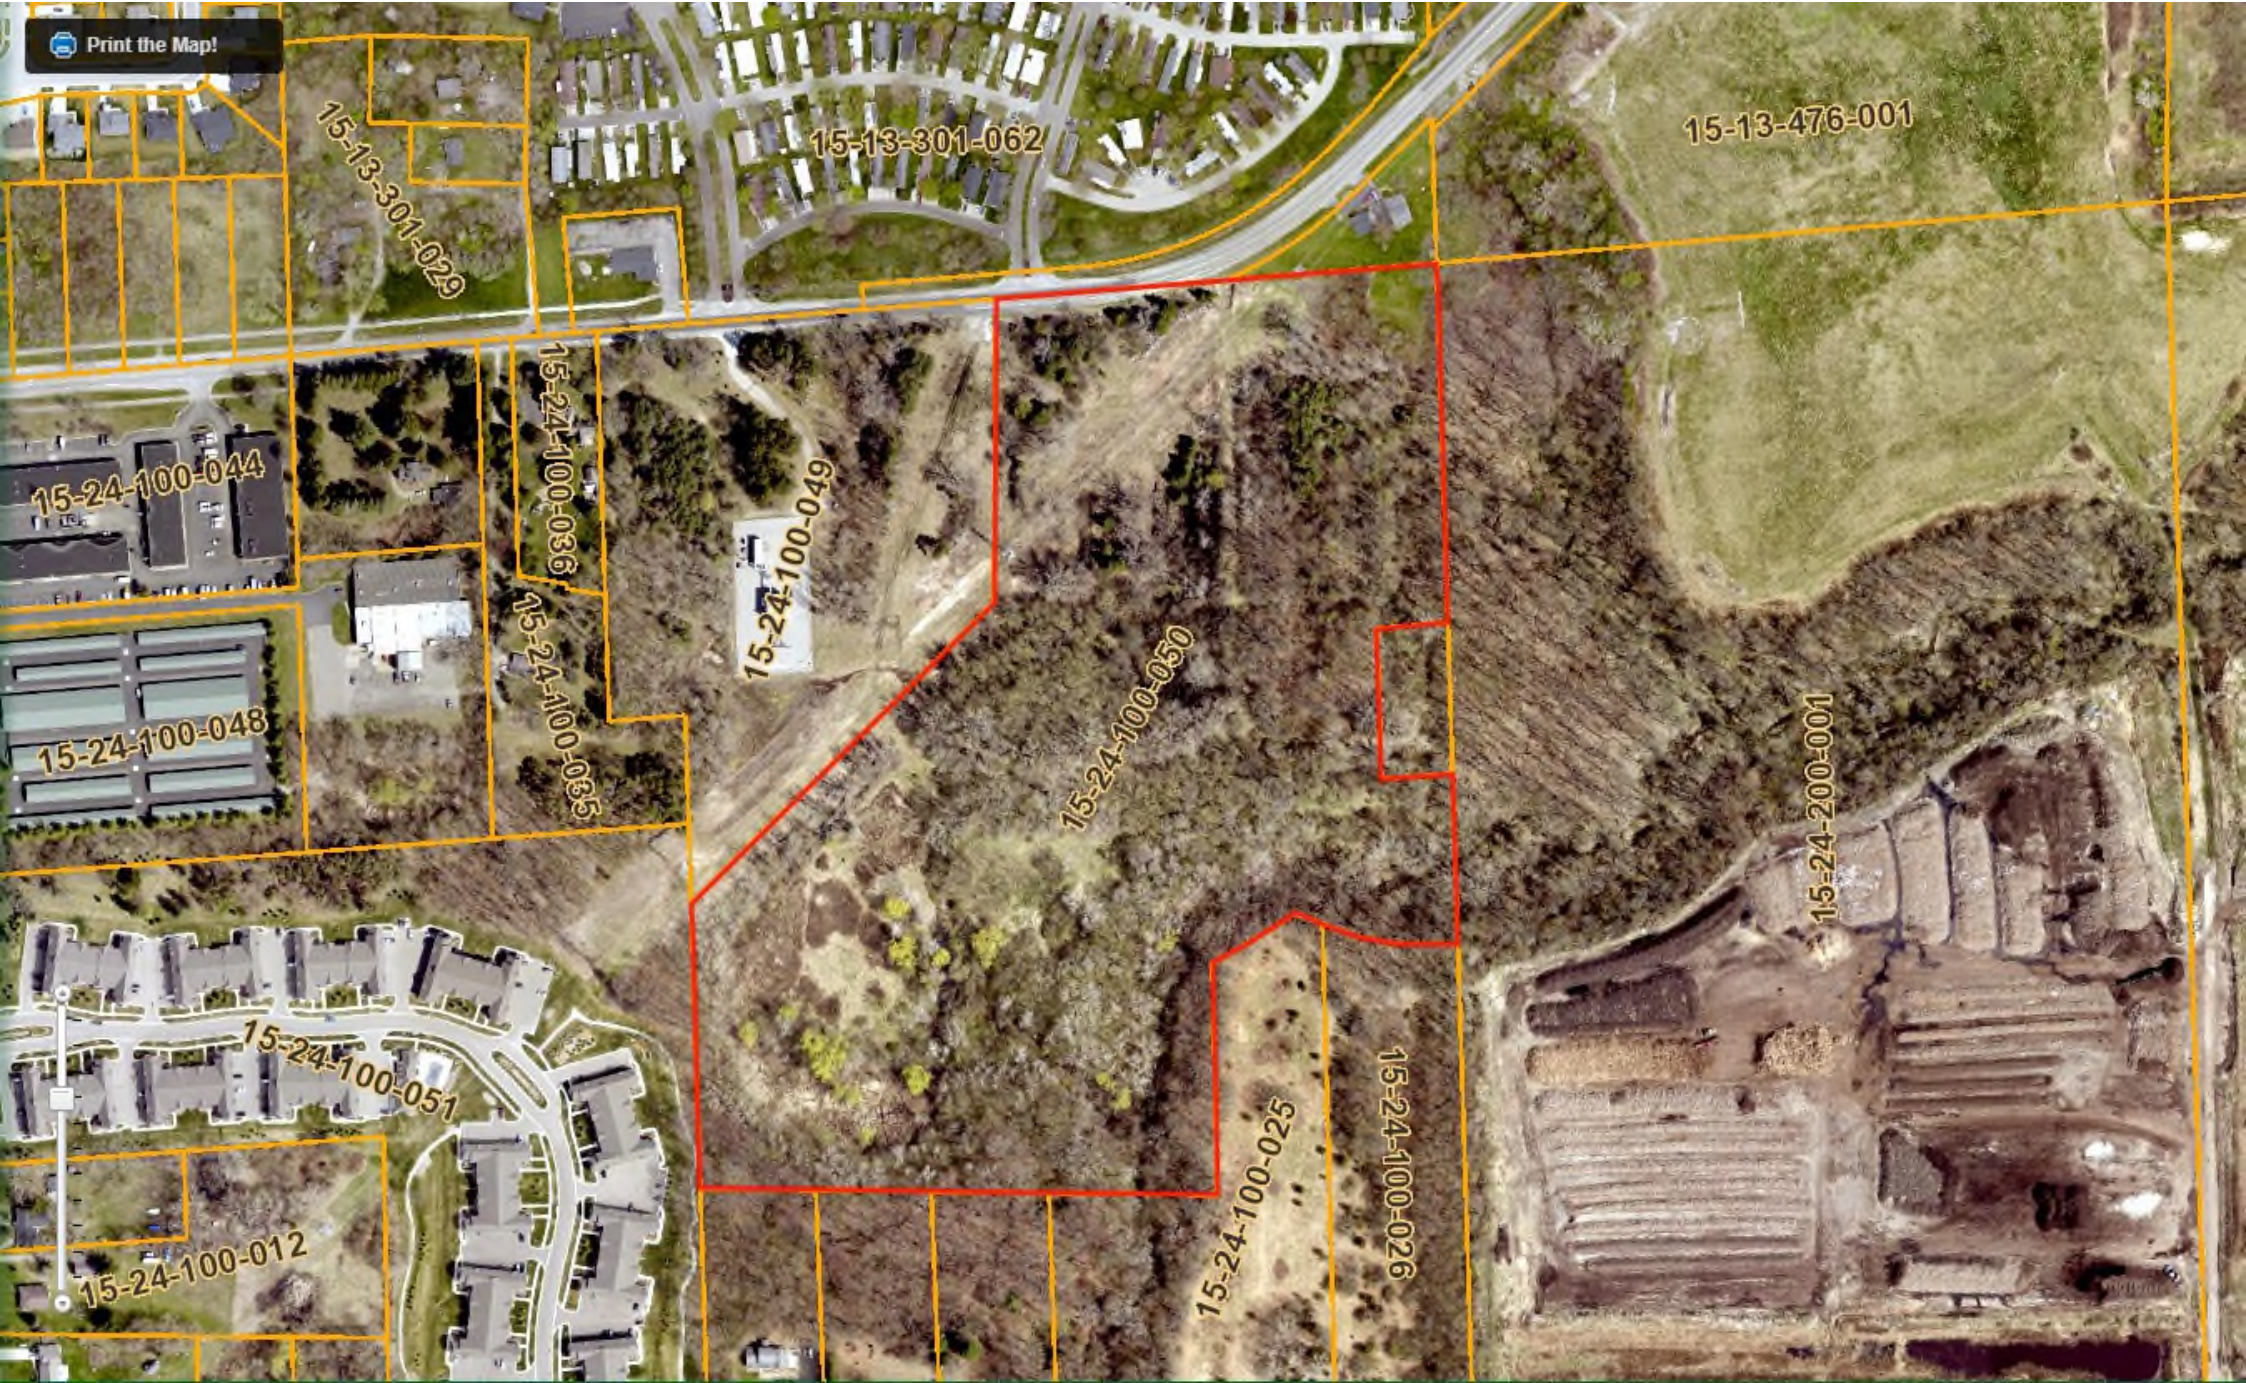
Highland Park Woodfill
 Located in the northwest corner of the Landfill Planning Area is the Highland Park Woodfill area (map IDs 14 & 15 in Figure 3.5). This parcel was used by the city of Highland park to dispose of an unknown quantity of diseased trees during the 1970s and 1980s.

Special Concerns:
 The woodfill may be unstable and could effect the weight bearing capacity of the soils.

Opportunity for Redevelopment:
 Medium While some environmental concerns may exist, it is anticipated that this will not cause significant concerns.

Conclusions and Concerns:
 These parcels requires that proper due diligence be conducted during redevelopment. At a minimum Phase I Environmental Site Assessment (ESA) should be conducted and if determined to be necessary a Phase II Subsurface Investigation, Baseline Environmental Assessment, and Due Care Plan should be completed.
