PRELIMINARY REPORT
ROCHESTER HILLS HISTORIC DISTRICTS STUDY COMMITTEE
EUREKA FRUIT FARM, 1021 HARDING ROAD
ROCHESTER HILLS, MICHIGAN
Draft February 2021

DESCRIPTION OF THE DISTRICT

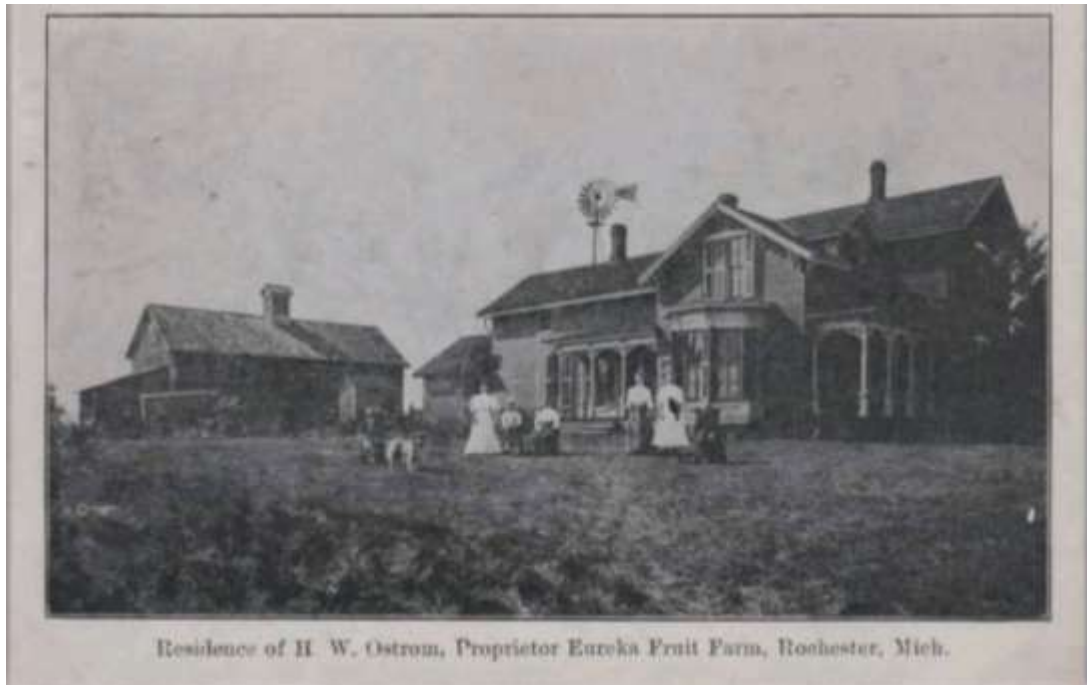
Photo 1 Photo of H.W. Ostrom house, Eureka Fruit Farm, unknown date, courtesy property owner.

A historic photograph of an unknown date shows the house with a two-story barn in the background. The house shows more of its original elements such as cornice brackets and decorative porch posts and brackets.

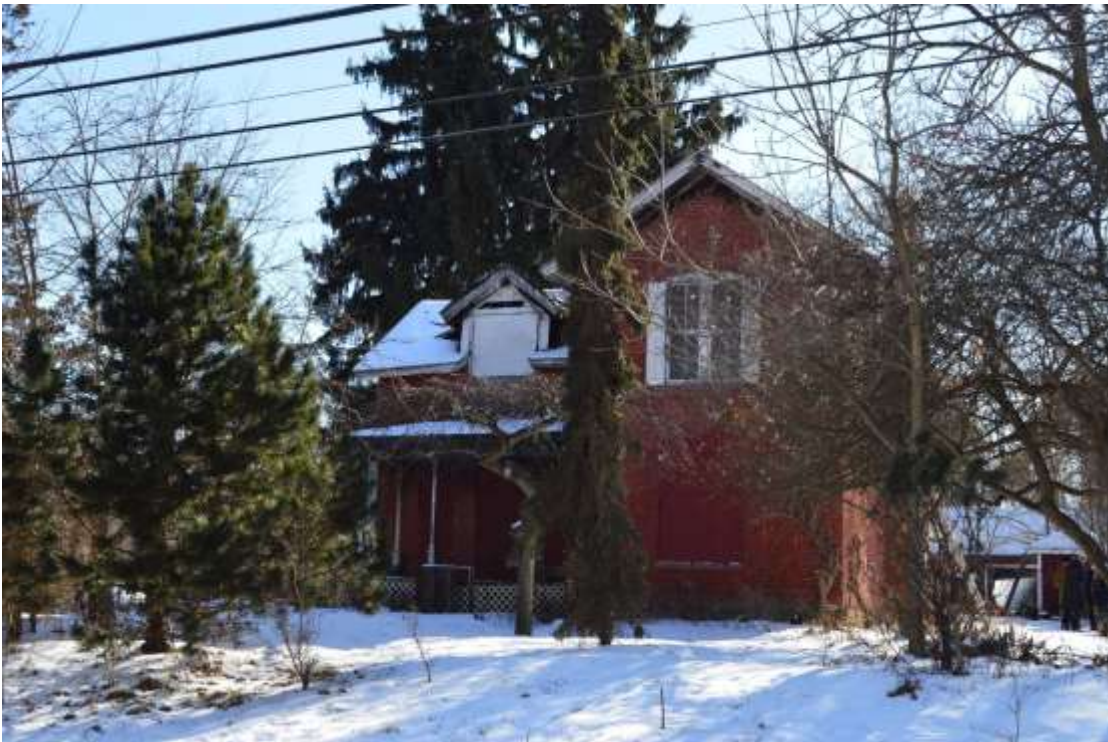
Photo 3 Photo of 1021 Harding, January 2021.

Other than windows and portions of the roof all damaged by fire the district has not lost its original physical characteristics from when it was designated.

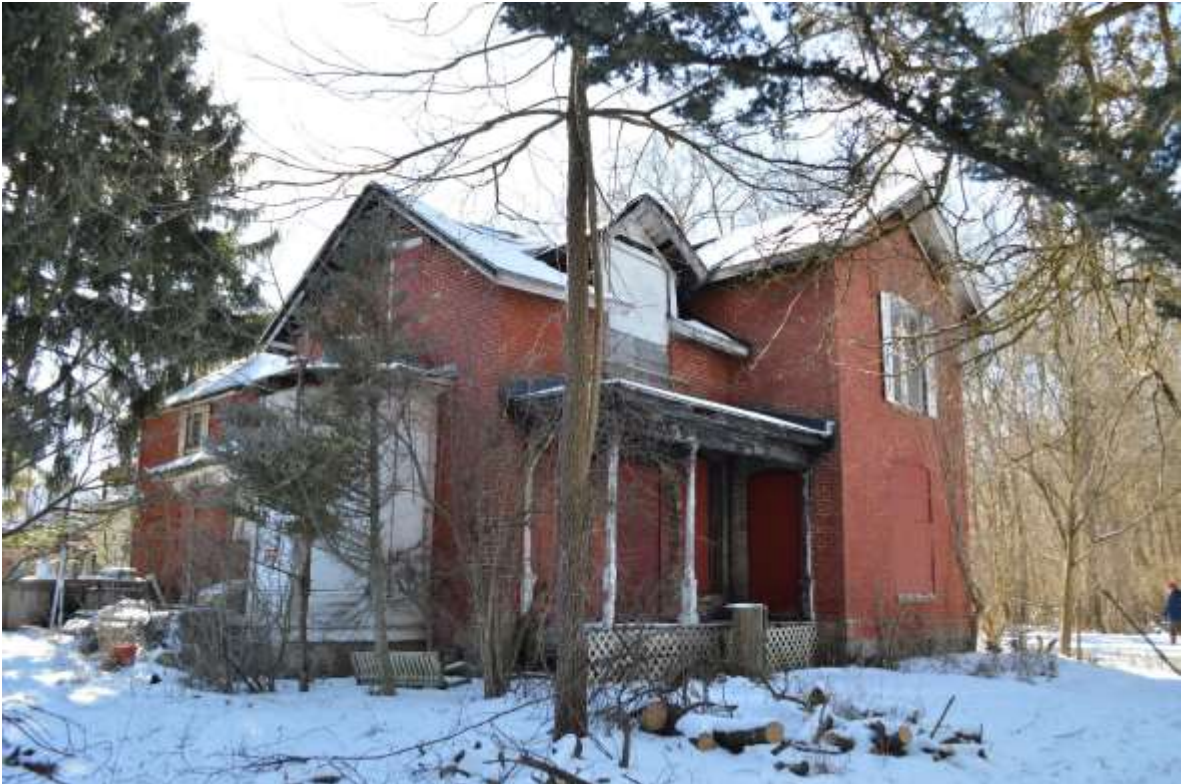
The house's east elevation is comprised of the gable end of the wing, and the side of the rear ell. The gable end of the wing has a five-sided projecting one-story tall bay with a stone foundation, wood walls, and a hipped roof. The window openings are boarded. Above the bay, in the gable end, is a window opening with a shallow-arch lintel. The window opening is boarded. The east elevation of the rear wing has the remains of a hipped roof porch at the first floor and a shallow arched window opening. Behind the porch there is a door flanked by two window openings that are boarded over. There is one square window opening at the second floor with no window sash and small louvered shutters.

2-Looking southwest at front and east side of house, January 2021

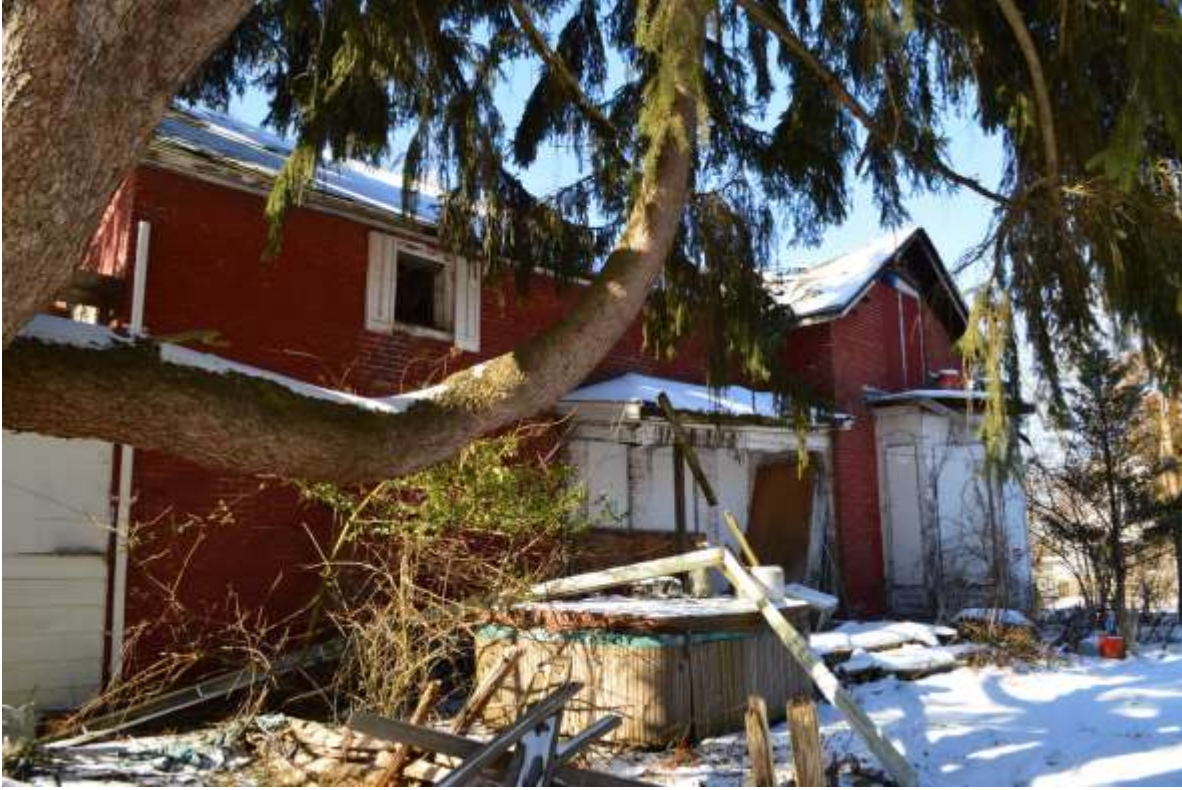
3-Looking northwest at east side of house, January 2021

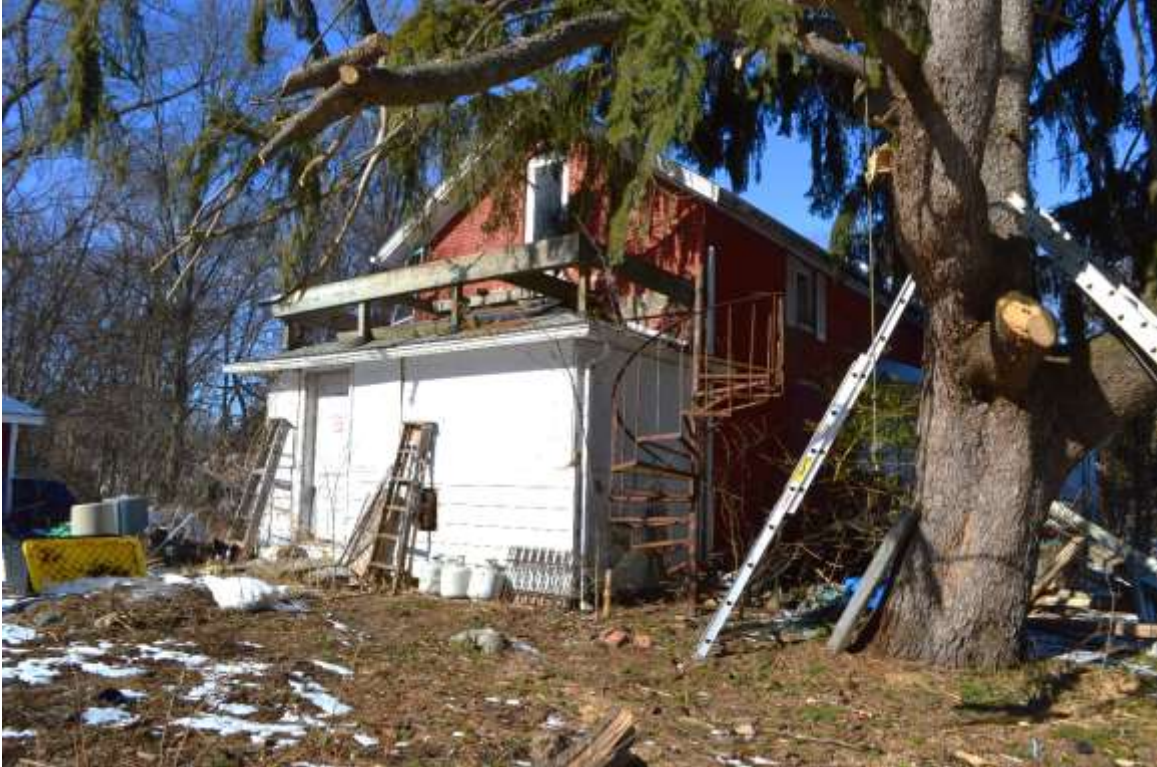
At the rear of the house there is a one-story tall hip roof enclosed porch with wide siding on the lower half and boarded window openings in the upper half. A single door is located near the west side. The second floor of the rear ell has a single tall opening in the center. The rear elevation of the upright has a one-story hip roof addition that is clad in wood clapboard siding. A door and window opening in the addition are both boarded over. In the second floor of the upright there is a tall narrow window opening with a shallow arch lintel that is boarded over.

4-Looking northwest at rear of house, January 2021

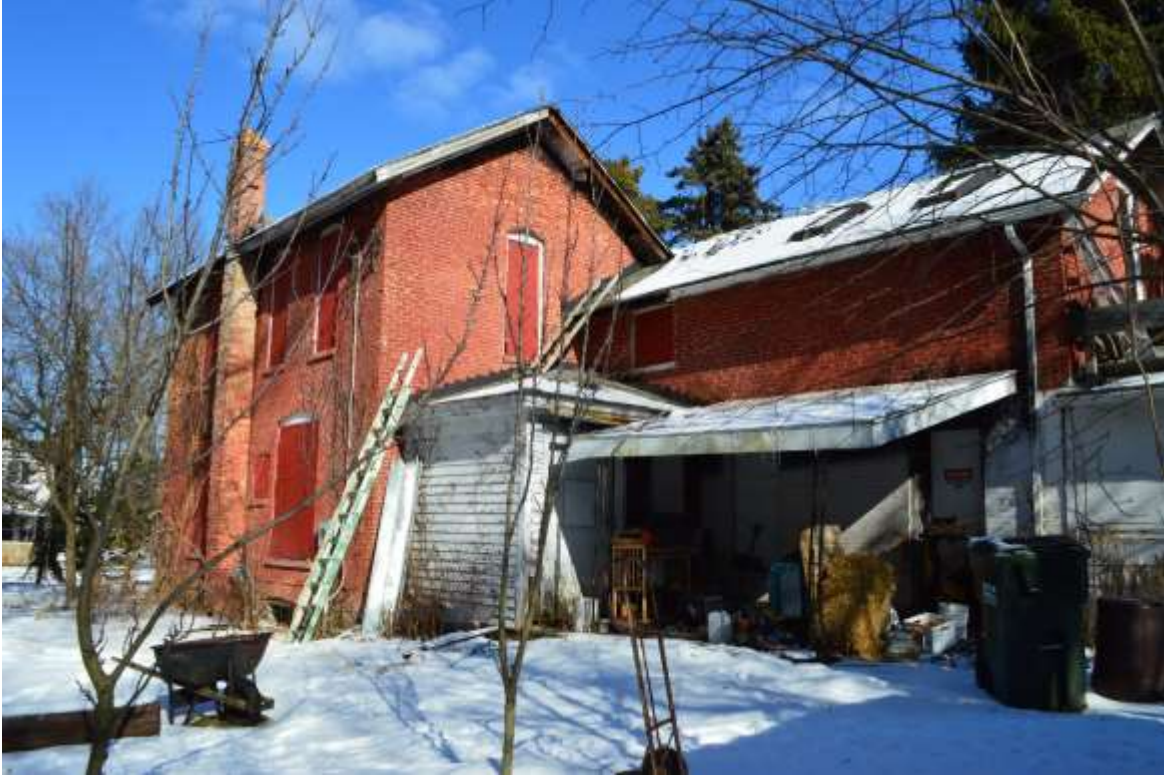
The west elevation of the house consists of the two-story tall upright, the side of the one-and-a-half-story tall rear ell, and the side of the small one-story addition to the rear of the upright. The upright has a non-original exterior brick chimney in the center of the wall. To the north of the chimney are wide shallow-arched window openings at the first and second floor that are boarded over. To the south of the chimney at the first floor there is a small window opening, and a larger shallow arched window opening. Both are boarded over. At the second floor there are two narrow window openings with shallow arched lintels. The side of the rear ell consists of the

clapboard sided addition to the upright. The remains of a shed roof porch extends along the remainder of the side of the rear ell. There are two boarded window openings at the first floor. At the second floor there is one boarded window opening near the rear wall of the upright. There are two skylights in the gable roof of the rear ell.

5-Looking northeast at west side and rear of house, January 2021

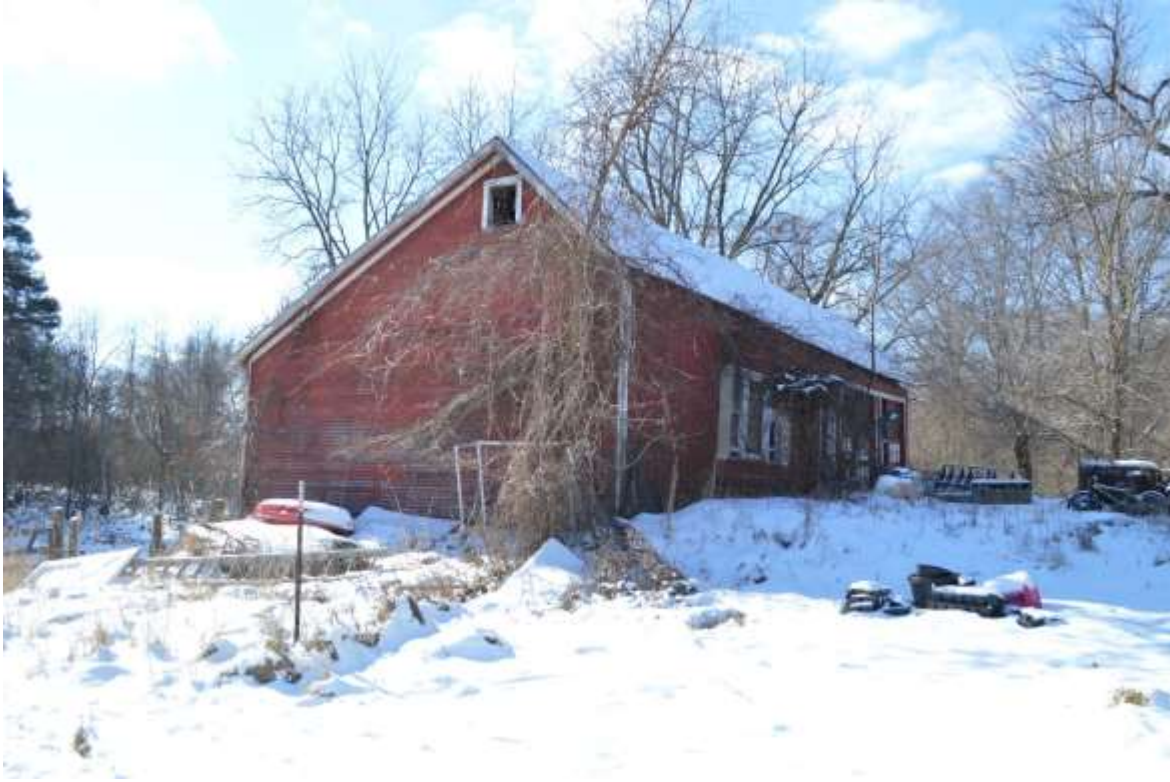
The barn is located south of the house and is one-and-a-half stories tall with a saltbox gable roof – the rear slope is longer than the front. The eaves have exposed rafter tails. The barn has a rectangular footprint. The barn is built into the hill so that the lower level is equal to the lower ground level. The barn has a cobblestone basement and the walls are clad in narrow wood clapboard siding.

7-Looking southwest at barn north and east elevations, January 2021

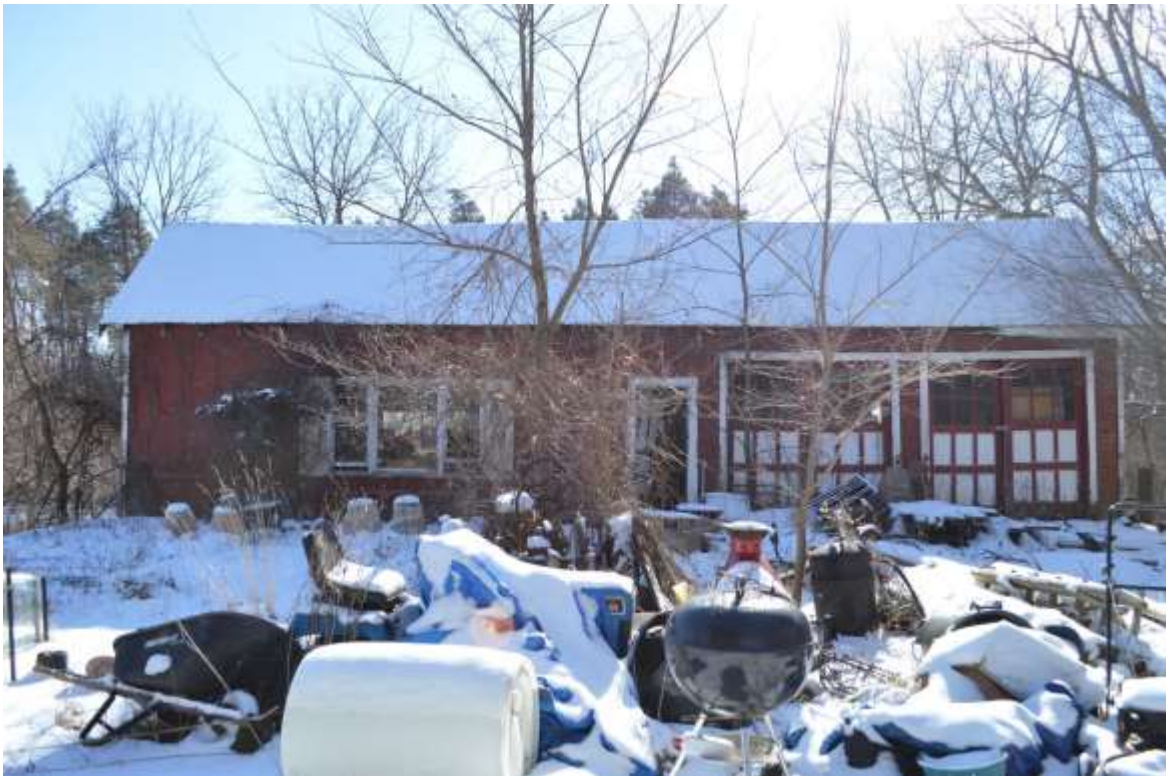
The north elevation has two wide door openings with paneled wood sliding doors with windows in the upper third of each door. There is a wood panel pedestrian door. A wide opening in the east half of the elevation contains a combination of double-hung windows with a wider fixed sash window in between. The east elevation has a small square opening in the top of the gable, the ground slopes away sharply toward the south. The west elevation is identical with a more gradual slope toward the south. The south elevation has wide openings at both ends of the lower level that have half-high wood gates across the bottom. The wall in between the openings has seven four-over-four windows that alternate with sections of wall clad with wood louvers. In the upper level at the east end there is a wide window opening containing two one-over-one double hung windows flanking a large, fixed center sash. In the west end there are three four-over-four double hung windows.

8-Looking south at north elevation of barn, January 2021

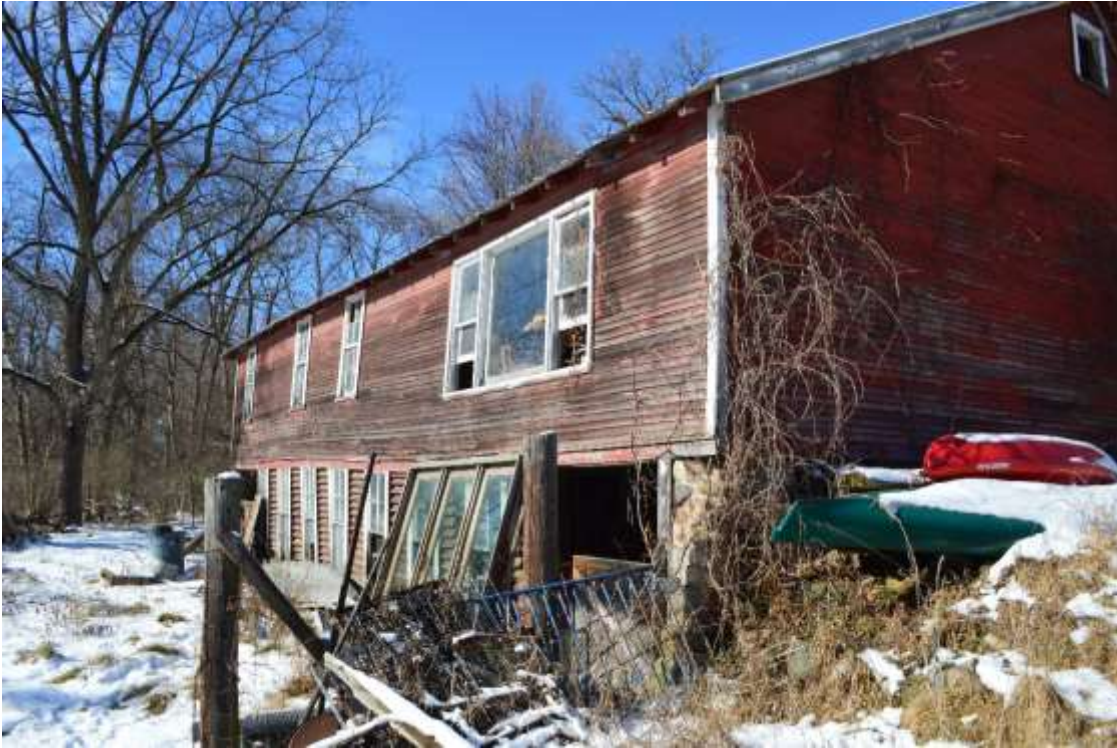
9-Looking northwest at south elevation of barn, January 2021

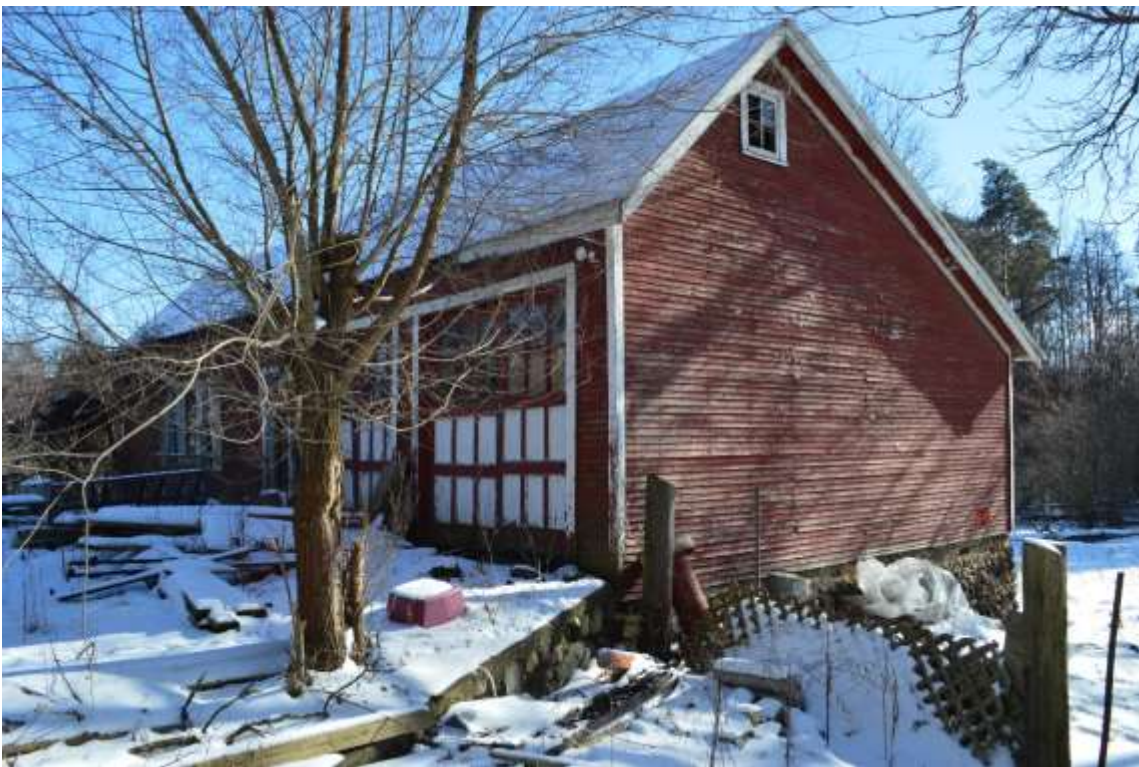
10-Looking southeast at north and west elevations of barn, January 2021

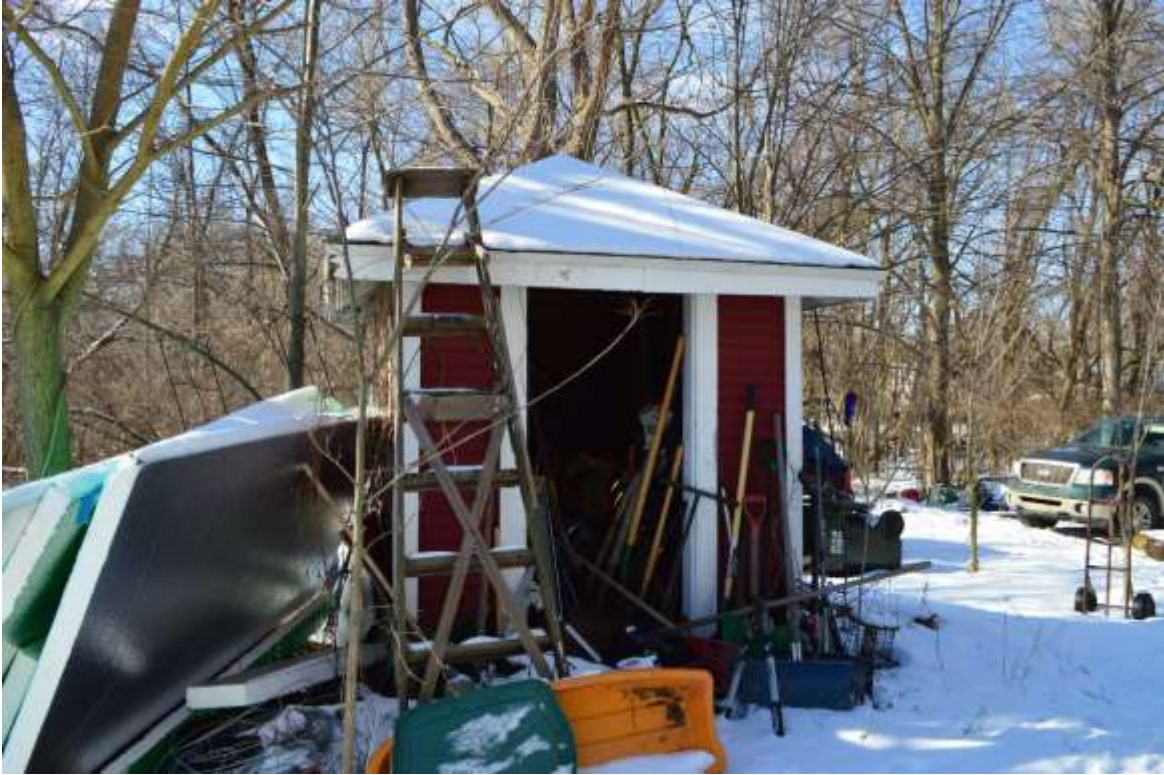
To the southwest of the house is a one-story tall pumphouse with a square footprint and pyramidal roof. The walls are clad in narrow wood clapboard with wood trim. The west and north elevations have no openings. The east elevation has a single door opening with no door. The south elevation has a small window opening with a casement window.

11-Looking west at pumphouse, January 2021

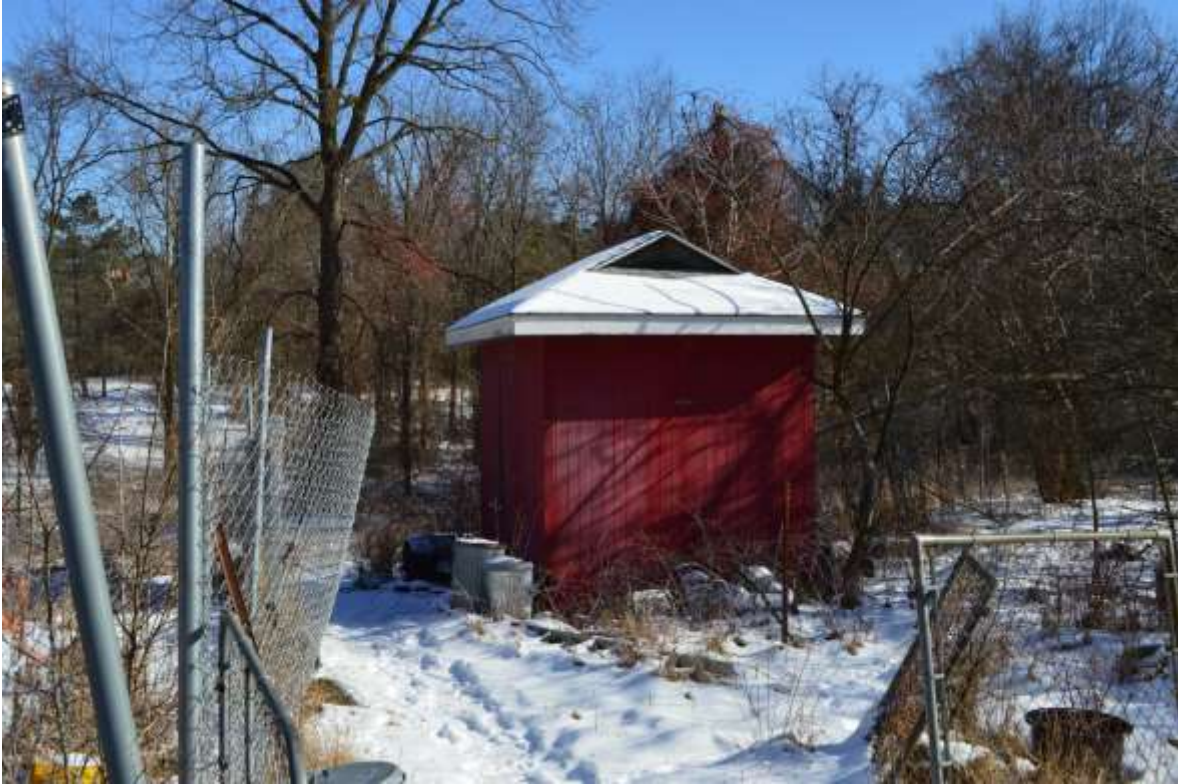
The shed is one-story tall with a gable hip roof and deep eaves. It is clad in modern vertical wood siding. The hinged door matches the siding and makes the building appear that there are no openings.

12-Looking east at storage shed, January 2021

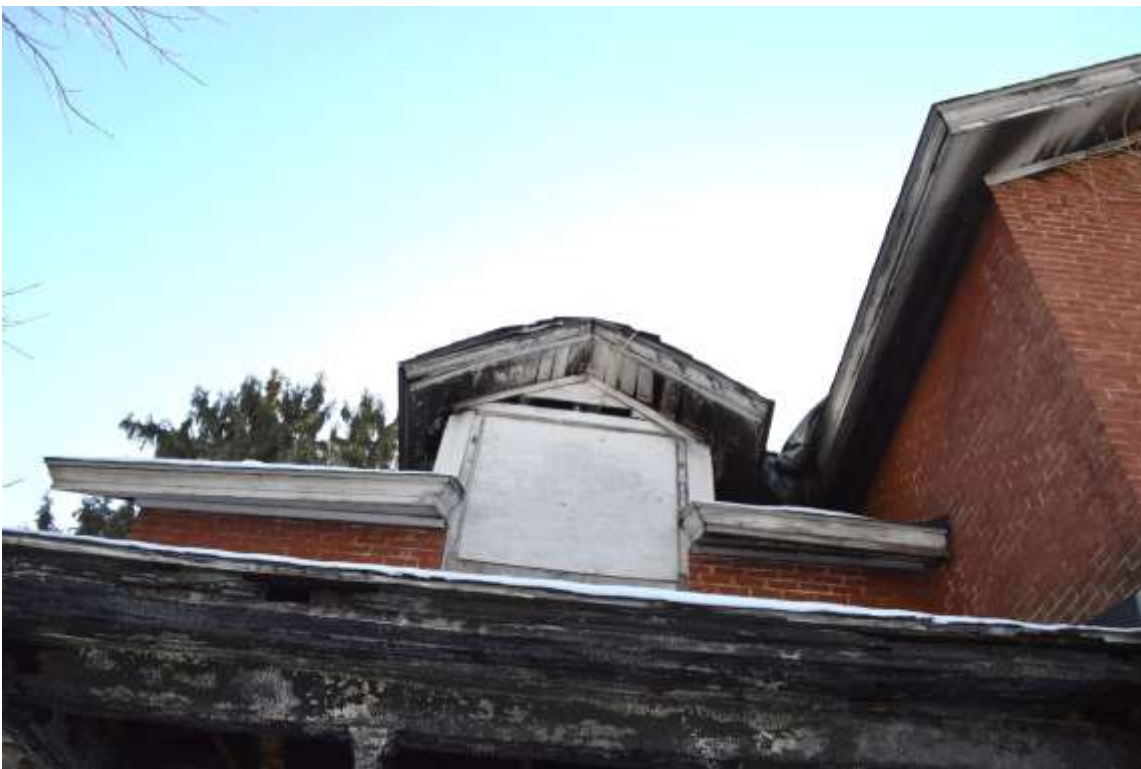
Note that the house suffered an extensive fire in November 2017. As a result many window and door openings are boarded over, there are tarps on the roof, and there is evidence of fire damage on some areas of the brick walls and the roof.

16 – North dormer showing fire damage, January 2021

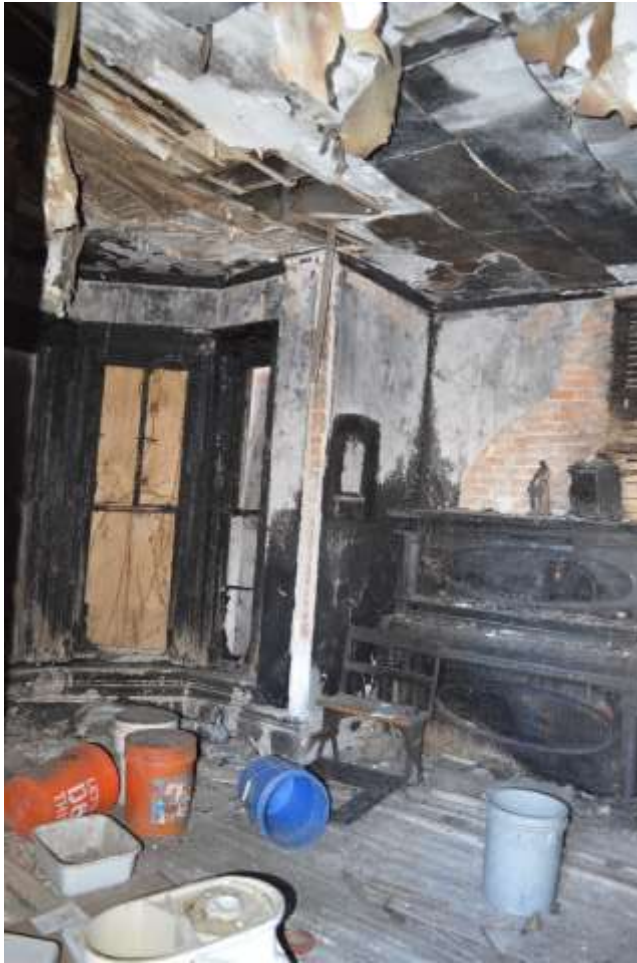
17 – Looking at fire damaged interior, damaged east bay window to left, January 2021
