PRELIMINARY REPORT
ROCHESTER HILLS HISTORIC DISTRICTS STUDY COMMITTEE
EUREKA FRUIT FARM, 1021 HARDING ROAD
ROCHESTER HILLS, MICHIGAN
Draft February 2021

DESCRIPTION OF THE DISTRICT

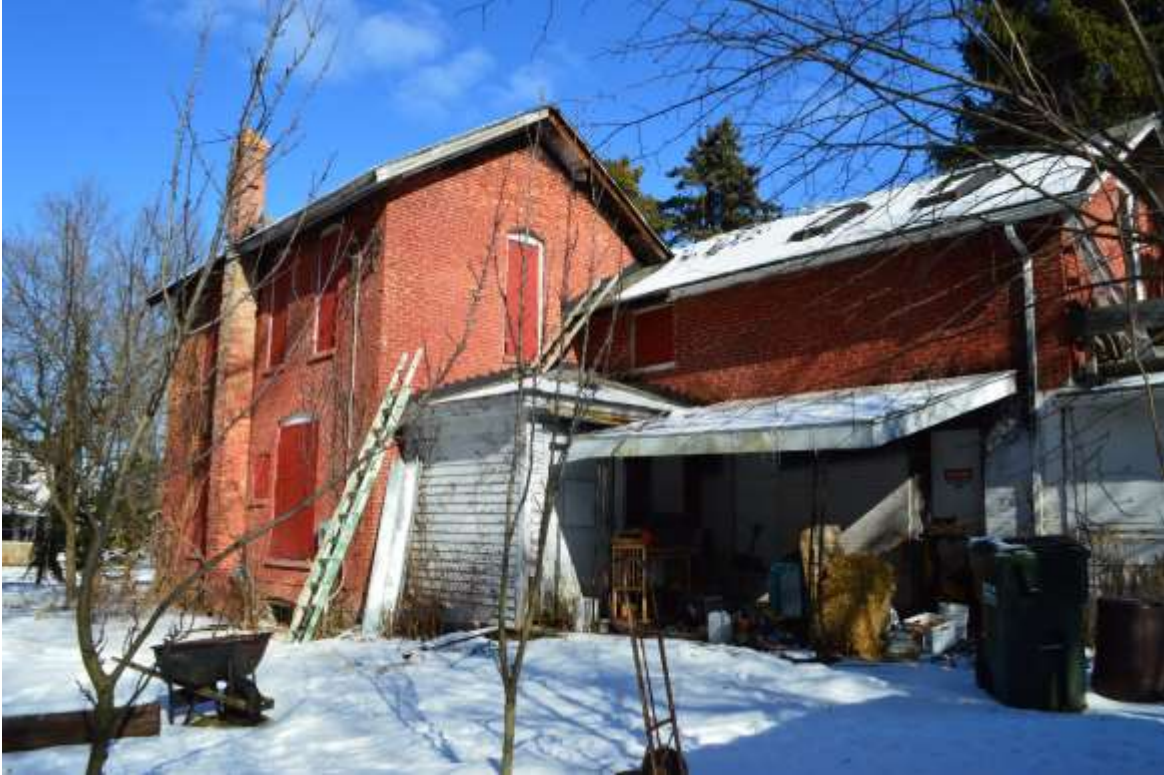
The west elevation of the house consists of the two-story tall upright, the side of the one-and-a-half-story tall rear ell, and the side of the small one-story addition to the rear of the upright. The upright has a non-original exterior brick chimney in the center of the wall. To the north of the chimney are wide shallow-arched window openings at the first and second floor that are boarded over. To the south of the chimney at the first floor there is a small window opening, and a larger shallow arched window opening. Both are boarded over. At the second floor there are two narrow window openings with shallow arched lintels. The side of the rear ell consists of the

clapboard sided addition to the upright. The remains of a shed roof porch extends along the remainder of the side of the rear ell. There are two boarded window openings at the first floor. At the second floor there is one boarded window opening near the rear wall of the upright. There are two skylights in the gable roof of the rear ell.

5-Looking northeast at west side and rear of house, January 2021

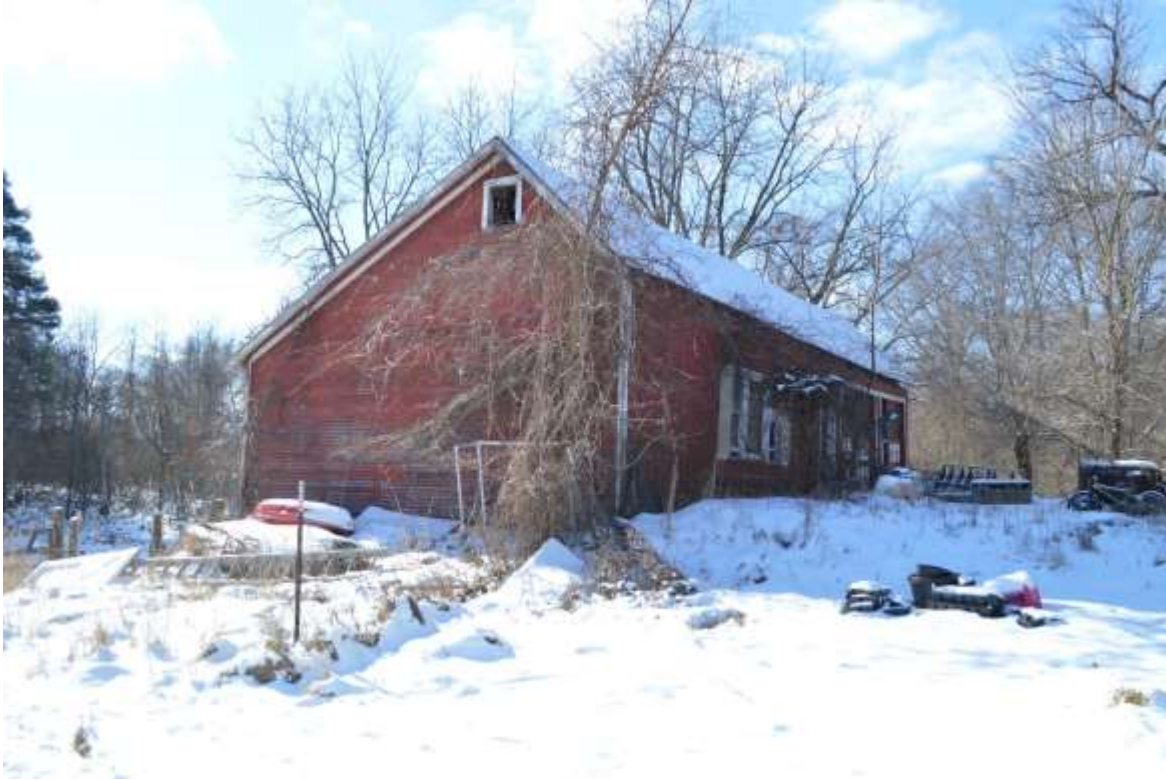
The barn is located south of the house and is one-and-a-half stories tall with a saltbox gable roof – the rear slope is longer than the front. The eaves have exposed rafter tails. The barn has a rectangular footprint. The barn is built into the hill so that the lower level is equal to the lower ground level. The barn has a cobblestone basement and the walls are clad in narrow wood clapboard siding.

7-Looking southwest at barn north and east elevations, January 2021

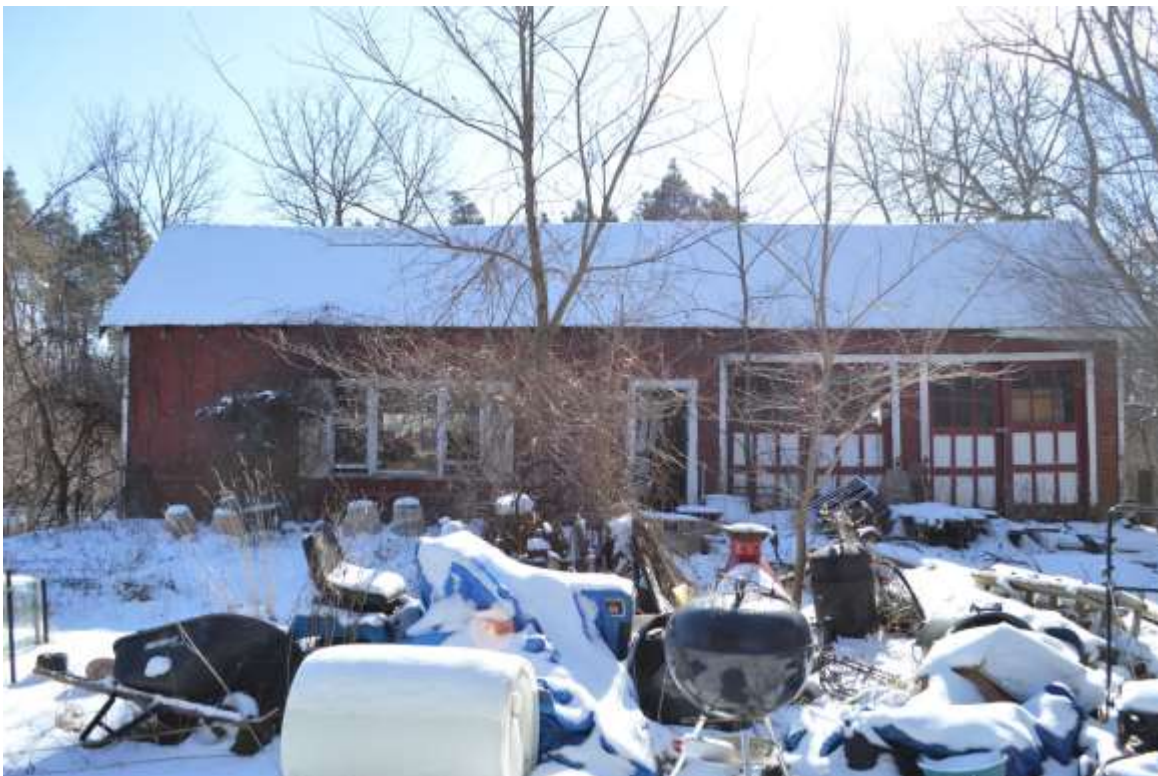
The north elevation has two wide door openings with paneled wood sliding doors with windows in the upper third of each door. There is a wood panel pedestrian door. A wide opening in the east half of the elevation contains a combination of double-hung windows with a wider fixed sash window in between. The east elevation has a small square opening in the top of the gable, the ground slopes away sharply toward the south. The west elevation is identical with a more gradual slope toward the south. The south elevation has wide openings at both ends of the lower level that have half-high wood gates across the bottom. The wall in between the openings has seven four-over-four windows that alternate with sections of wall clad with wood louvers. In the upper level at the east end there is a wide window opening containing two one-over-one double hung windows flanking a large, fixed center sash. In the west end there are three four-over-four double hung windows.

8-Looking south at north elevation of barn, January 2021

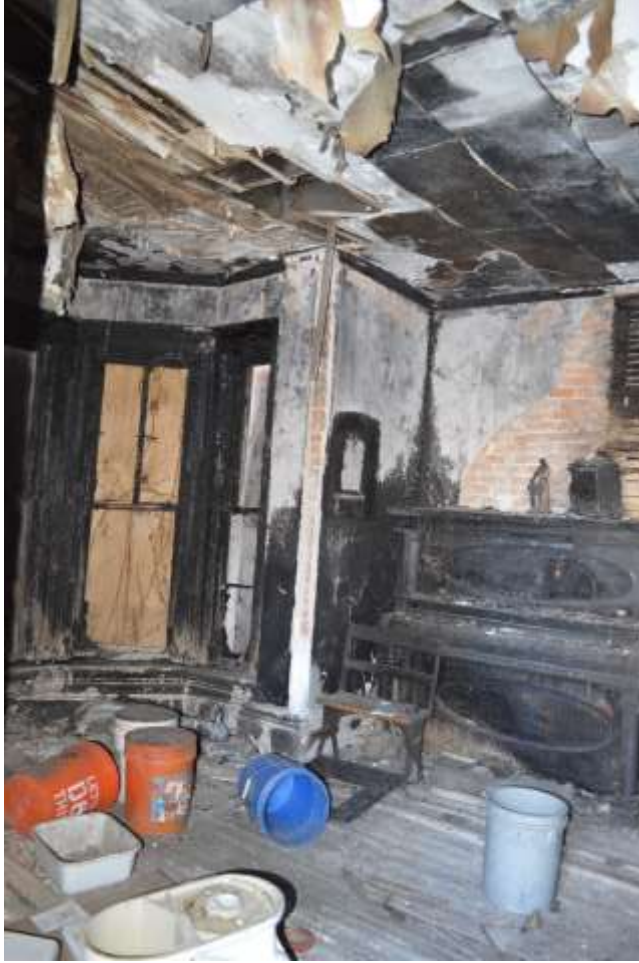
Note that the house suffered an extensive fire in November 2017. As a result many window and door openings are boarded over, there are tarps on the roof, and there is evidence of fire damage on some areas of the brick walls and the roof.

17 – Looking at fire damaged interior, damaged east bay window to left, January 2021
