ACT 381 COMBINED BROWNFIELD PLAN

FOR THE FORMER GASOLINE DISPENSING STATION AND FORMER DEALERSHIP PROPERTY LOCATED AT 3010 AND 3050 SOUTH ROCHESTER ROAD, ROCHESTER HILLS BROWNFIELD REDEVELOPMENT AUTHORITY

July 14, 2014

PM Environmental, Inc.

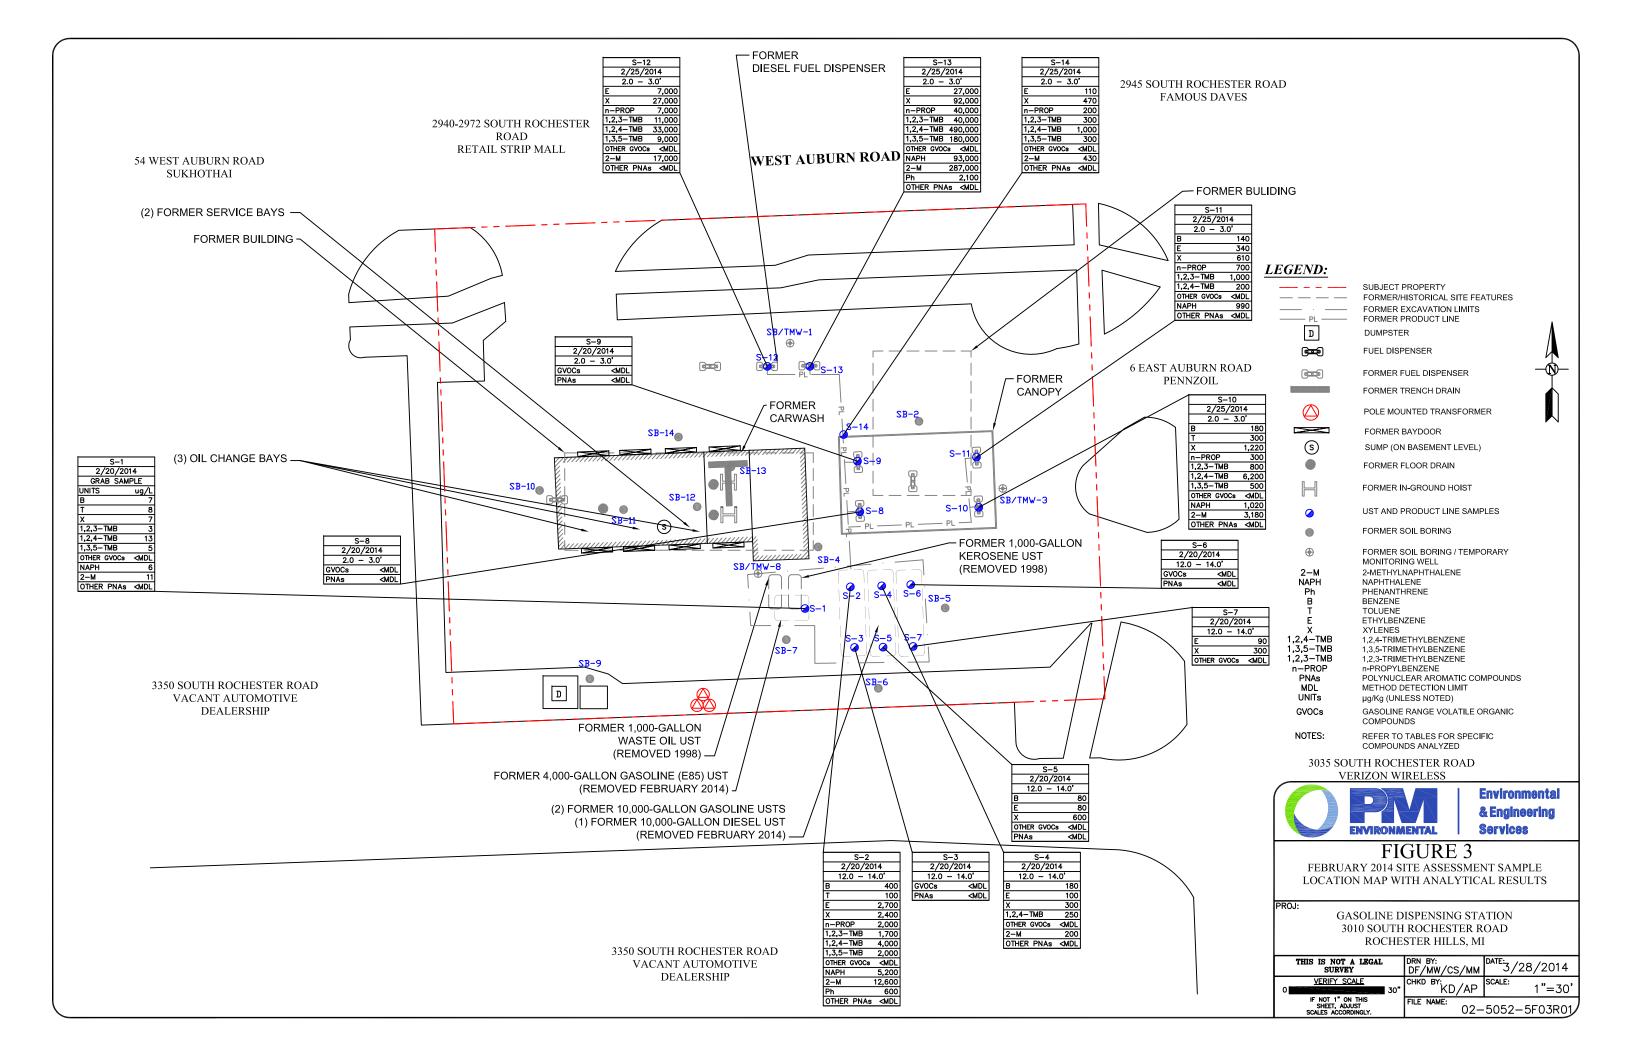
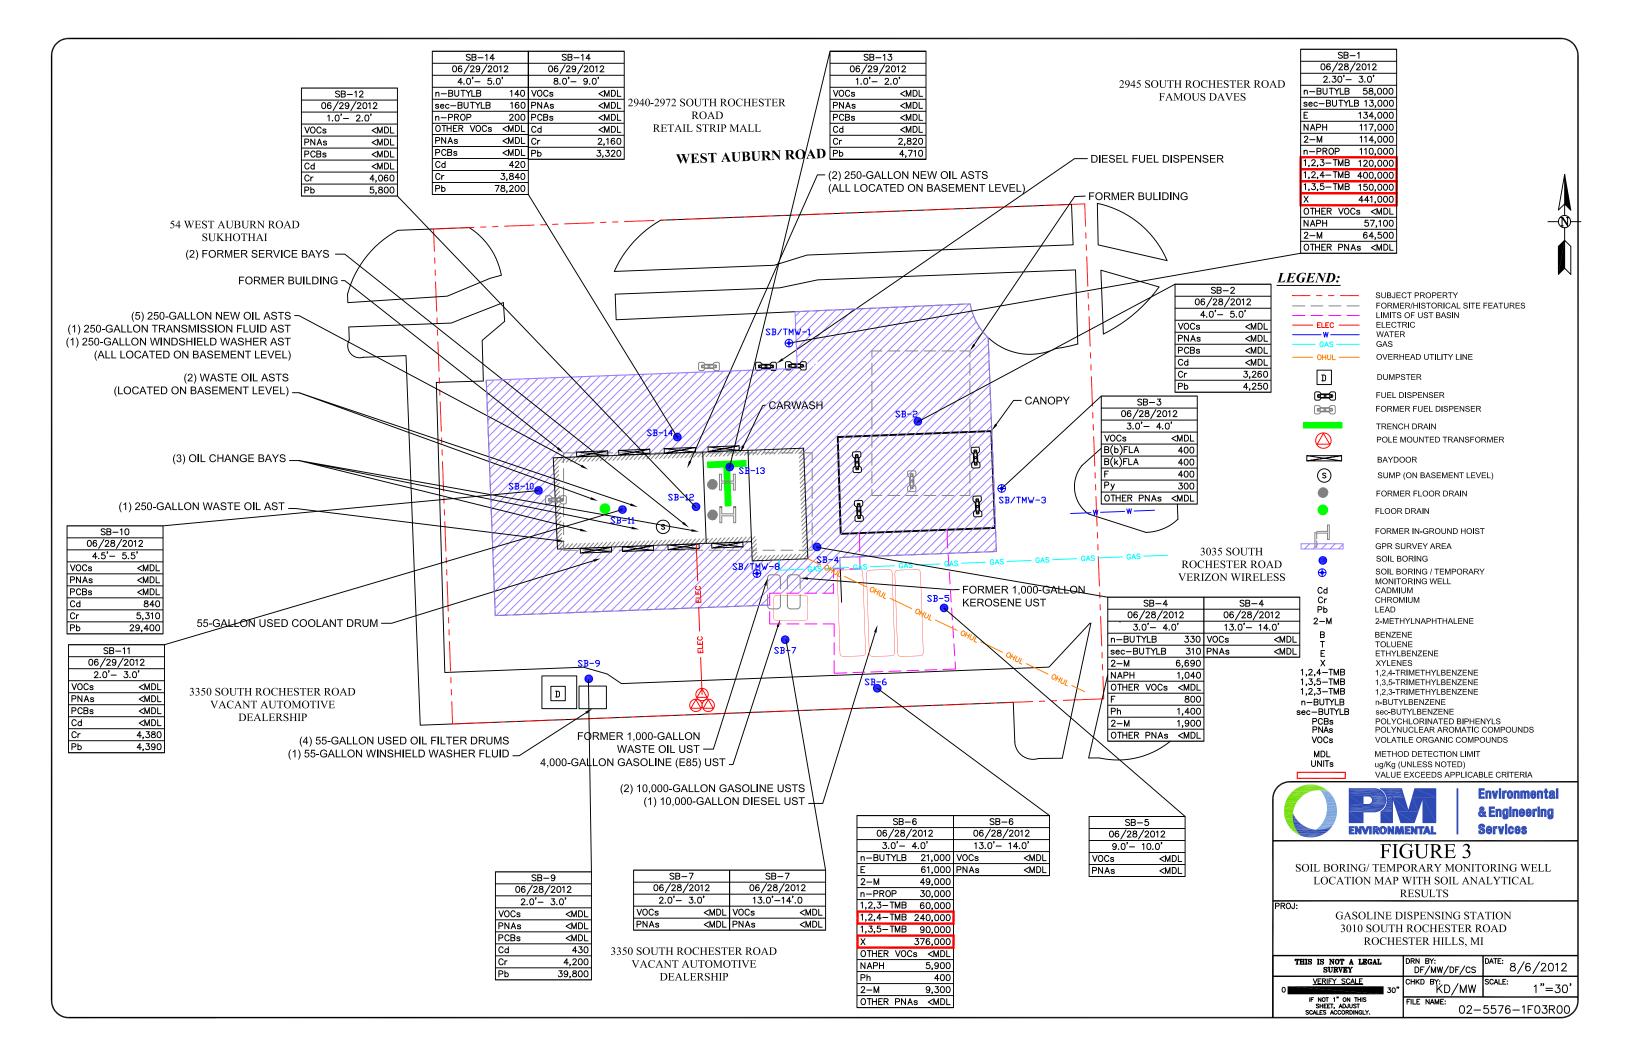
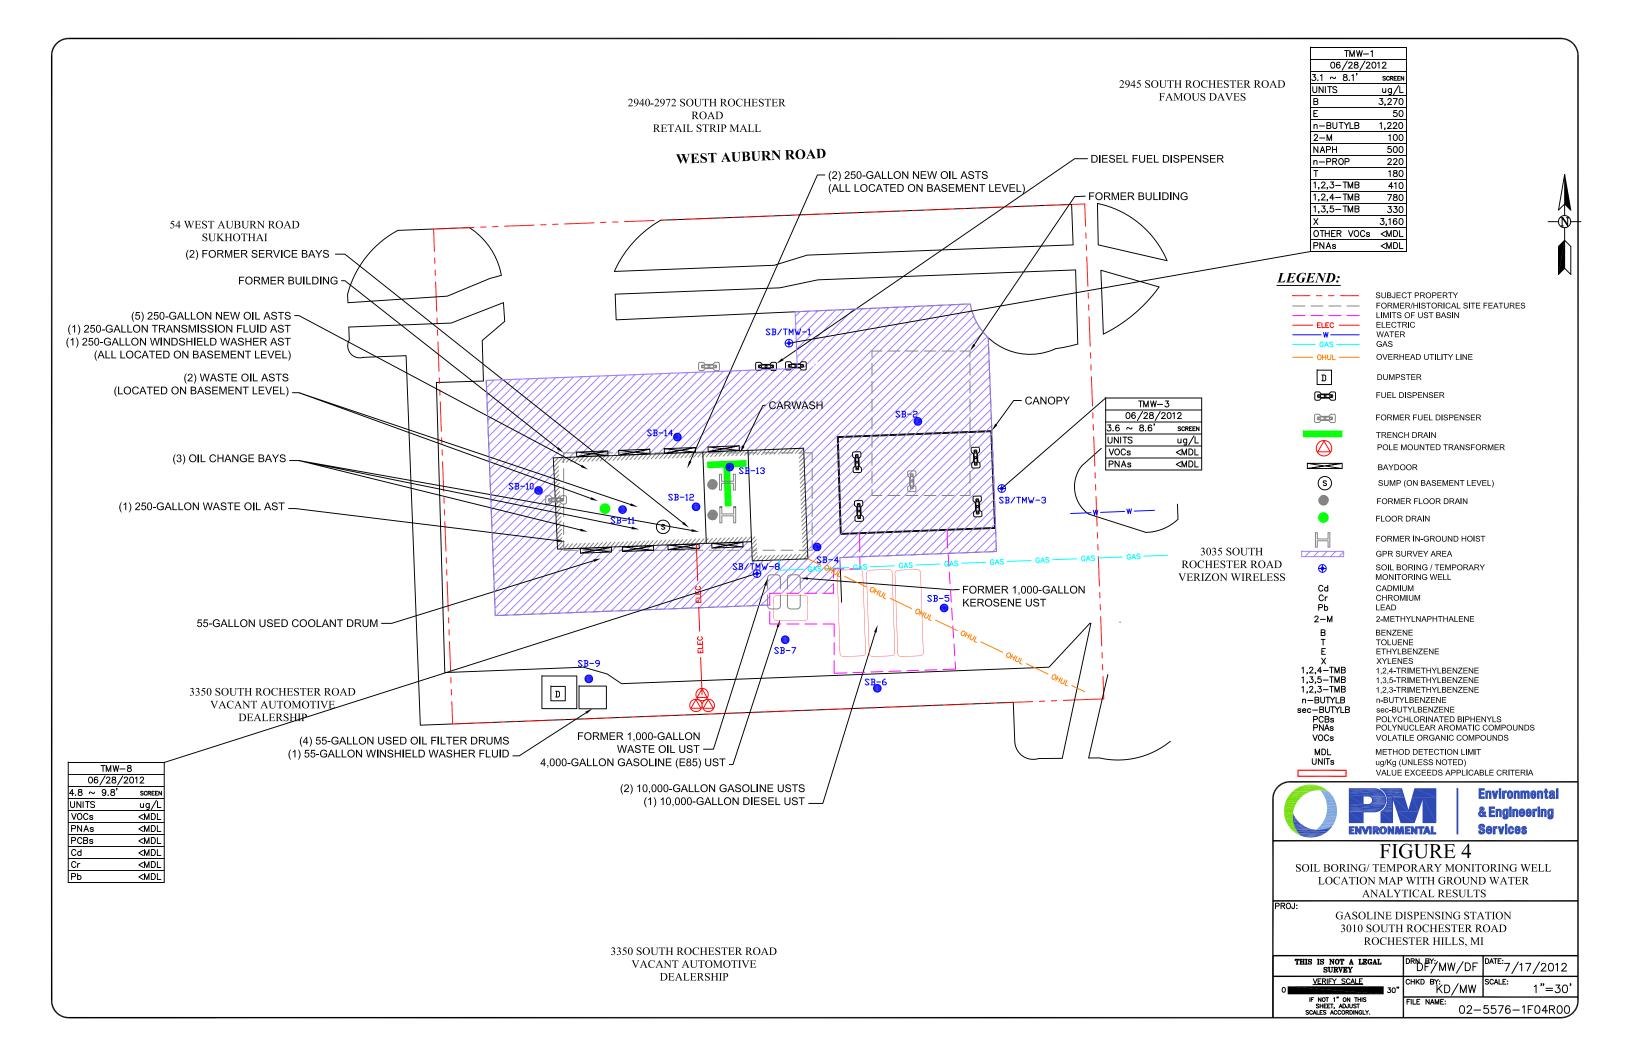
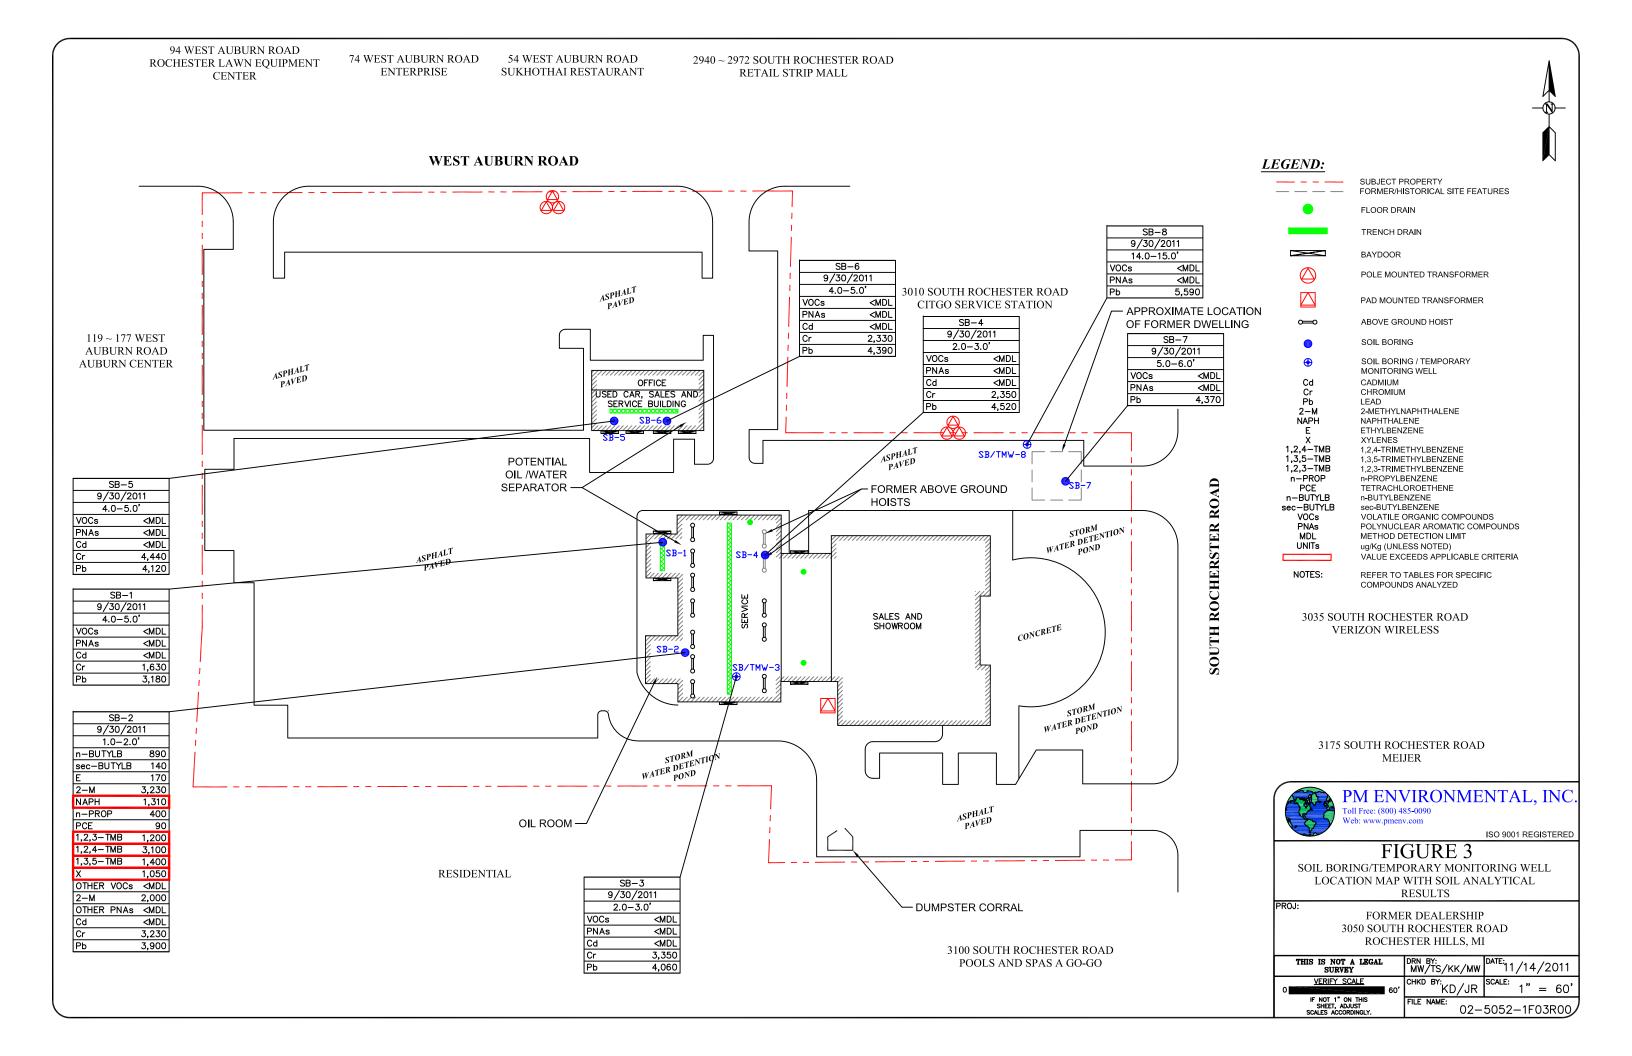
Sampling Location and Known Extent of Contamination Map(s)

On June 28 and 29, 2012, PM advanced 14 soil borings (SB-1 through SB-14), installed three temporary monitoring wells (TMW-1, TMW-3, and TMW-8), and collected soil and ground water samples to assess the RECs identified in PM's June 7, 2012 Phase I ESA. Seventeen soil samples and three groundwater samples were submitted for laboratory analysis of volatile organic compounds (VOCs), PNAs, PCBs, cadmium, chromium, and lead, or some combination thereof. Soil samples were collected for laboratory analysis based on the highest photoionization detector (PID) field screening measurements in parts per million (ppm), noticeable evidence of contamination (i.e., discoloration or odors), or from the likely source depths. The soil boring locations are depicted in Figure 3 exhibit of this plan.

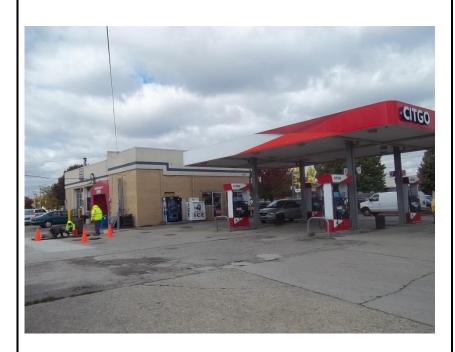
Photograph 1

Additional view of the northeastern subject building (fuel station/quick lube shop) located at 3010 South Rochester Road

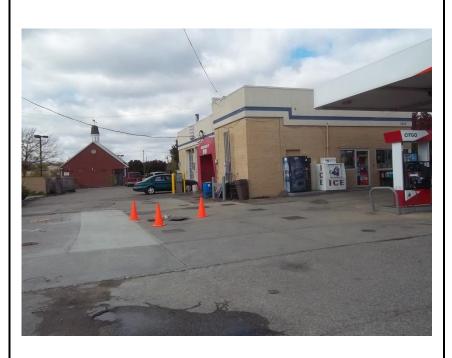
Photograph 2

View of the UST basin located south and southeast of the fuel station/quick lube building

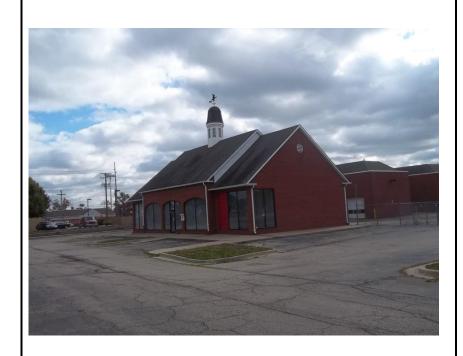
Photograph 3

View of the former northern used car sales/service dealership building (3050 South Rochester Road)

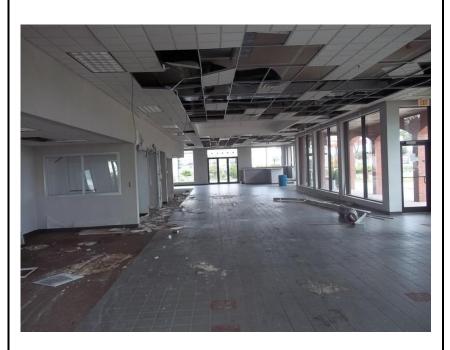
Photograph 4

View of the former new car showroom located in the eastern portion of the eastern dealership building (3050 South Rochester Road)

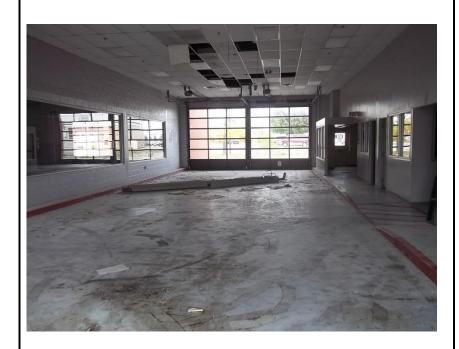
Photograph 5

View of the former service drop-off located in the central portion of the eastern dealership building (3050 South Rochester Road)

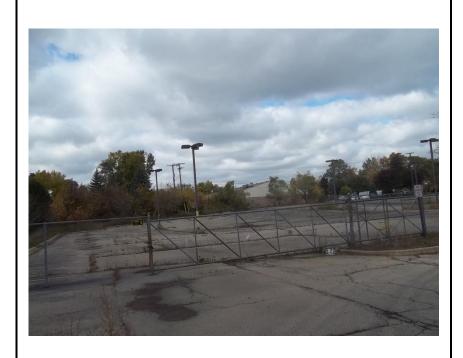
Photograph 6

View of the former vehicle storage lot in the western portion of the property

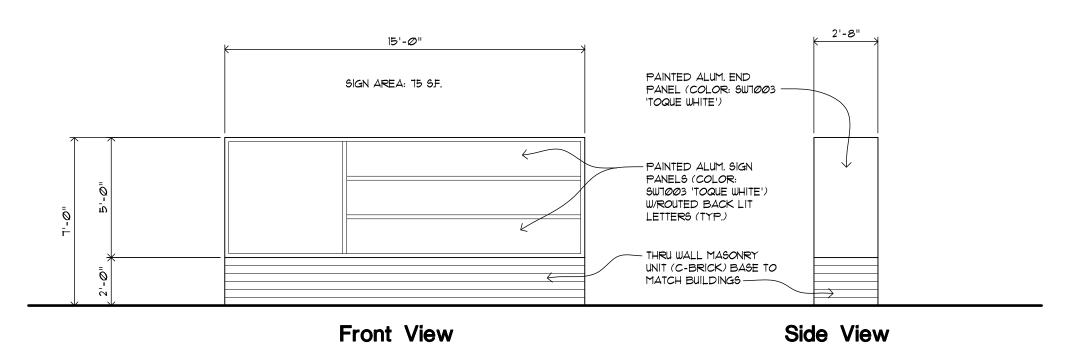
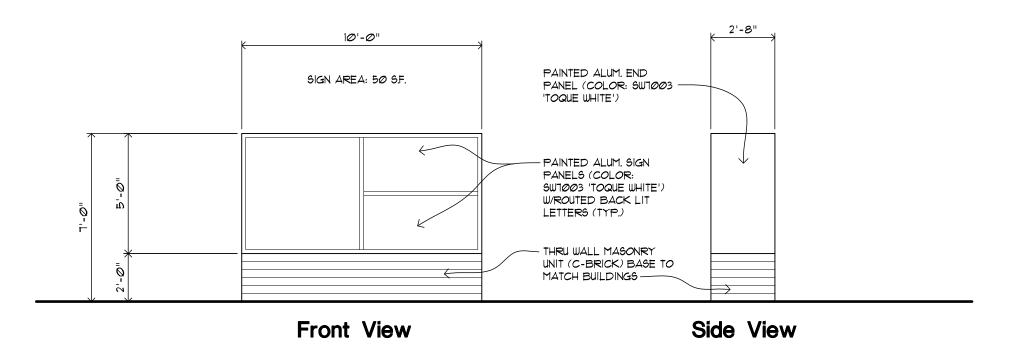
Monument Sign A (2-Sided)

Monument Sign B (2-Sided)

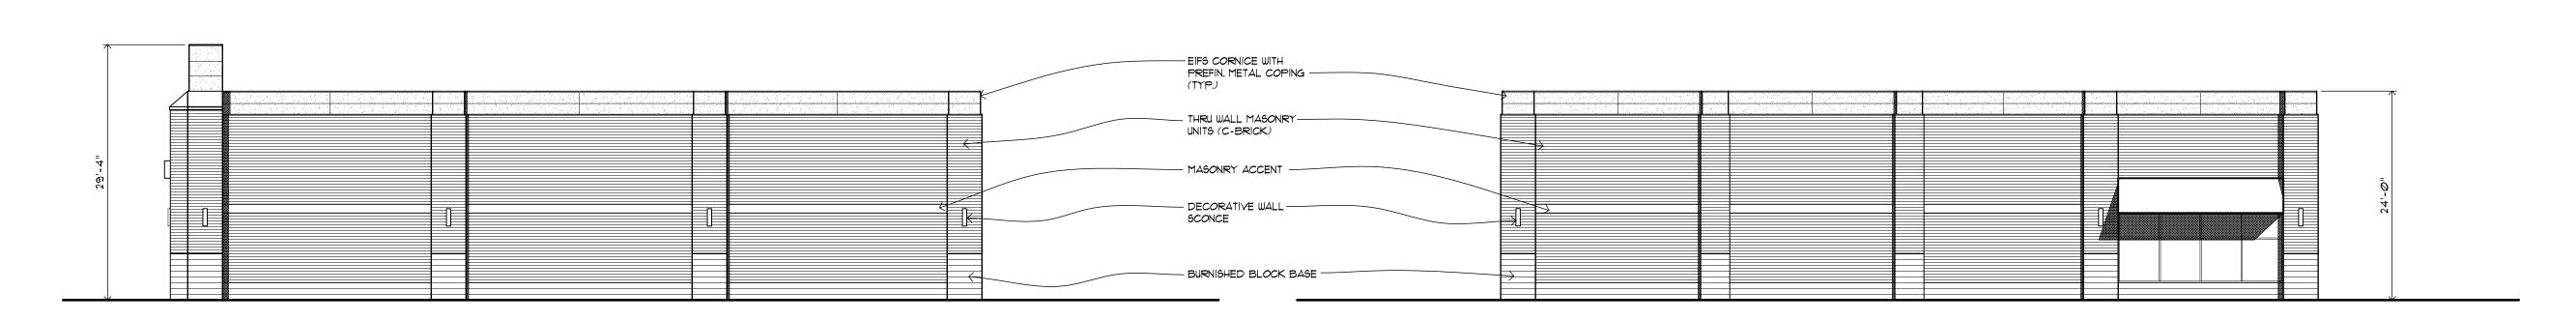
North Elevation - Bldg. D

East Elevation - Bldg. B

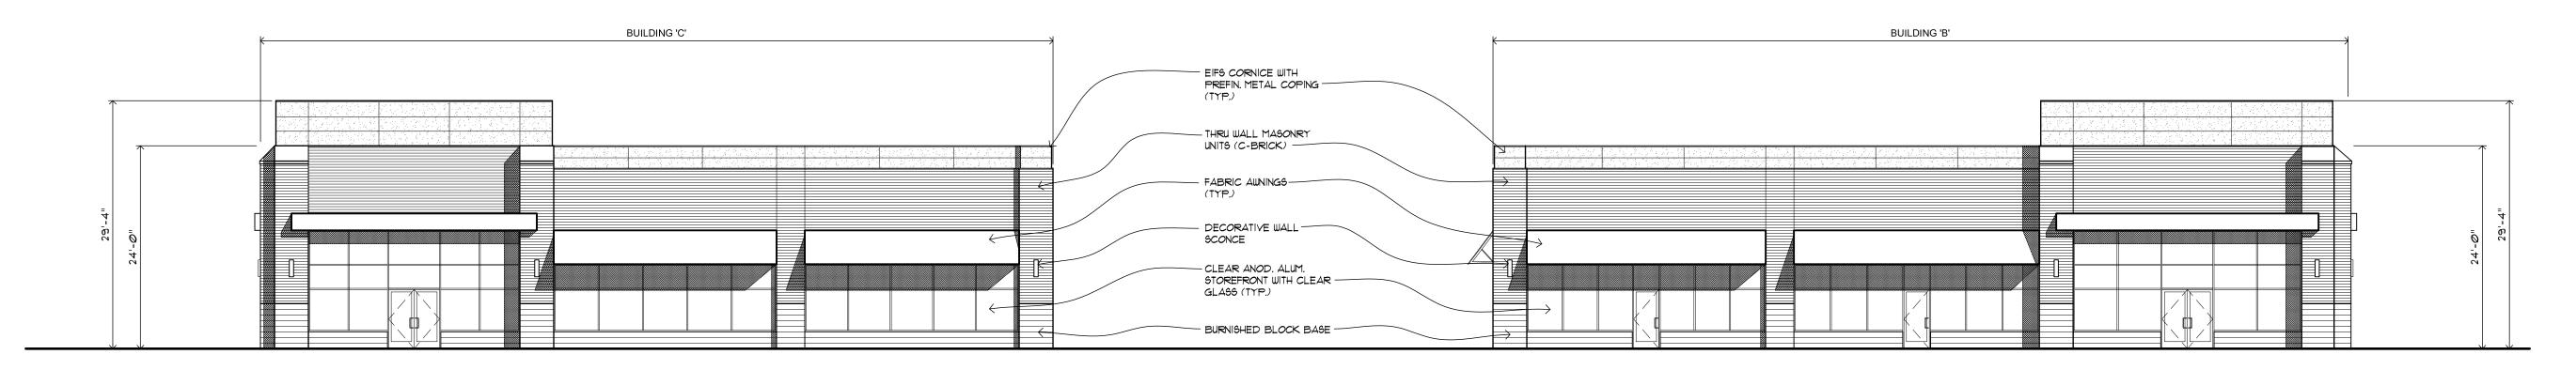
North Elevation - Bldg. C - Auburn Road

North Elevation - Bldg. B - Auburn Road

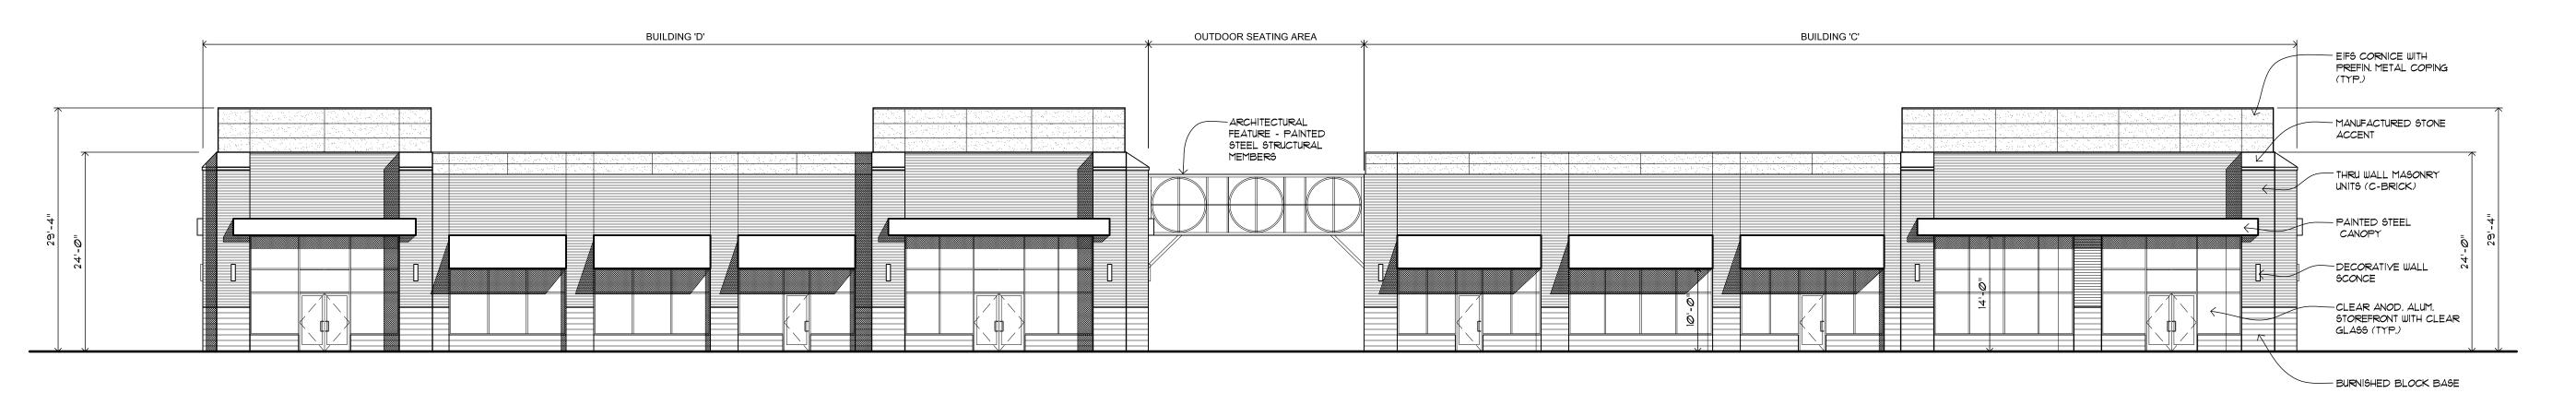
East Elevation - Bldg. D - Rochester Road Scale: 3/32"=1'-0"

East Elevation - Bldg. C - Rochester Road

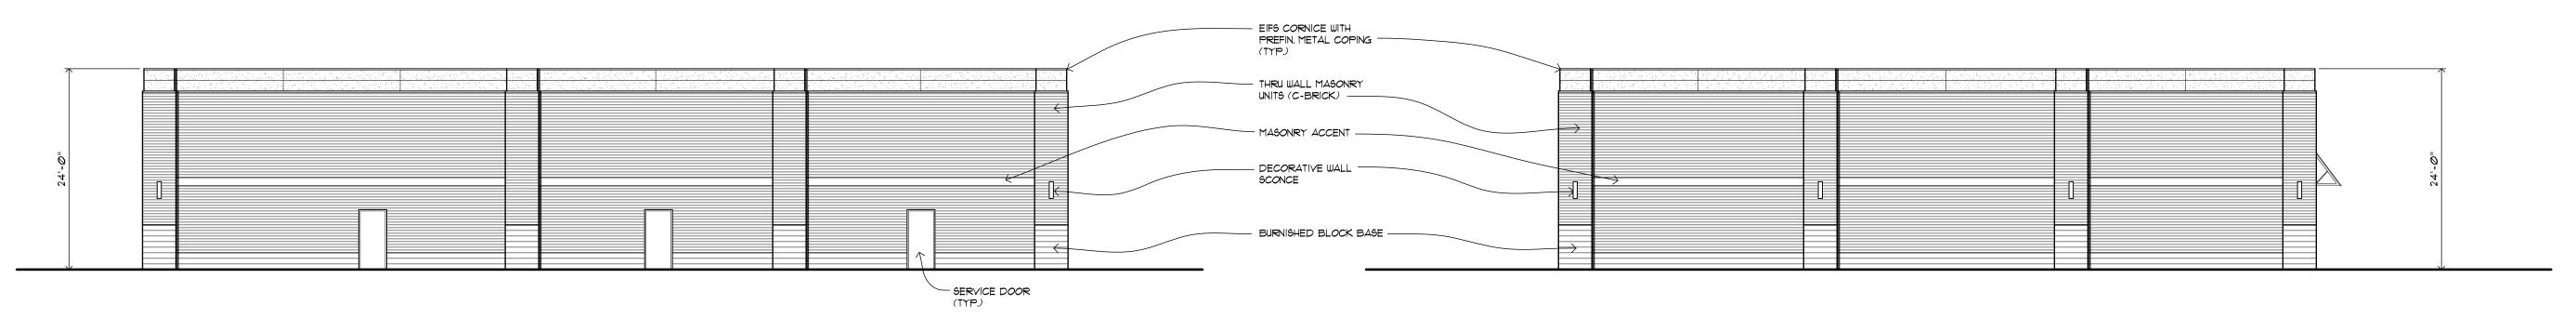
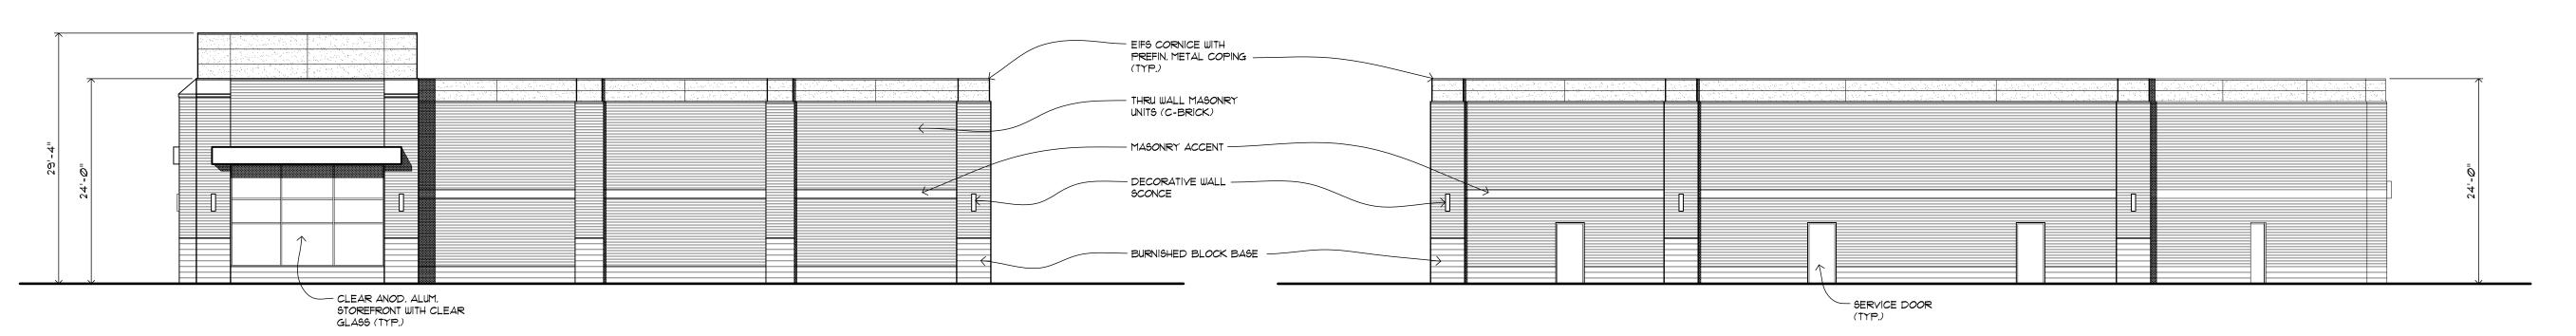
West Elevation - Bldg. C Scale: 3/32"=1'-0"

South Elevation - Bldg. C Scale: 3/32"=1'-0"

West Elevation - Bldg. B
