SITE SURVEY

COMMONLY KNOWN AS: 3600 AUBURN RD., ROCHESTER HILLS, MI 48307
PARCEL ID#15-30-376-032

FIRE PROTECTION PLAN

PROPOSED
RENOBATION AND ADDITION
3600 W. AUBURN ROAD
CASTLE COMMERCIAL CARPENTRY

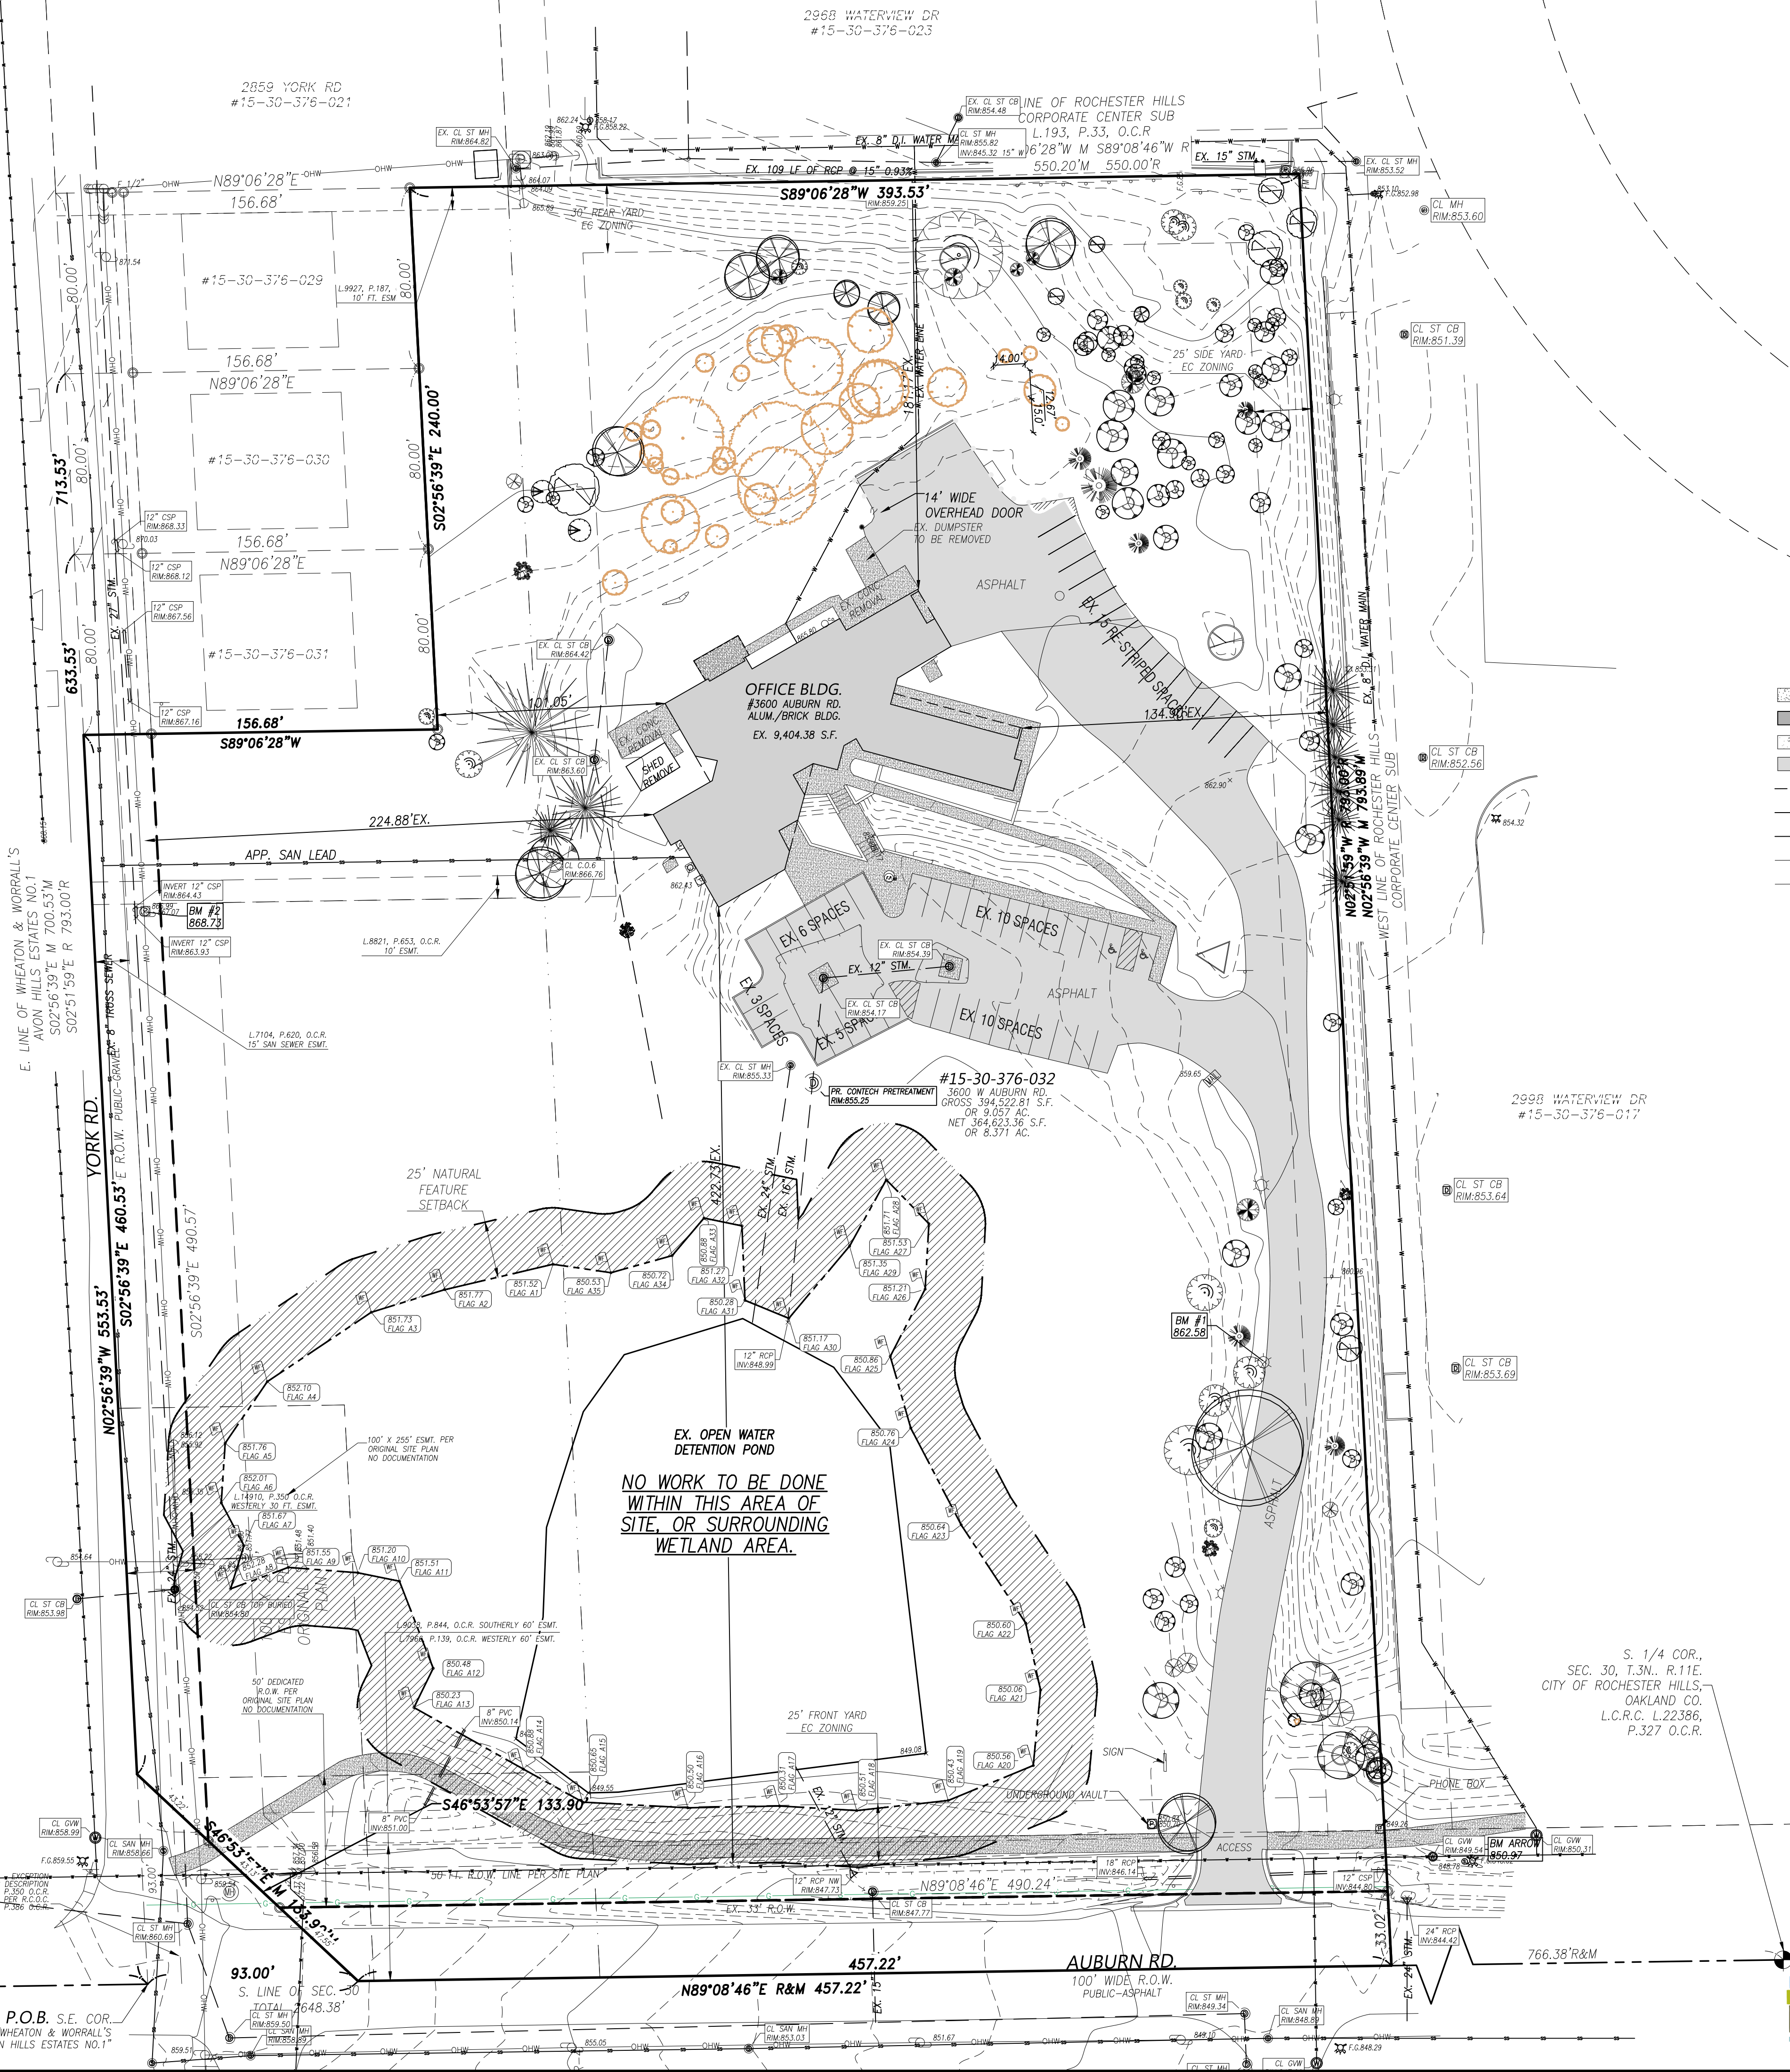
BENCHMARK:
BM #1: EAST SIDE OF CONCRETE BASE ON LIGHT POLE LOCATED ON THE WEST SIDE OF DRIVE, 240' NORTH OF ENTRANCE. ELEVATION: 862.58 NAVD88 DATUM
BM #2: MAG NAIL IN THE EAST FACE OF UTILITY POLE LOCATED ON THE EAST SIDE OF YORK RD. MIDDLE OF SITE. ELEVATION: 868.73 NAVD88 DATUM

SITE SURVEY
A PART OF THE SOUTHWEST FRACTIONAL 1/4 OF SECTION 30, T.3N., R.11E., CITY OF ROCHESTER HILLS, MICHIGAN, OAKLAND COUNTY, COMMONLY KNOWN AS: 3600 AUBURN RD., ROCHESTER HILLS, MI 48307; PARCEL ID#15-30-376-032

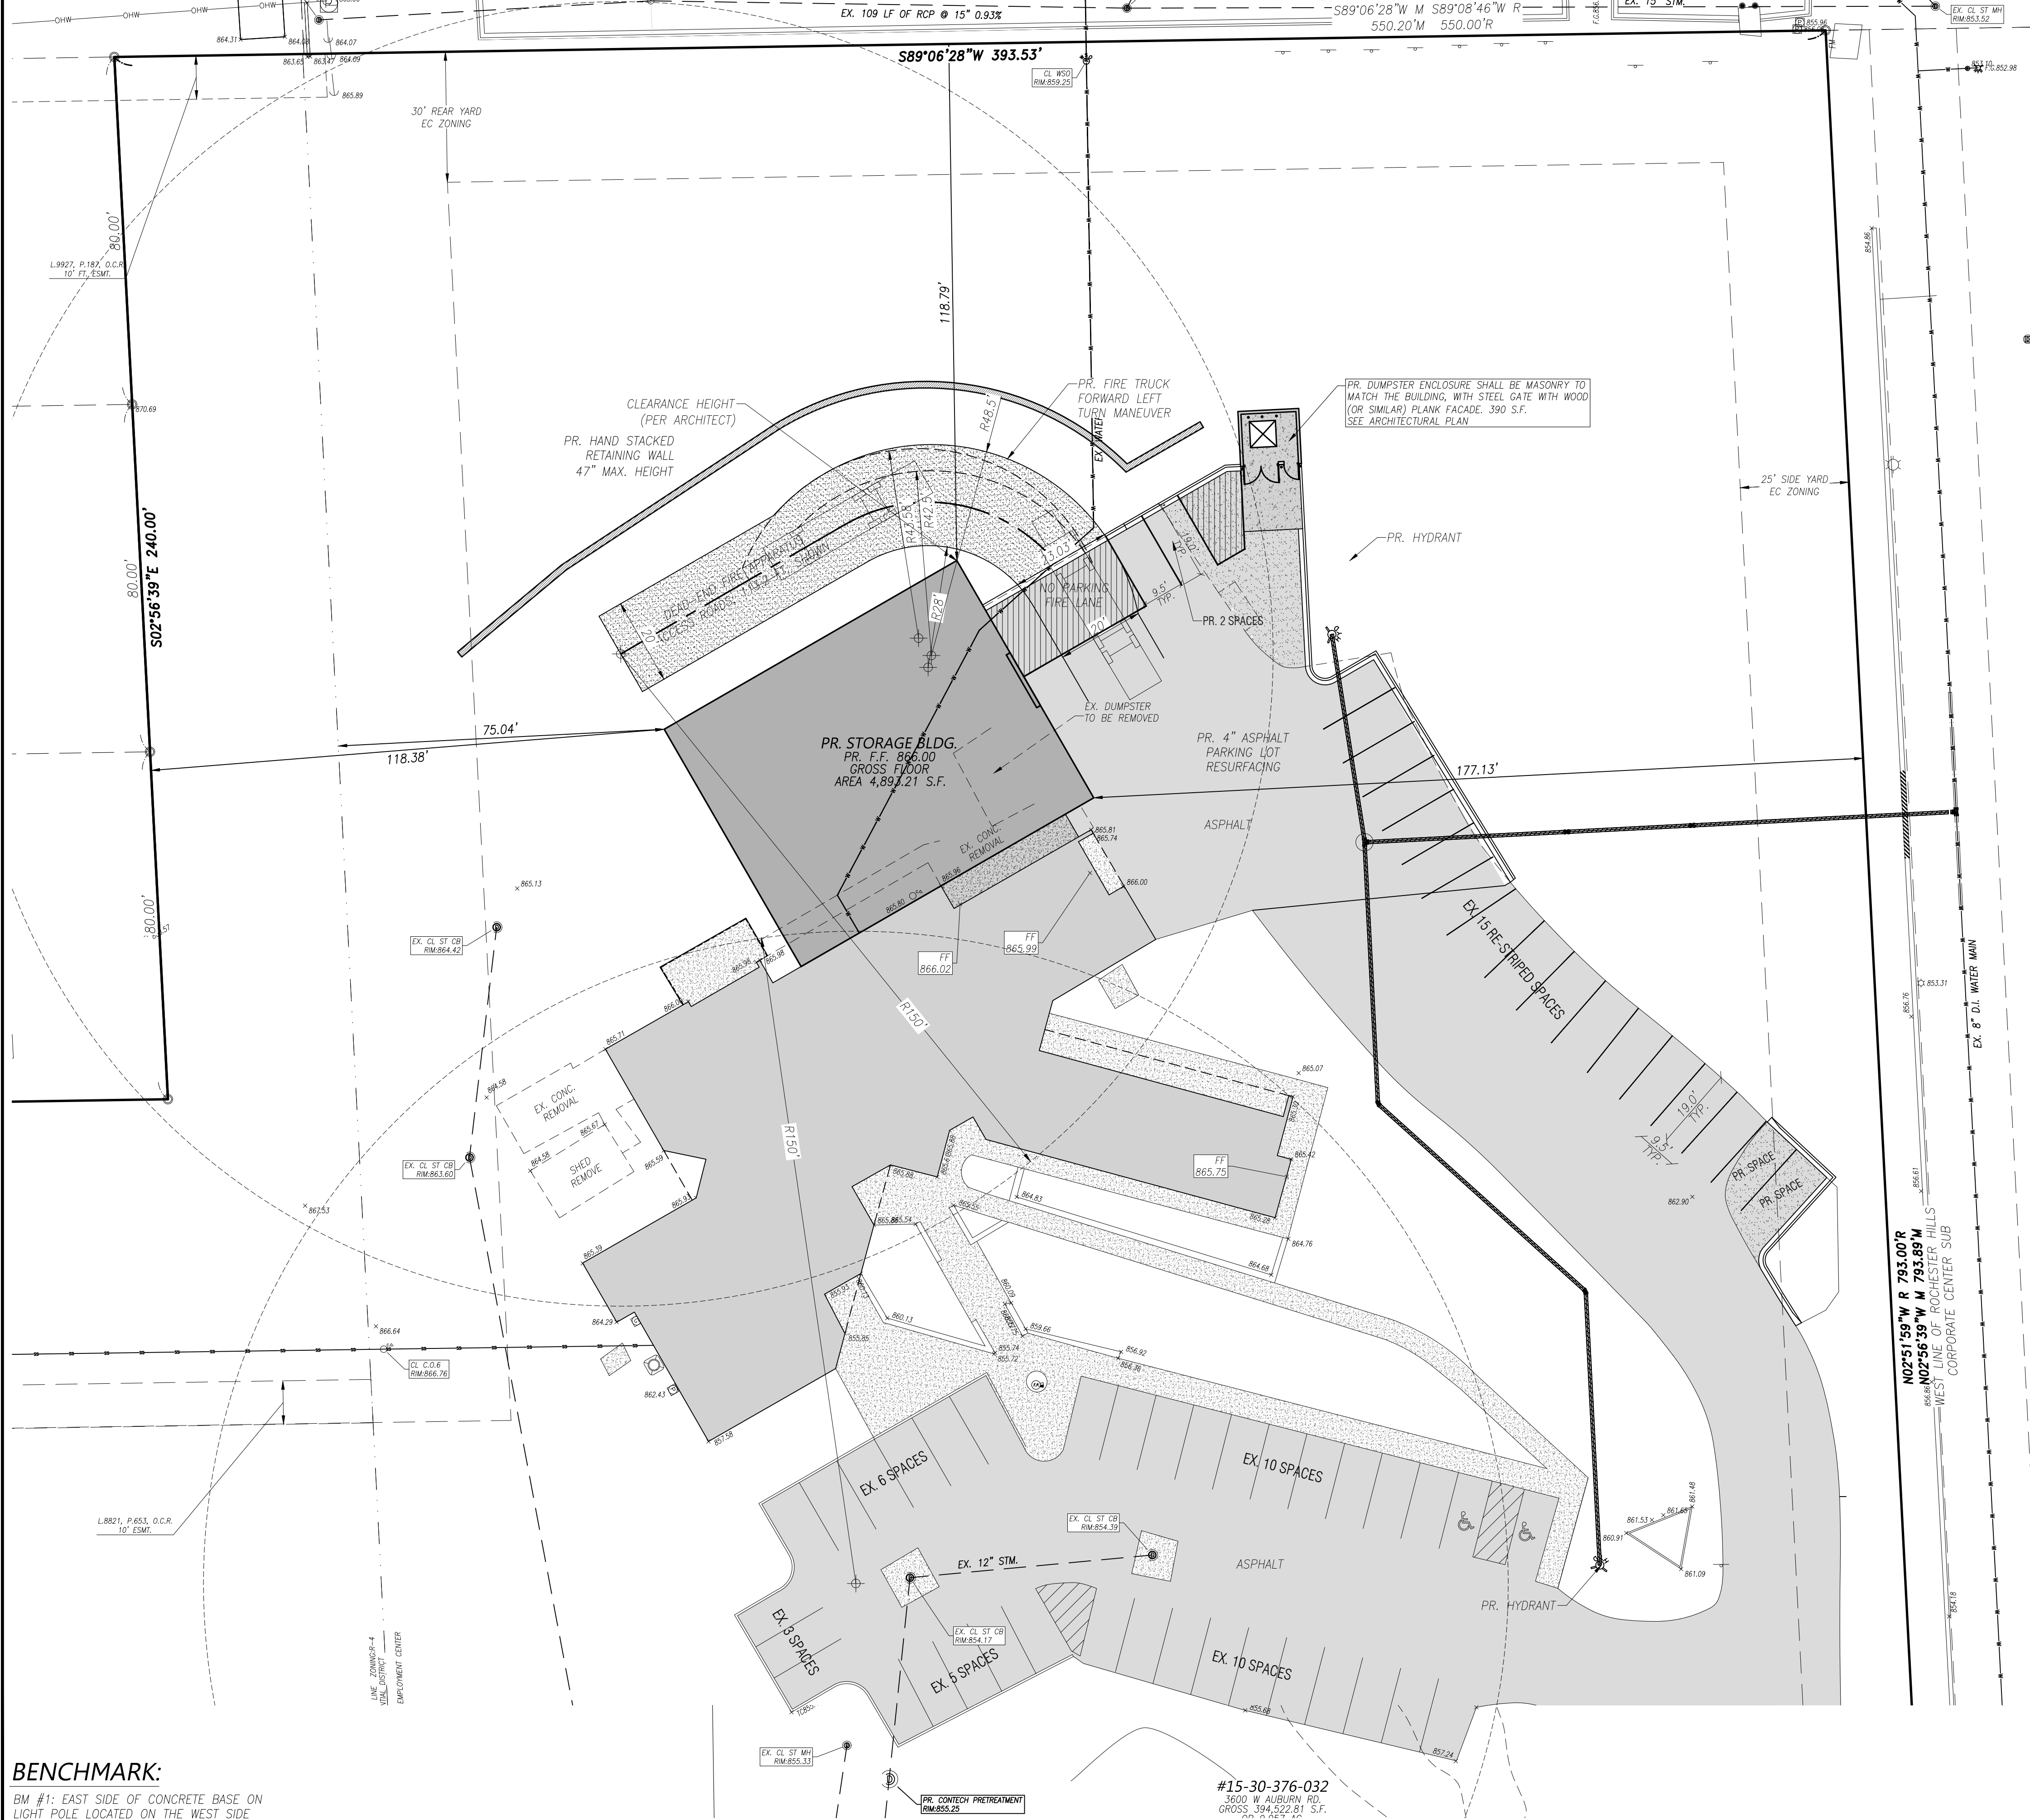
FIRE DEPARTMENT NOTES:

CONSTRUCTION SITES SHALL BE SAFEGUARDED IN ACCORDANCE WITH IFC CHAPTER 14.

A KNOX KEY SYSTEM SHALL BE INSTALLED, IN A LOCATION APPROVED BY THE FIRE CODE OFFICIAL. ORDERING INFORMATION IS AVAILABLE FROM THE KNOX COMPANY AT "KNOXBOX.COM".

FIRE LANES SHALL BE CONSPICUOUSLY POSTED ON BOTH SIDES OF THE FIRE LANE, WITH FIRE LANE SIGNS SPACED NOT MORE THAN 100 FT. APART, FIRE LANE SIGNS SHALL READ "NO STOPPING, STANDING, PARKING, FIRE LANE", AND IN CONFORMANCE WITH THE MICHIGAN MANUAL OF UNIFORM TRAFFIC CONTROL DEVICES.

PROVIDE A "NO PARKING FIRE DEPARTMENT CONNECTION" SIGN OVER THE FIRE DEPARTMENT CONNECTION.

A WHITE/CLEAR STrobe LIGHT SHALL BE TIED INTO THE FIRE ALARM SYSTEM AND INSTALLED OVER THE FIRE DEPARTMENT CONNECTION.

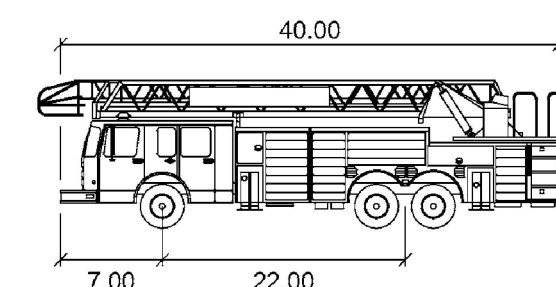
Fire Truck

feet
Width	: 8.5
Track	: 8.5
Lock to Lock Time	: 6.0
Steering Angle	: 33.3

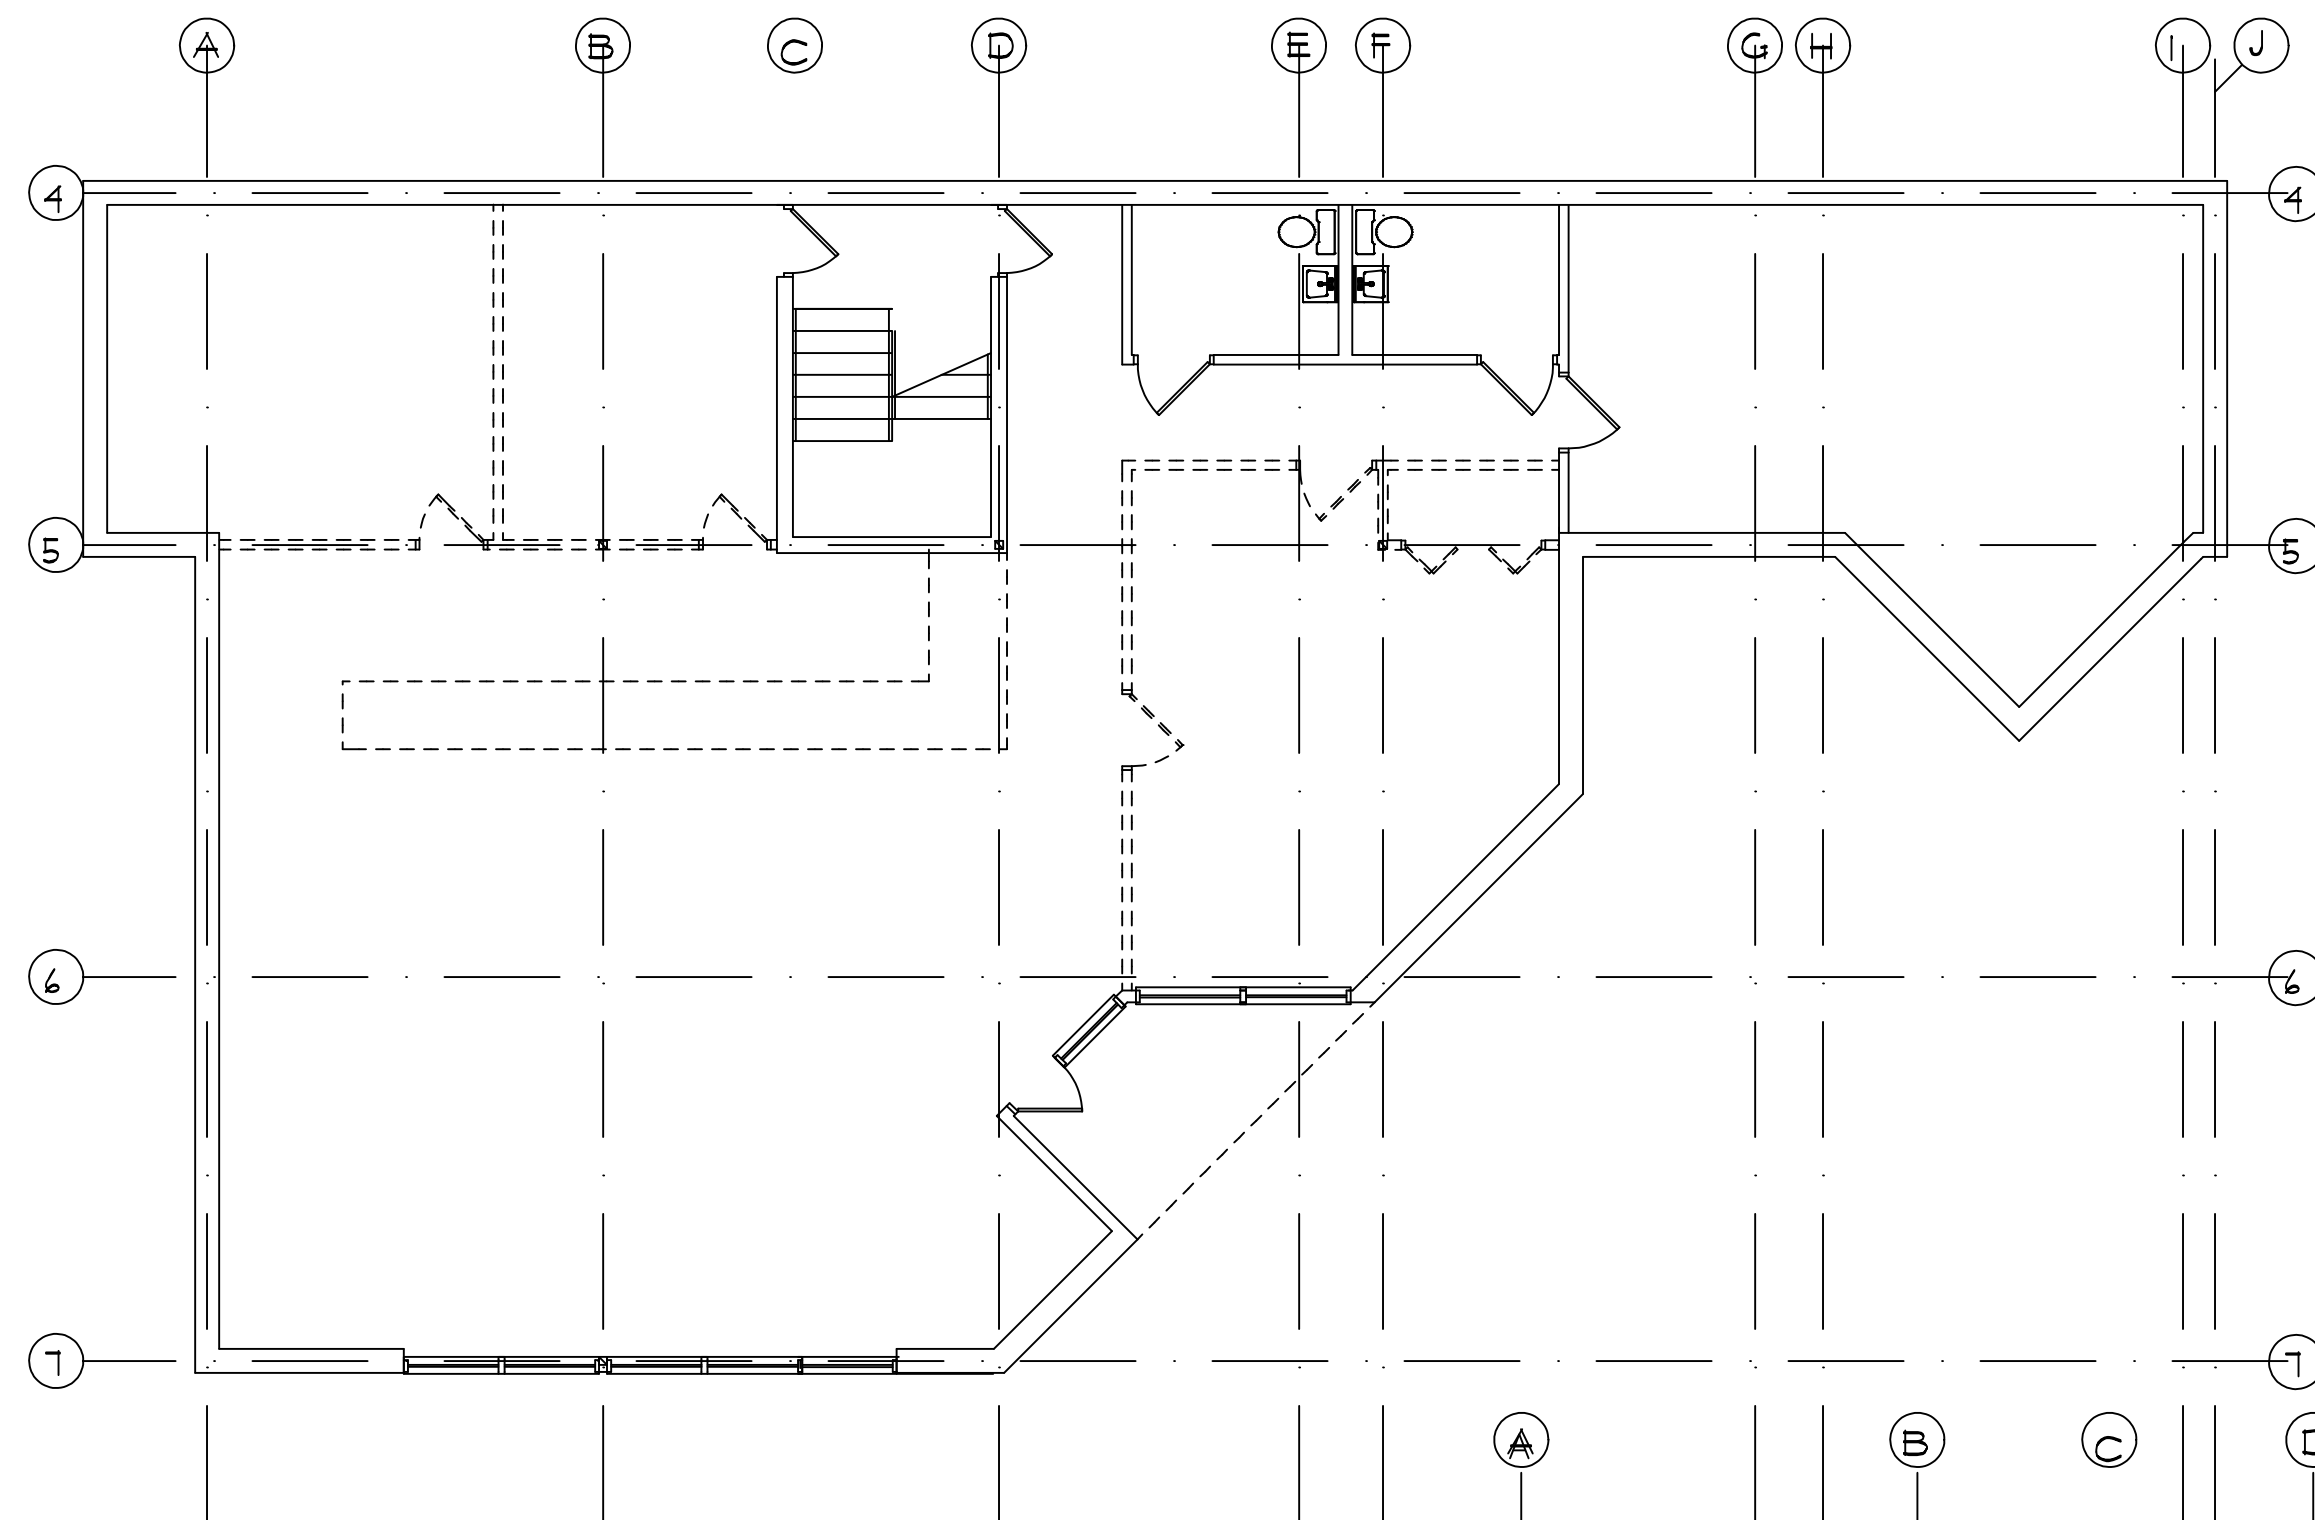
LOWER LEVEL FLOOR PLAN

SCALE: 1/8"=1'-0"

CODE EVALUATION

USE GROUP B & S-2
CONSTRUCTION CLASS IIB
BUILDING IS NOT SPRINKLED
ALLOWABLE FLOOR AREA PER TABEL 506.2

B	23,000 SF ALLOWABLE SF
S-1	11,500 SF ALLOWABLE SF (MOST RESTRICTIVE)
TOTAL SF BUILDING 16,589 SF TOTAL ACTUAL SF

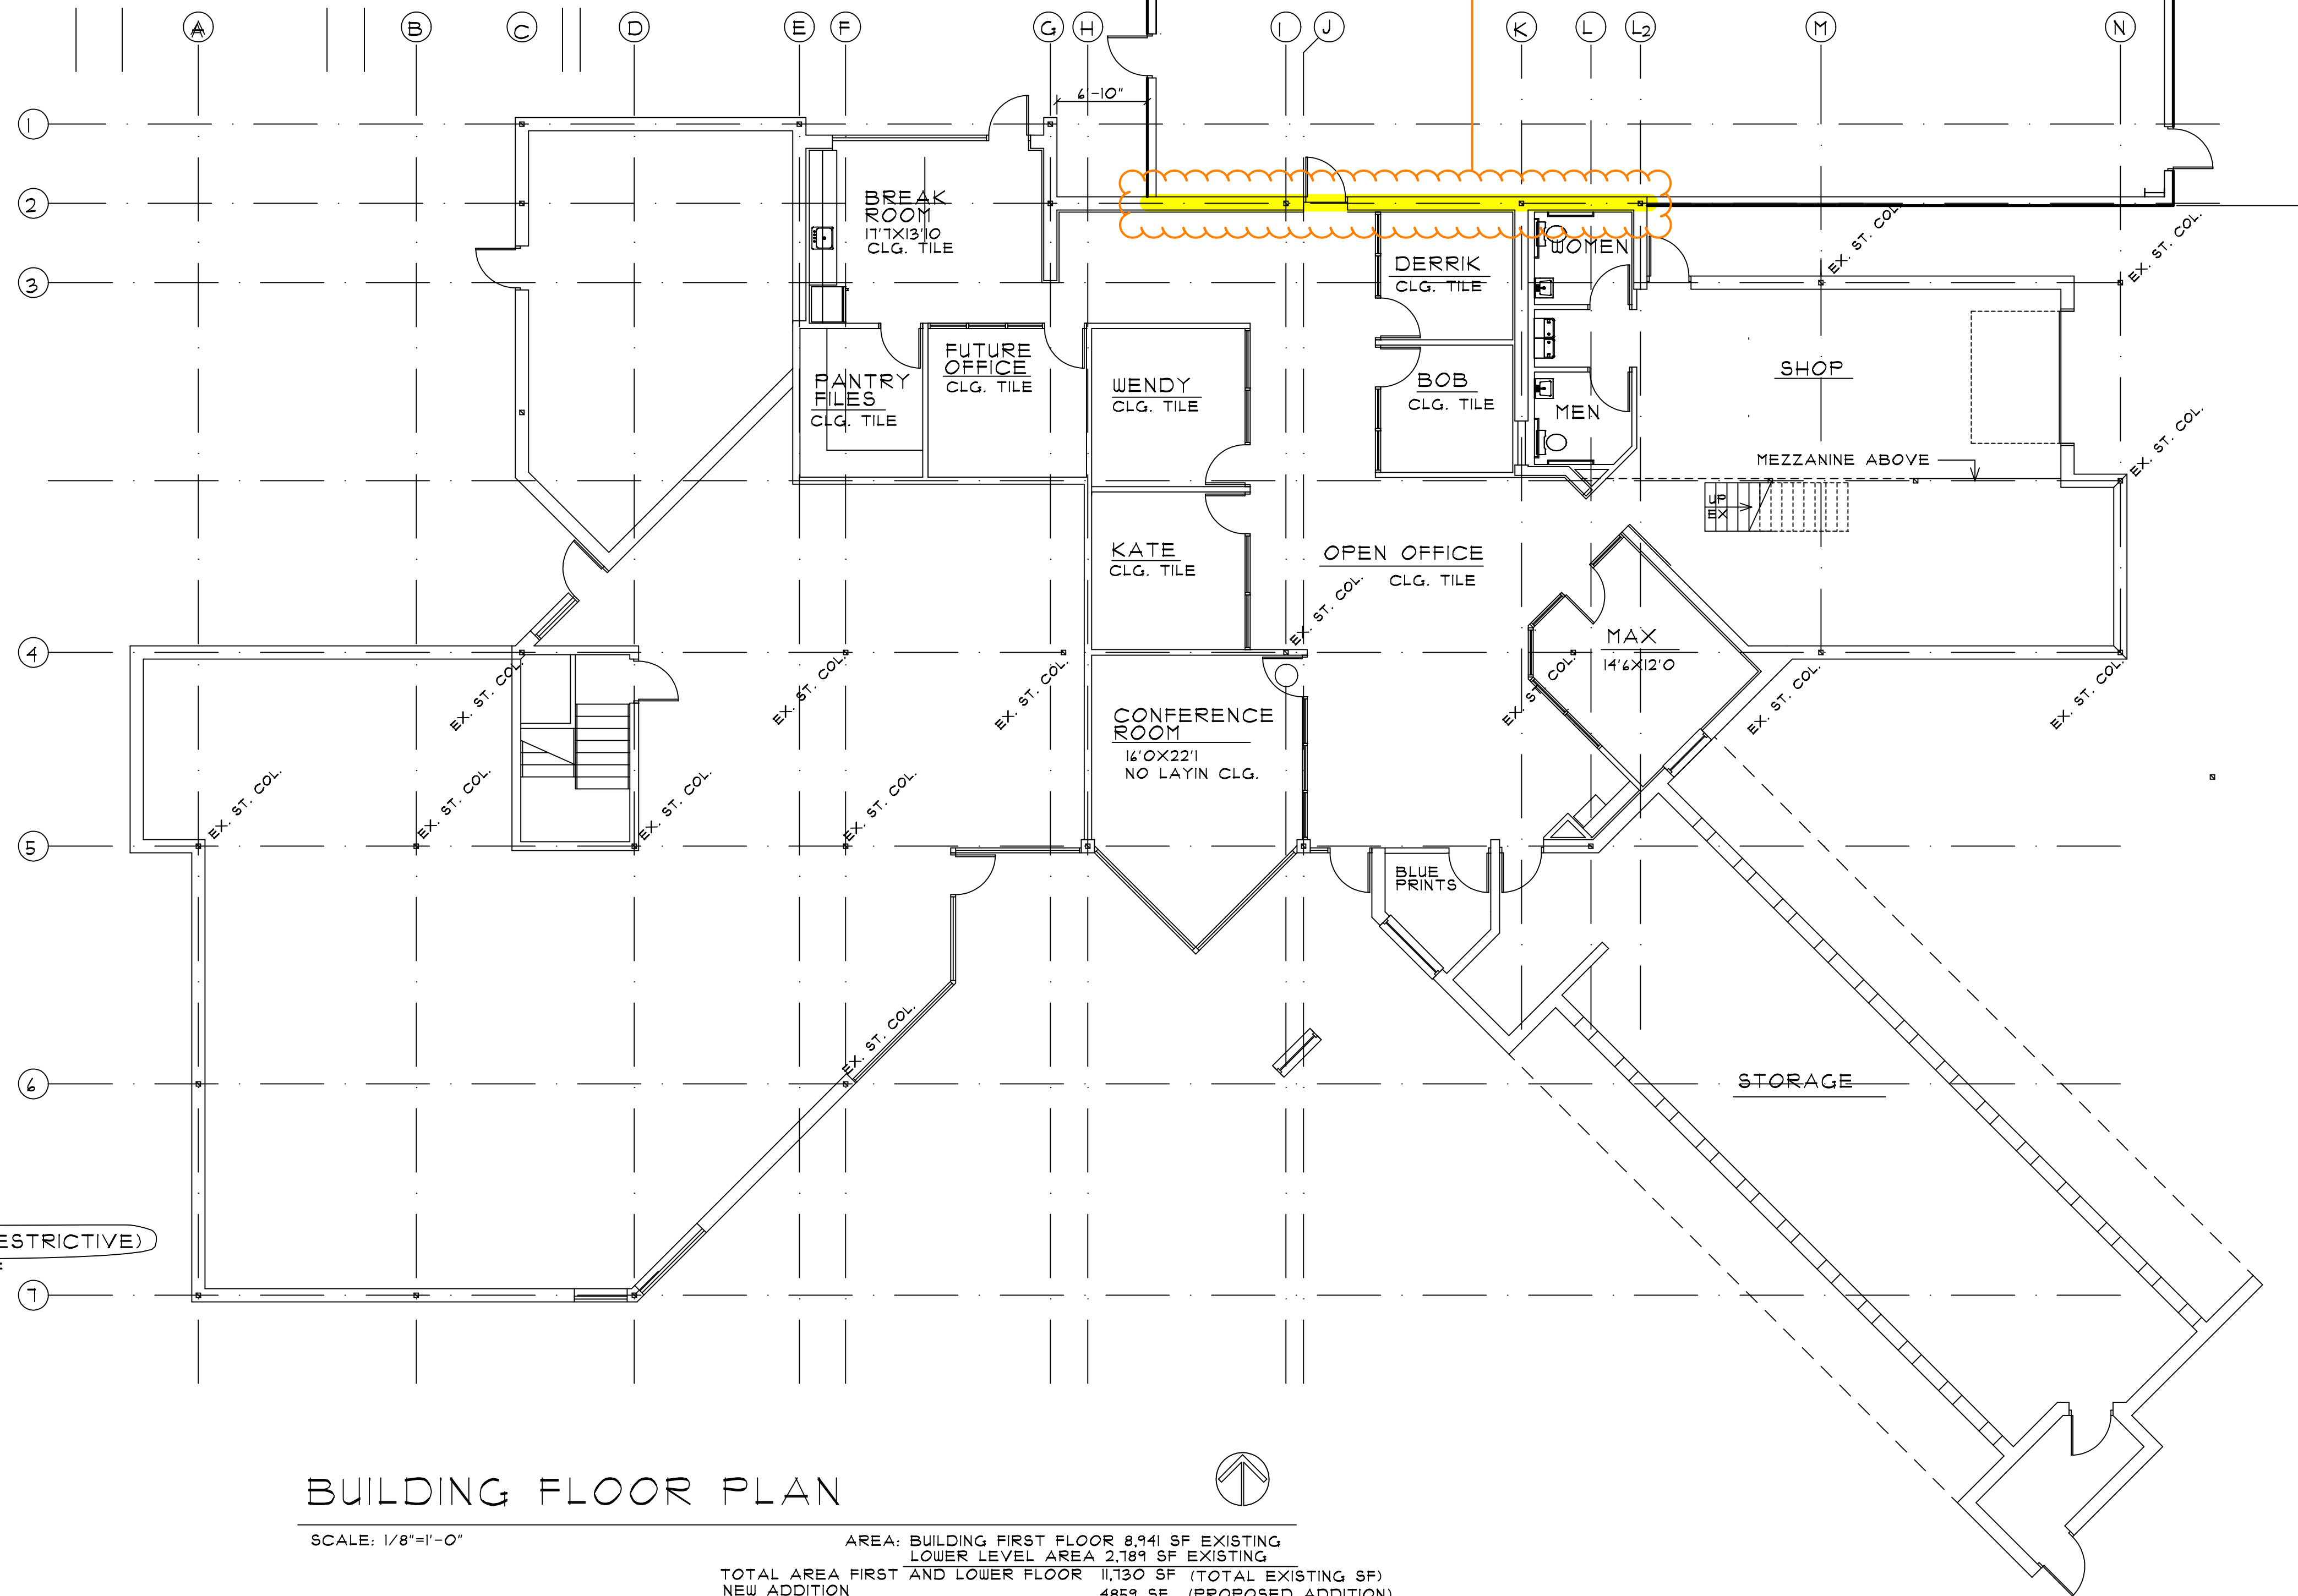
BUILDING FLOOR PLAN

SCALE: 1/8"=1'-0"

AREA: BUILDING FIRST FLOOR 8,941 SF EXISTING
LOWER LEVEL AREA 2,189 SF EXISTING
TOTAL AREA FIRST AND LOWER FLOOR 11,130 SF (TOTAL EXISTING SF)
NEW ADDITION 4859 SF (PROPOSED ADDITION)

A 2 hour fire-resistant separation is required between occupancies per Section 508.3.1.
The fire area of the first floor of the building exceeds the allowable for a S-1 occupancy per Section 903.2.1, item #1, therefore the building shall be sprinklered or the mixed occupancies shall be separated.
If a fire-resistant separation is selected, Table 508.4 indicates no separation requirement between a B and S-1 occupancy. However, there is a 2 hour fire separation required between a B and a less hazardous S-2 occupancy. This Plans Examiner feels this is an inaccuracy in the building code that creates an unsafe conditions for the occupants and the more restrictive separation will be required.

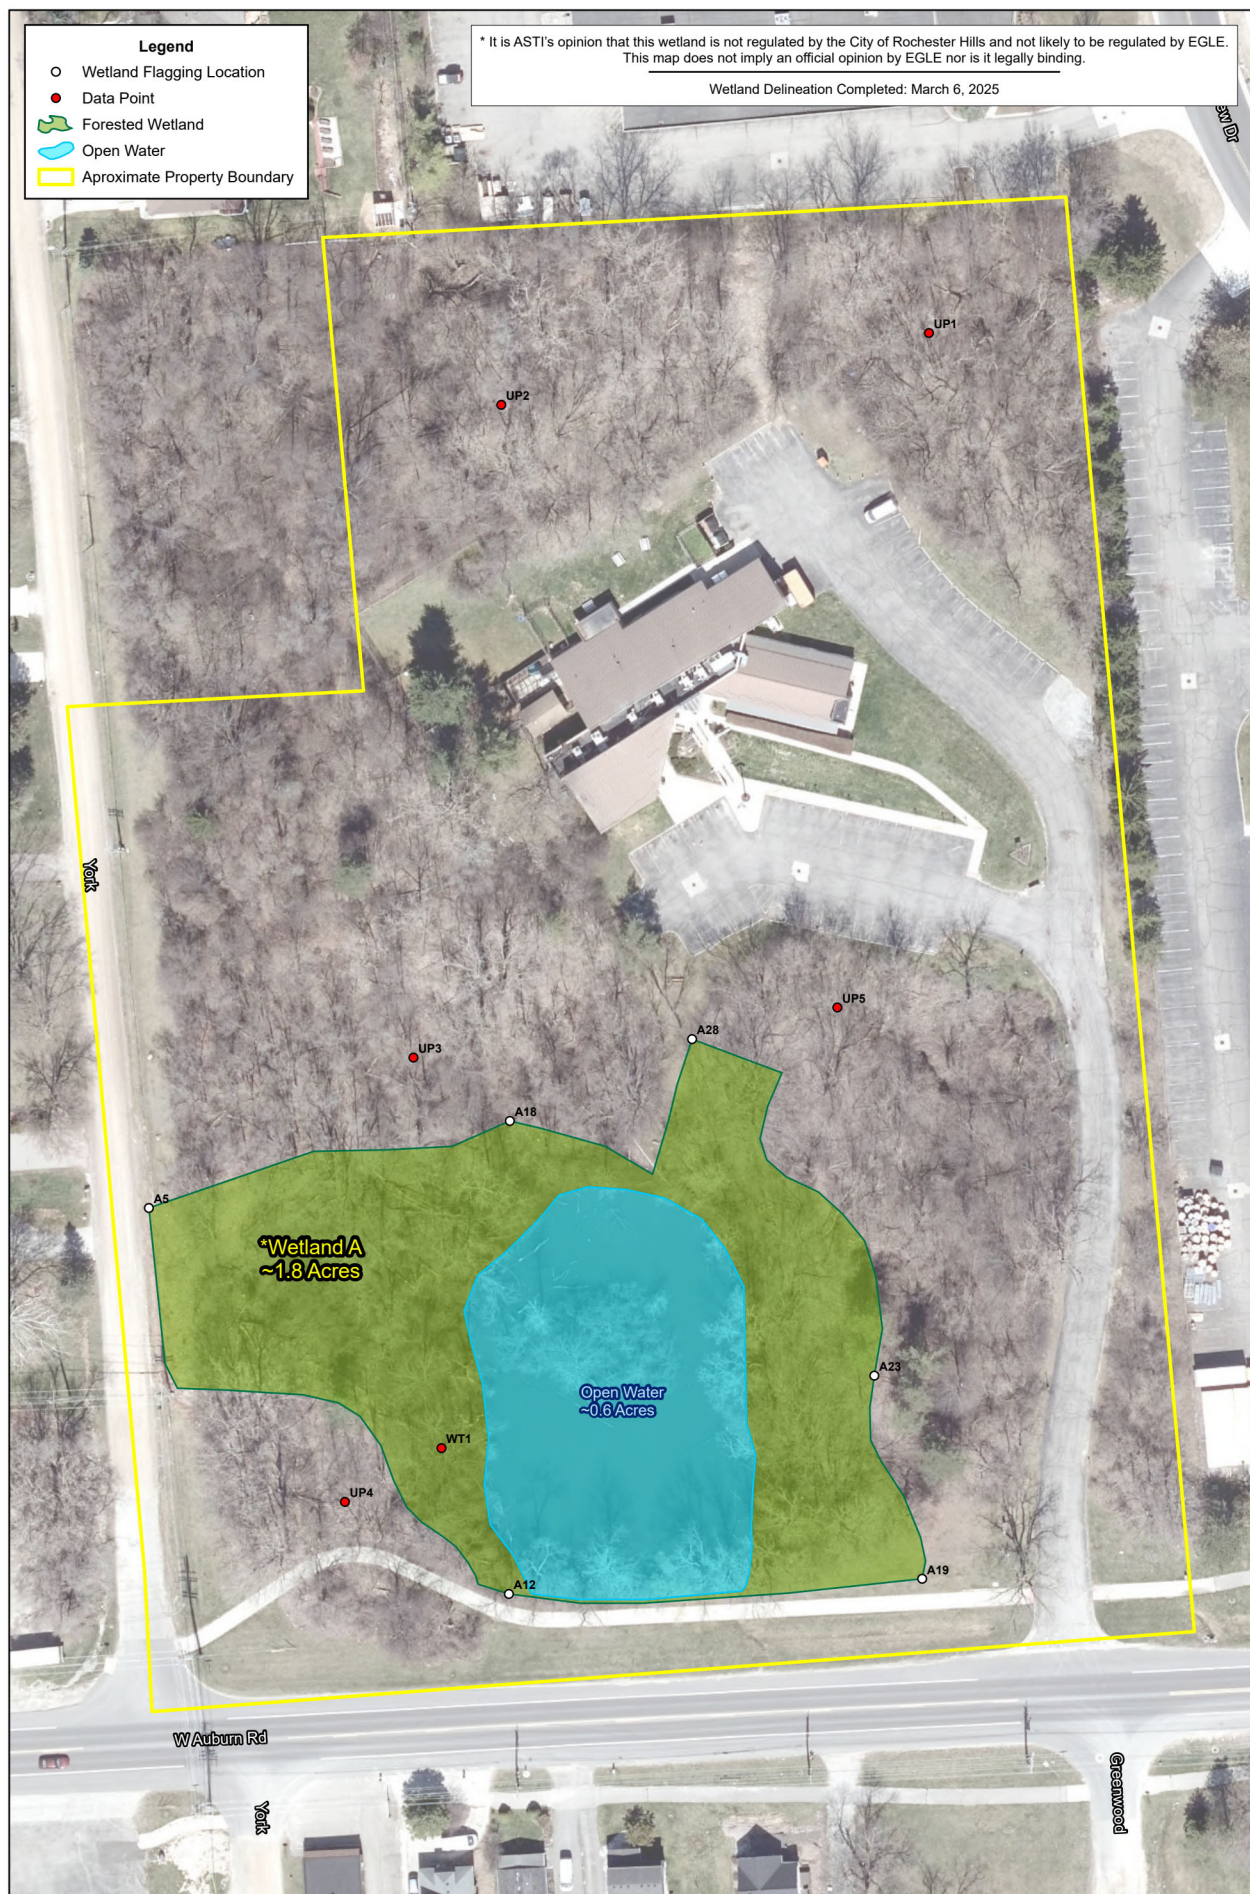
Attachments: Figure 1 – Approximate Wetland Boundaries
Completed USACE Wetland Data Sheets

Wetland A is a forested and emergent/open water wetland approximately 1.8 acres in size located in the south-central portion of the Property (Figure 1). Vegetation within the forested portion of Wetland A was dominated by box elder (*Acer negundo*), green ash

ASTI Environmental (ASTI) completed a Wetland and Watercourse Boundary Determination in accordance with the City of Rochester Hills Wetland and Watercourse Protection Ordinance for the Property on March 6, 2025. One wetland not regulated by the City of Rochester Hills and not likely regulated by the Michigan Department of Environment, Great Lakes, and Energy (EGLE) was observed on the Property (Figure 1 – *Approximate Wetland Boundaries*). ASTI offers the following comments for your consideration.

Please note that the acreage of Wetland A as detailed in this report and Figure 1 is approximate and that the exact acreage of Wetland A will be determined through a professional survey to be completed by the applicant of the on-site flagging as placed by ASTI in the field. ASTI will review the City-regulatory status of Wetland A based on this survey through review of site plans for the Property as provided to the City by the applicant.
