September 19, 2025
Project No.: 21-0217

**RE: Camden Crossing Test Pit Observations for Infiltration Testing
Crestline Road
Rochester Hills, Oakland County, Michigan**

TEST PIT EXHIBIT

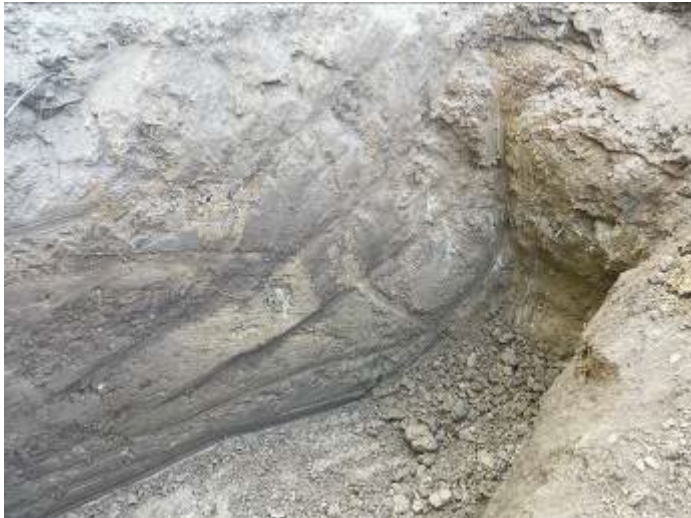
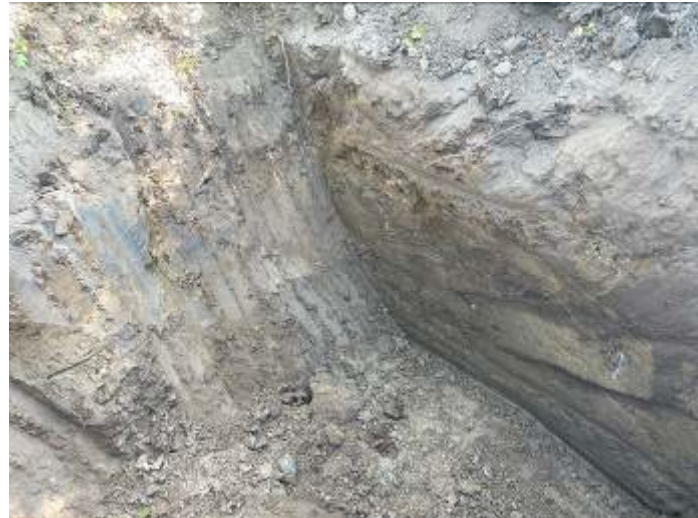
NOTES: TP-1 – Dry at completion, no water encountered			
PEA REP: J. Andare		DATE: 9/16/2025	FIGURE:1

A layer of fill soil consisting of silty sand extending to approximately 1.5 feet bgs containing concrete slab fragments was encountered underlying the topsoil at TP-1. A clay-crock containing water was encountered in TP-4 at an approximate depth of 2 feet.

Test Pit #	ELEV. (ft)	DESCRIPTION	REMARKS
1	0	Topsoil: Dark Brown/Black Clayey Sand with Roots	3.0 Hand Pen Dry
	0.7	Brown Silty Clay Fill Concrete Slab	
	1.5	Brown Silty Clay	
	8.0	End Test Pit	
Photo 1		Photo 2

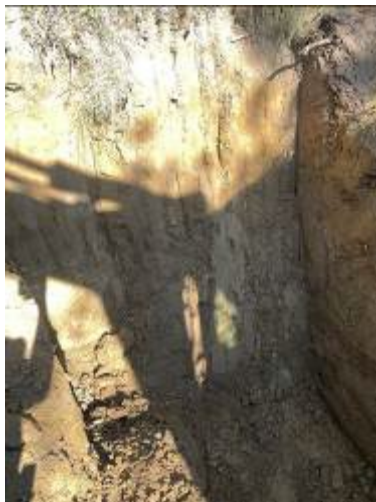
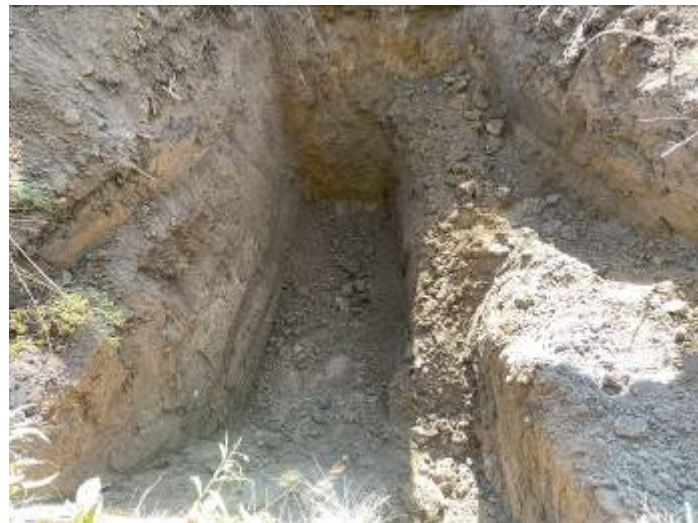
NOTES: TP-2 – Dry at completion, no water encountered			
PEA REP: J. Andare		DATE: 9/16/2025	FIGURE:2

Test Pit #	ELEV. (ft)	DESCRIPTION	REMARKS
2	0	Topsoil: Dark Brown/Black Clayey Sand with Roots	2.5-3.0 Hand Pen Dry
	0.7	Brown Silty Clay	
	8.0	End Test Pit	
Photo 1		Photo 2

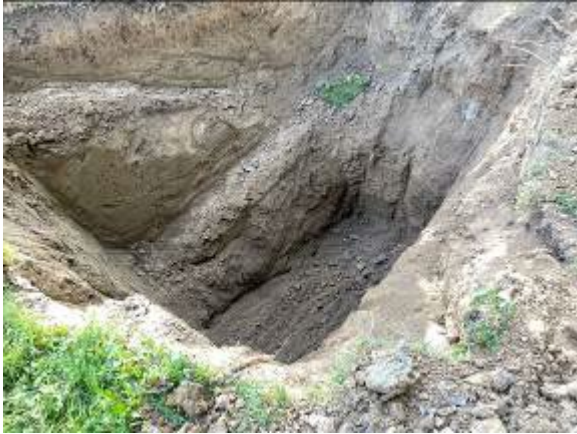
Photo 1

Test Pit #	ELEV. (ft)	DESCRIPTION	REMARKS
3	0	Topsoil: Dark Brown/Black Clayey Sand with Roots	
	1	Brown Silty Clay	4.0 Hand Pen
	12.0	Grey Silty Clay	3.5 Hand Pen
		End Test Pit	Dry

NOTES: TP-3 Dry at completion, no water encountered

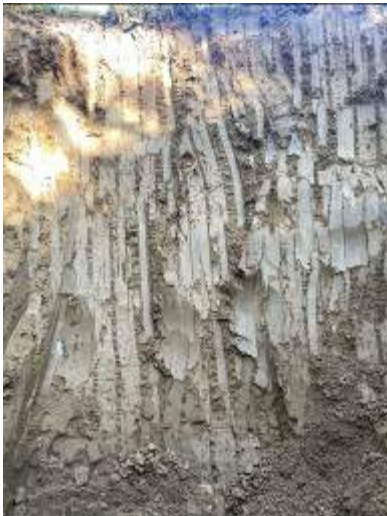
Photo 1

Test Pit #	ELEV. (ft)	DESCRIPTION	REMARKS
4	0	Topsoil: Dark Brown/Black Clayey Sand with Roots	
	0.7	Brown Silty Clay	3.0 Hand Pen
	3.0	Red Clay Crock	Holding Water
	8.0	End Test Pit	Trace Water

NOTES: TP-4 – Trace water at end of test dripping from clay crock
