Rochester Hills Natural Features Stewardship Program Long-Term Management Plan

**NISWANDER**
ENVIRONMENTAL

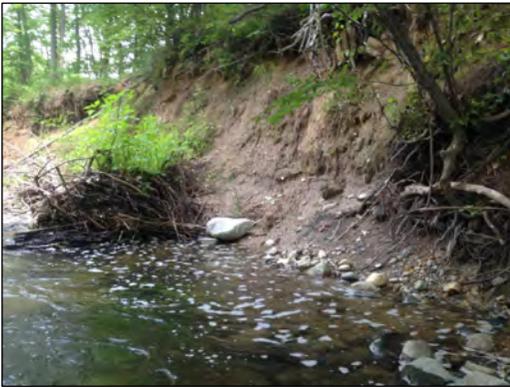
Clinton River bank erosion near City municipal offices

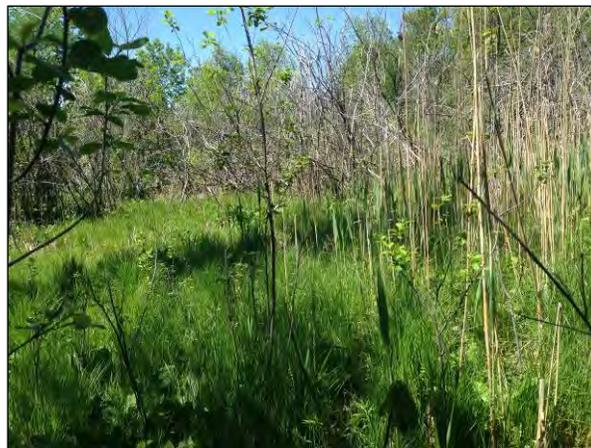
Potential fen area within the White property

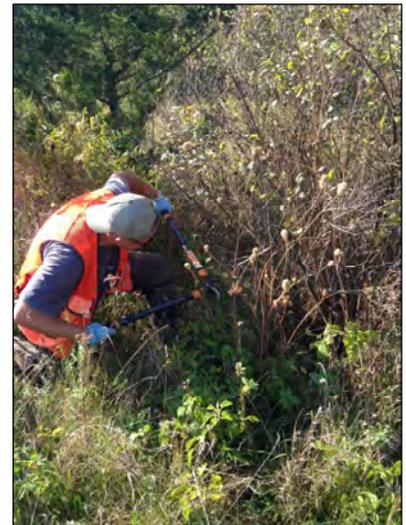
Woody species control at Riverbend Park

In general, woody species such as buckthorn, honeysuckle, multiflora rose, and autumn olive will be removed using the cut-stump method, which calls for these shrubs to be cut at the base and immediately treated with a triclopyr-based herbicide such as Renovate[®] or Garlon 3A[®]. It should be noted that these species cannot be removed using this method during the spring, however, when sap is flowing upward to the stems and buds. Therefore, to remove woody invasive shrubs, cut-stump treatments will be conducted annually in the late summer, fall, and/or winter.

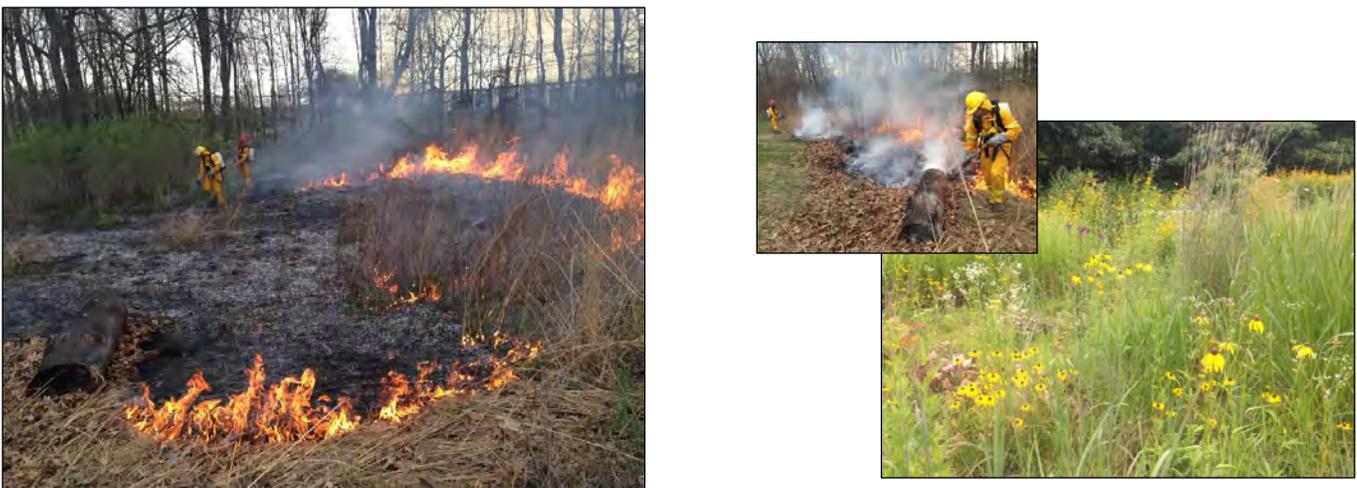
Prescribed burns restored prairie areas in Wayne County, and conditions three months following the burn

Natural areas need to undergo periodic disturbance such as burning, grazing, haying, or mowing in order to prevent cool season grasses, shrubs, and trees from becoming established. The use of prescribed burns is perhaps the most effective, economic, and valuable method to control undesirable vegetation. Historically, prairies and meadows were maintained through fire occurring naturally or set by indigenous people. Fire prevents the growth of shrubs and trees while setting back succession to the grassland stage.

Prescribed burns also prevent invasive cool-season grasses from becoming established since they are not adapted to withstand fire like many of the prairie species currently present within several of the Greenspace properties. Fire burns the dead plant material that lies above the ground surface and allows the high-quality nutrients from the dead plants to return to the soil. These nutrients fortify the deep roots of the prairie vegetation where the plant will re-sprout in late spring. Rotating controlled burns is the best long-term management of meadows, as it is the natural process that ensures healthy regeneration of prairie species. Burning the several of these areas every 2-3 years will maintain the healthiest stands. Niswander Environmental recommends that several areas be burned over the next 10⁺ years to promote native vegetation.

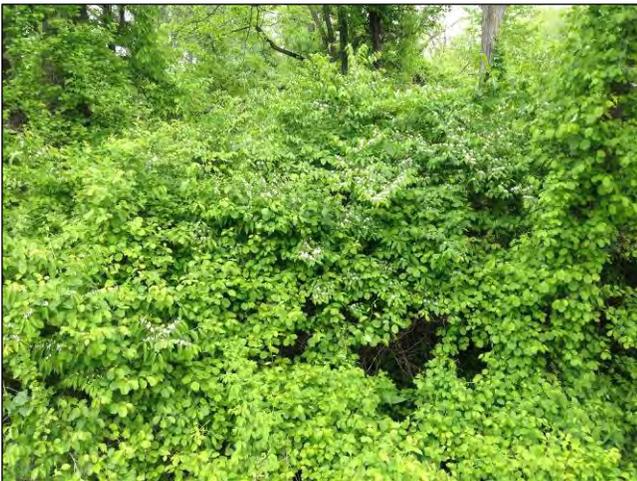
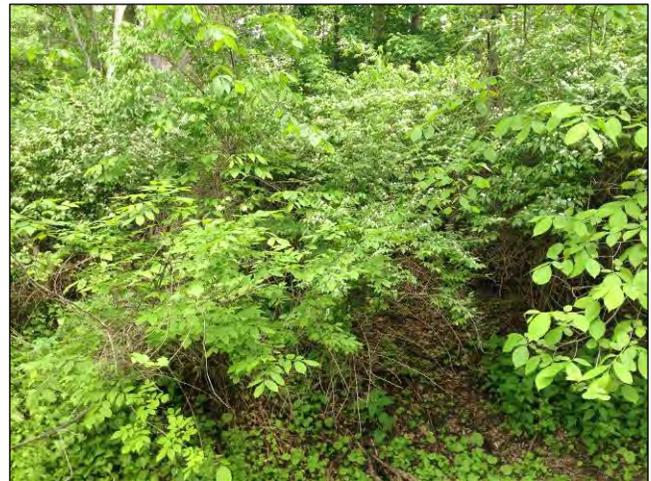
Honeysuckle, bittersweet, and buckthorn (above) dominate much of the upland forest on the Harding property.

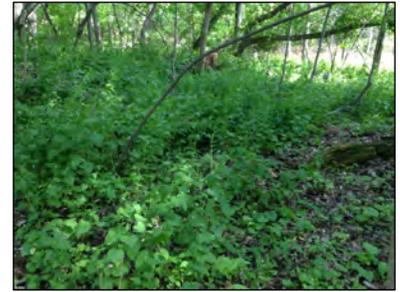
Garlic mustard infestation in the northwestern portion of the site.

Garlic mustard is distributed throughout the Harding property, primarily in wooded areas (particularly in the south and west [Figure 3e; Appendix B]). It is assumed that it will take at least five years to control the mustard populations on the site, depending on the number of volunteer work crews that can be deployed.

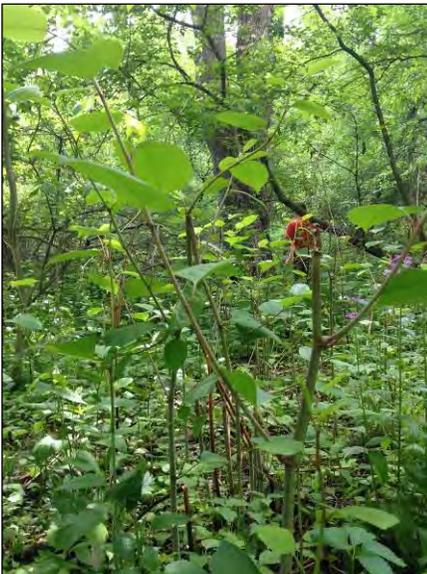
Japanese knotweed (left) populations are currently isolated to a few areas and with proper management can be eradicated.

Japanese knotweed populations were observed in forested areas between the River Bend Road trailhead and Harding Avenue (Figure 3d; Appendix B). This is relatively uncommon since they prefer sunny openings, but control of this species is nonetheless critical to suppress advancement.

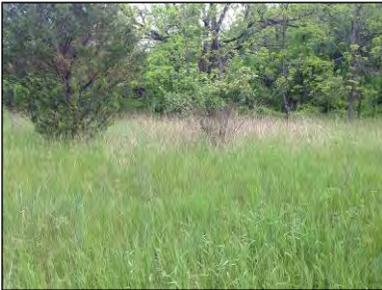
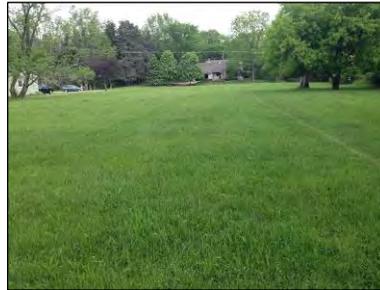
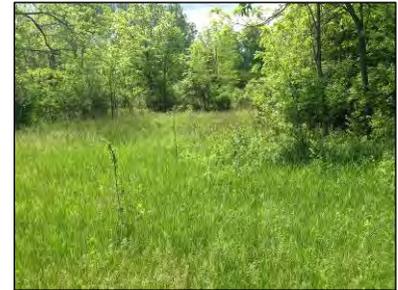
Old field openings within the forested areas of the Harding property offer high potential for successful prairie restoration

There are three areas of old field and/or lawn totaling roughly 3 acres on the Harding site that could be restored to prairie in an economic fashion (Figure 3b; Appendix B). With the exception of the lawn, these areas were likely once prairie since remnant prairie species were observed in small numbers. It is anticipated that these areas could be used for educational opportunities since they are highly visible and located along an existing footpath, at a trailhead on Harding Avenue, and along the heavily utilized Clinton River Trail. Although a few native species are present, a vast majority of the vegetation present consists of non-native, cool season grasses such as bluegrass and fescue.

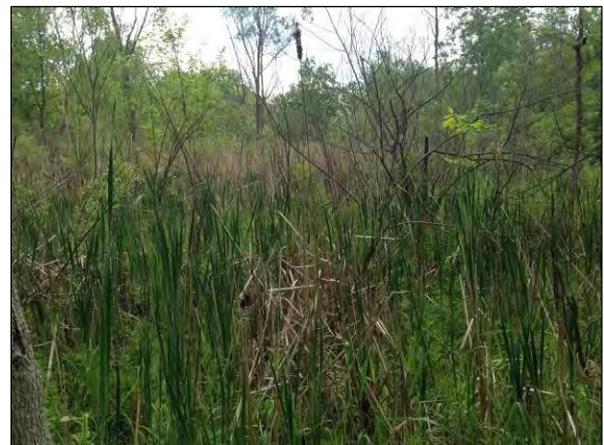
The former wet meadow, now a scrub-shrub wetland

The wet meadow/potential fen area in the southeastern portion of the property (Figure 3a; Appendix B) was, up until recently, a high quality wetland with the potential for being classified as a fen due to the hydrological characteristics and the uncommon and unique plants that were observed in 2010. Since 2010, there has been a significant invasion of this area by woody plants and narrow-leaved cattail, which has significantly reduced the plant diversity with only a few pockets of high quality habitat remaining in the wetland. To maintain the natural diverse herbaceous plant community present in the wet meadow, woody plant management is necessary as without it, natural ecological succession will allow the woody plants to completely dominate the site over the next few years, choking out and eliminating the herbaceous plant community. Historically these types of habitats were naturally managed through regular fires that suppressed the woody plants and allowed the herbaceous plants to flourish. With the removal of natural fires from the landscape, woody plant invasion is one of the major threats to these natural communities. In lieu of burning, Niswander Environmental recommends that management activities be undertaken to reduce and control woody plants and invasive narrow-leaved cattail in the wet meadow allowing the native herbaceous vegetation to return.

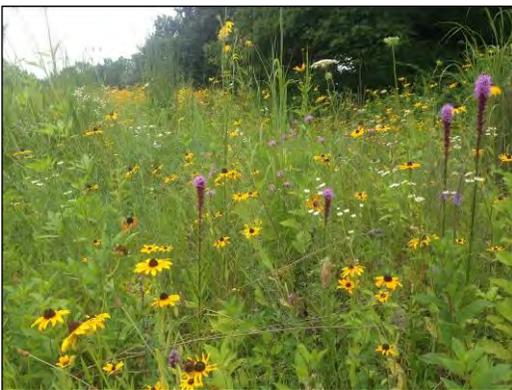
Prairie restoration in Oakland County, four years after seeding

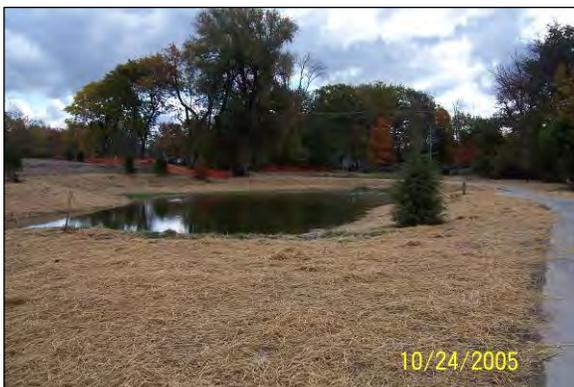
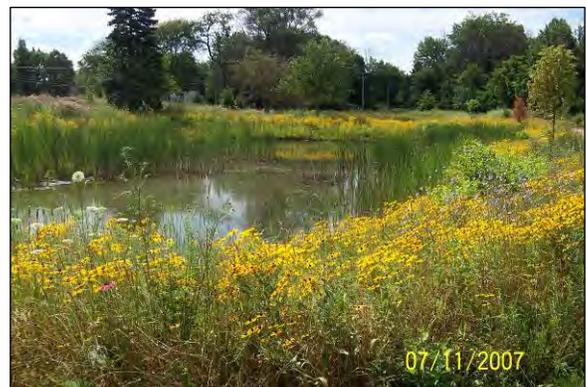
Before and after photo depicting a pond area enhancement/prairie restoration at Country Club Village development in Rochester Hills. Prairie restorations typically require at least three growing seasons to fully establish

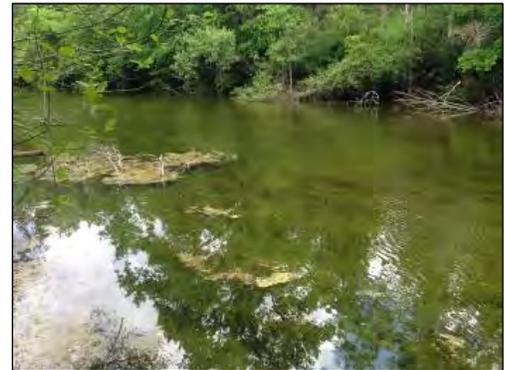
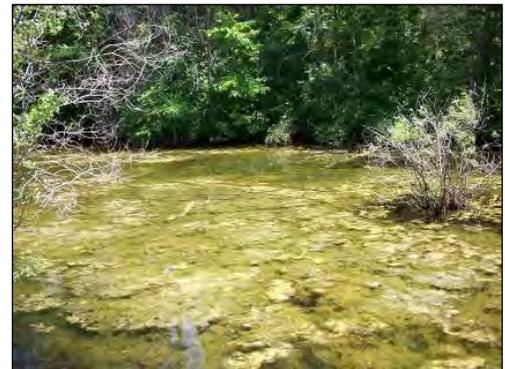
The pond area at the Harding site in 2010 (top) and in 2015 (bottom)

A small pond sits in the eastern portion of the Harding property, along a footpath and just north of the Clinton River Trail (Figure 3c; Appendix B). The area surrounding the pond is relatively small (1-2 acres), but offers excellent potential for enrichment due to its high visibility and the presence of invasive honeysuckle, autumn olive, buckthorn, and non-native grasses and forbs. Enhancing the pond buffer is cost-effective and could dramatically improve the immediate area through invasive species control and seeding and planting. Similar to the prairie restoration, this area could be readily showcased because of its location. Interpretive signage promoting pond life, along with benches and secluded viewing shelters could be installed to enhance educational opportunities.

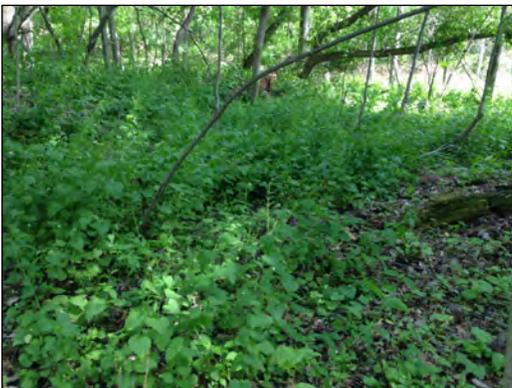
Garlic mustard infestation in the southern portion of the Harding site in 2015

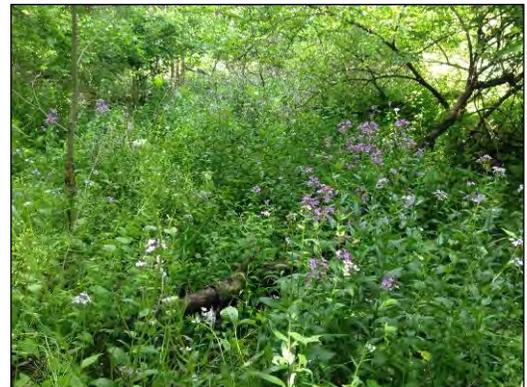
Garlic mustard intermixed with Dame's rocket, present in the western forested areas

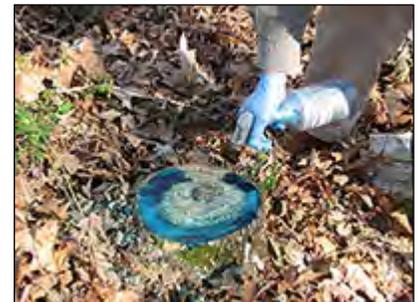
Cut-stump treatments are the preferred method for control of invasive woody shrubs

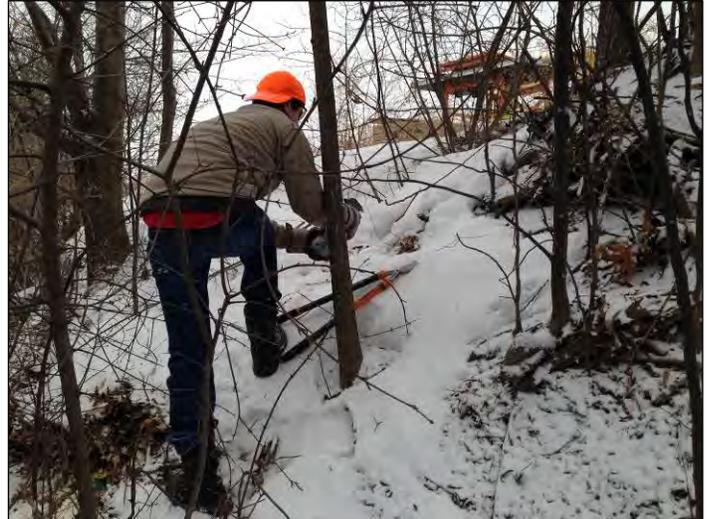
Cut-stump treatment of glossy buckthorn and honeysuckle along streambank in Oakland County, winter 2014

- Begin control efforts in highest quality areas and those along footpaths and trails.
- Cut-stump treatment of all woody shrubs in the work zone using a 27% solution of triclopyr-based herbicide to prevent re-sprouting.
- Coordinate with Parks and Forestry to chip and haul woody shrubs off-site

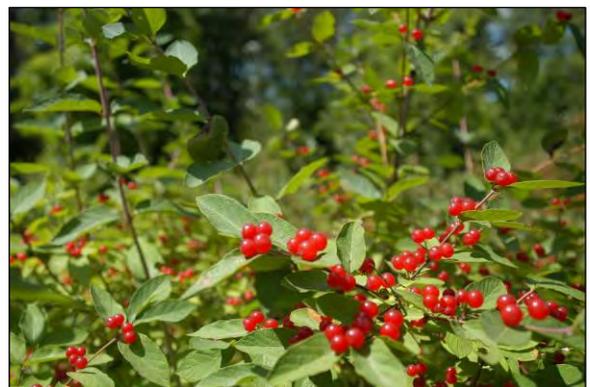
Non-native honeysuckle

Much of the understory vegetation within the Harding property is non-native, comprised of honeysuckle, buckthorn, autumn olive, multiflora rose, European privet, and Oriental bittersweet. These shrubs often form tall, dense monocultures where they shade out understory vegetation, reduce native tree/shrub regeneration, and prohibit wildlife movement.

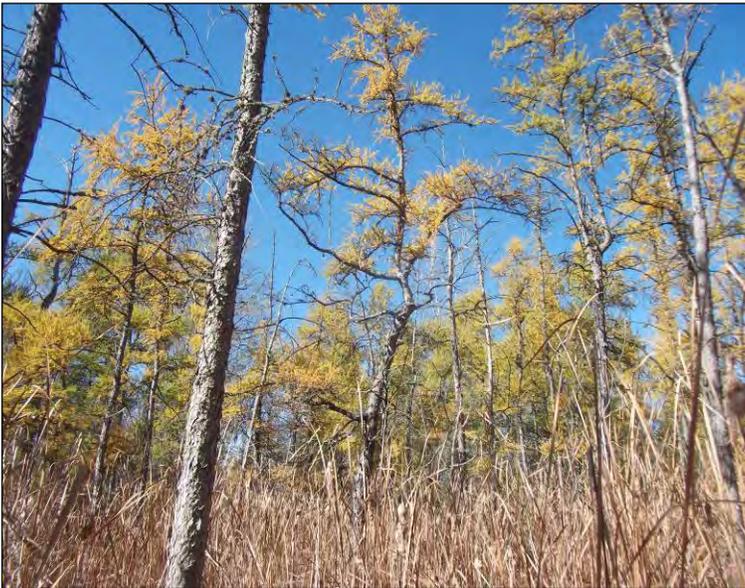
The White property features high quality natural features and exhibits locally rare and unique vegetation such as tamarack (above)

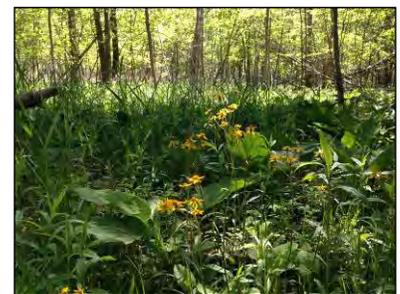
The tamarack swamp located in the southern portion of the property exhibits numerous fen characteristics

typically characterize a prairie fen. The soil structure within the swamp consists of deep organic muck, but soils in the potential fen area are marly and likely calcerous.

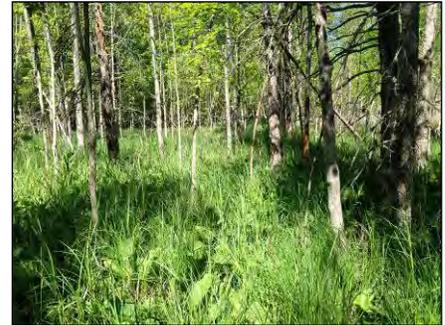
Forested floodplain wetland in the southern portion of the White property

Areas along the Clinton River are classified as forested floodplain wetland, but also exhibit characteristics of a southern hardwood swamp community, both of which are similar in community structure and plant diversity. This area (Figure 4b; Appendix B) is subject to periodic flooding, which can affect the overall species composition in the immediate area from year to year. Mature canopy trees along the river include red maple, elm, silver maple, swamp white oak, muscledwood, and basswood, while much of the understory consists of sedge, nettle, skunk cabbage, wood reed, fowl manna grass, and aster. Areas immediately adjacent to the river contain an abundance of reed canary grass, with swamp aster, garlic mustard, glossy buckthorn, thistle, hawthorn, multiflora rose, and dame's rocket also present. The drier sandy, silty soils in this area are very different from those in the adjacent tamarack swamp, resulting in a mixture of both wetland and upland species (mesic). Floodplain areas such as this are seasonally inundated and function as important natural sponges, trapping sediments and other pollutants during flood events.

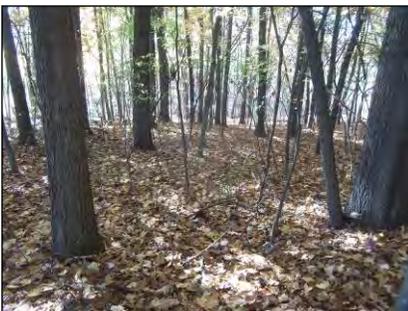
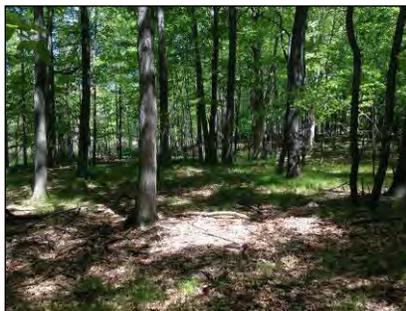
Much of the White property consists of mature upland forest on hilly terrain

Mature upland forest comprises approximately 45% of the White property (Figure 4; Appendix B). Unlike many urban forests, which often exhibit a dense understory of saplings, vines, and invasive shrubs, the woodlands on the White parcel are generally open due to the size/age of the trees and the high deer population. The most common species found on the site include cherry, red maple, sugar maple, red oak, white oak, and hickory. The sparse understory is comprised of various woodland sedges, jack-in-the-pulpit, and mayapple, and generally lacks invasive plants in most areas. Pockets of garlic mustard, privet, and multiflora rose exist sporadically throughout the upland forest, but are not seen as a serious threat to the quality of this landscape. Regardless, they should be treated before they become an issue.

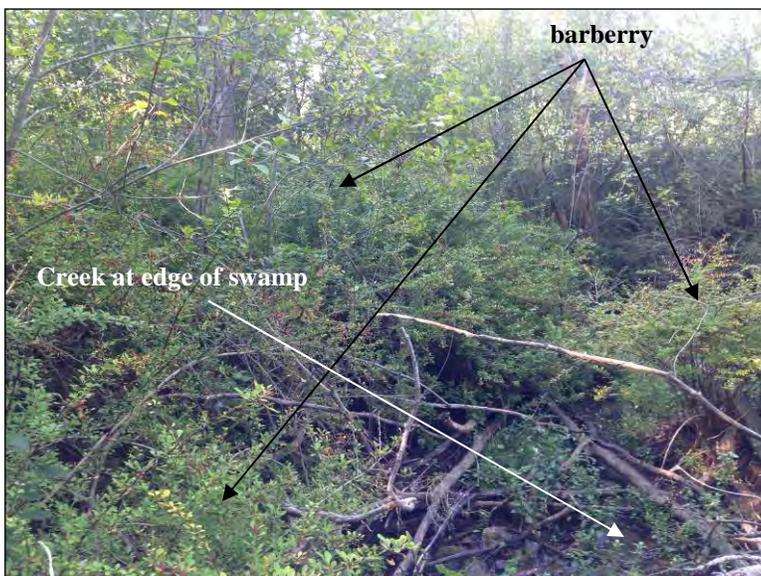
Japanese barberry poses a serious threat to both the upland forested areas and the high quality tamarack swamp

Although most of the forest is of high quality, there are several areas that need immediate attention. Japanese barberry poses a significant risk to not only the remaining upland forest, but also to the tamarack swamp. This non-native shrub was introduced from Asia as an ornamental but has escaped into oak forests and caused significant damage to many of the woodlots in southeast Michigan. It is compact and low growing, allowing lower branches to root and establish large, impenetrable colonies that quickly shade out native herbaceous species. Barberry is a prevalent and serious threat in one portion of the property, where it has already overtaken approximately 1.5 acres of mature forest. This infestation occurs along a creek at the edge of the tamarack swamp, and many barberry were observed growing in the muck soils of this wetland, which is uncommon but alarming.

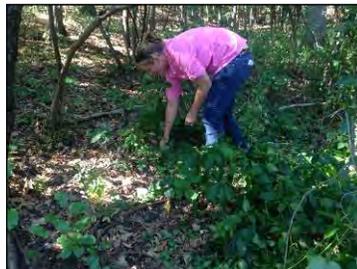
Swallow wort (left) was first observed on the White property in September 2015, growing near a wetland in the northwest portion of the site

A small population of invasive swallow wort was first observed in September 2015, in the northwest portion of the White property (Figure 4c; Appendix B). This plant was found growing at the base of a slope, near the wetland/upland interface. Although only a few dozen plants were present, this species has the ability to spread rapidly both horizontally and vertically, and tends to become more vigorous and productive as the population increases. This potential project scored relatively high on the GSAB Project Prioritization form (Appendix A) because it would be very quick and cost effective to treat in its current state. Should this plant be left to flourish, it will become a labor-intensive and costly species to eradicate.

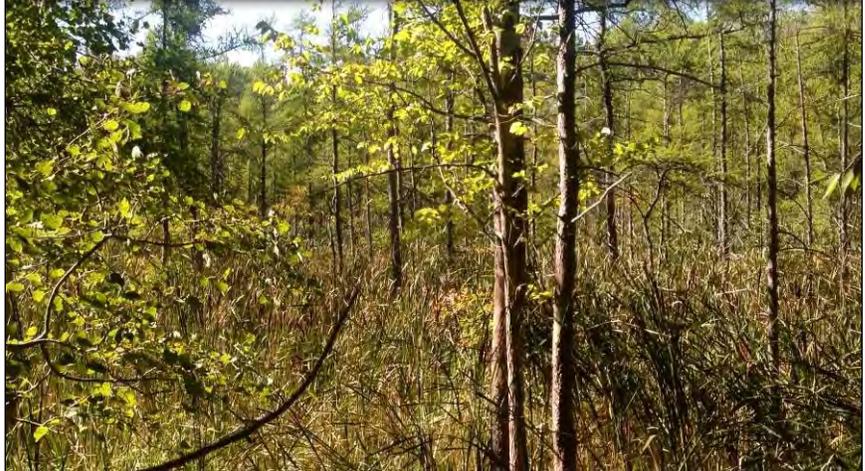
Selective use of herbicides is required in the tamarack swamp

Based on the quality of this rich tamarack swamp and potential remnant fen area, strategic invasive species control is warranted. Rather than foliar broadcasting herbicide on glossy buckthorn and Phragmites, a more selective treatment approach is necessary. Niswander Environmental recommends techniques such as cut-stump treatments for buckthorn and to some degree barberry, and hand wicking and/or spot treatment of herbicide on Phragmites. Where

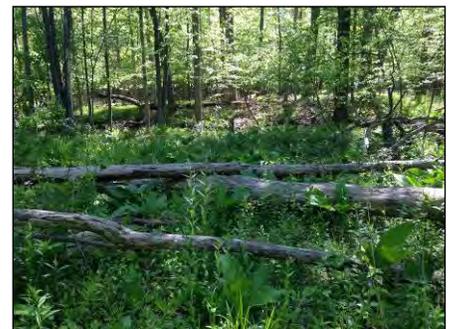
Forested floodplain located along the Clinton River on the White parcel

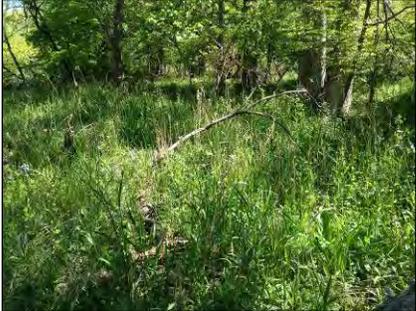
- Reed canary grass in the forested floodplain of the White property*
- Summer activities should focus on treating woody invasive shrubs such as buckthorn, rose, privet, olive, barberry, and honeysuckle using cut-stump methods. The second round of foliar herbicide treatments should be conducted in July on reed canary grass, since new sprouts will be emerging following the spring applications. A third and final round of treatment to reduce reed canary grass should be conducted by early September, with a focus on treating newly emerging plants or those missed previously.

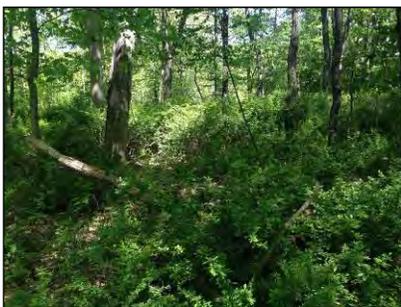
Japanese barberry comprises approximately 1.5 acres on the White parcel

Japanese barberry is locally abundant in one area of the White parcel (Figure 4d; Appendix B), and is sporadic in other areas. This species spreads rapidly, and can be physically difficult to control due to its sharp spines.

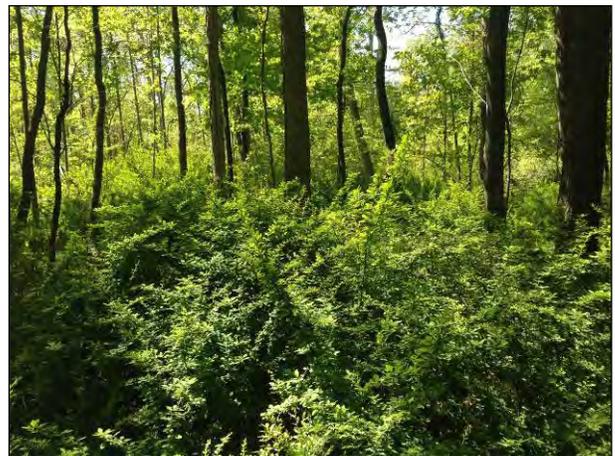
Japanese barberry in the central portion of the site

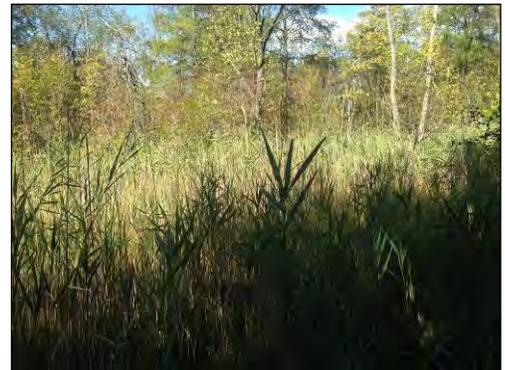
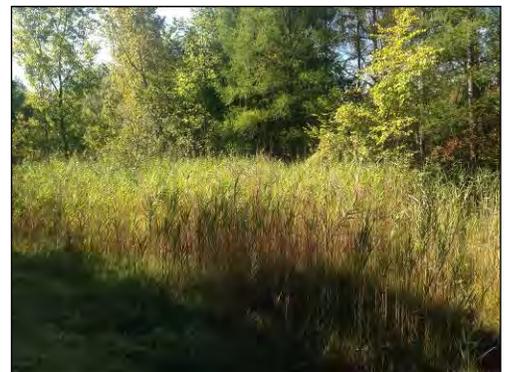
Phragmites has formed a tall, dense monoculture in the northern sections of the White parcel

- Broadcast foliar treat Phragmites beginning in late-August through September using a 2% solution of glyphosate. Begin in areas where Phragmites abuts higher quality wetland areas such as the tamarack swamp or floodplain forest, and work back from that point. Phragmites in this area is a tall, dense monoculture which could be effectively treated with a boom sprayer if access with an Argo or ATV is possible. If the use of vehicles is impractical or impossible, the chemicals will be applied with backpack sprayers.

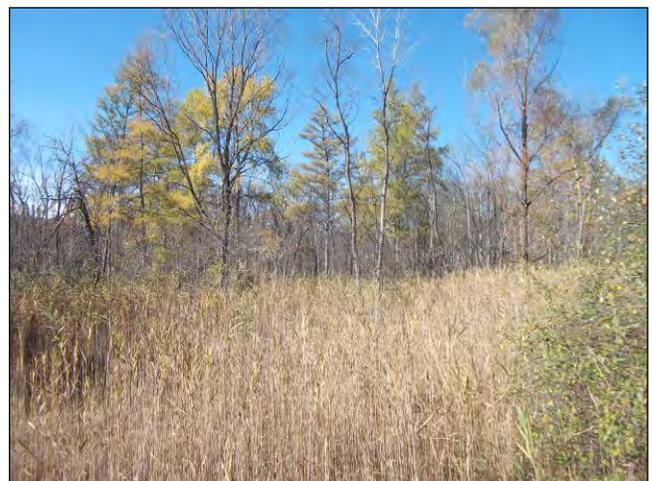
Phragmites and buckthorn near the northern boundary of the tamarack swamp in October 2014

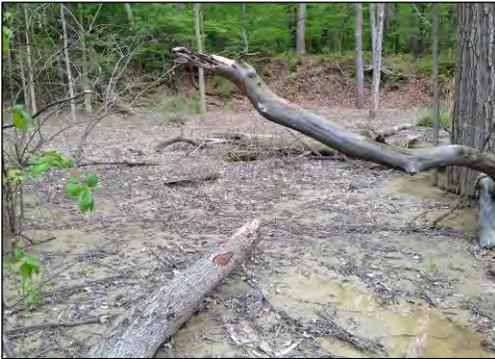
Considerable siltation is threatening the quality of the on-site floodplain forest and the Clinton River

The forested floodplain wetland located along the banks of the Clinton River in the southwestern sections of the property has the potential to be high quality if not for the presence of excessive silt entering and depositing in this area, which also appears to have caused an abundance of Phragmites to become

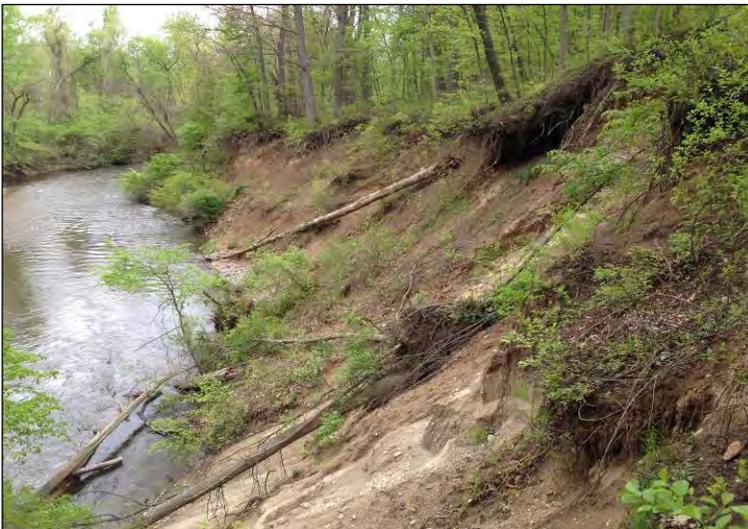
Views facing downstream of the severely eroding banks along the Clinton River at the Cloverport site

Restoration efforts to enhance the natural beauty of this Greenspace property should focus on removal of invasive understory species such as garlic mustard, Phragmites, Oriental bittersweet, and honeysuckle. Additionally, restoration efforts need to focus on preventing erosion and siltation that is negatively impacting the Clinton River. Retrofitting an upstream detention basin, stabilizing an eroding gully, and removing the existing silt deposits that are discharging to the Clinton River need to be top priorities, as does repairing the severely eroded banks that continue to fail and slump into the river.

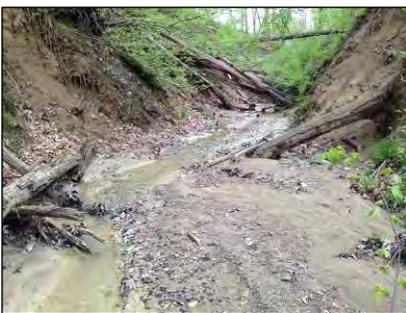
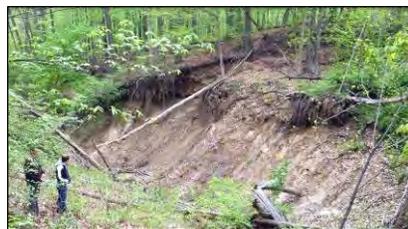
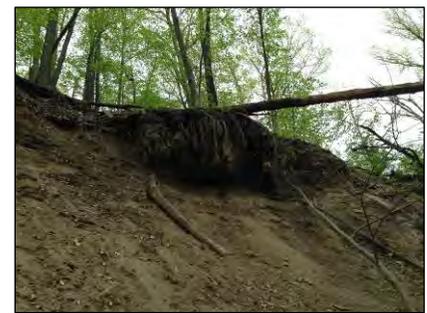
Stormwater discharging from a commercial detention pond upslope from the Cloverport property is causing substantial erosion and sedimentation into floodplain wetlands and the Clinton River

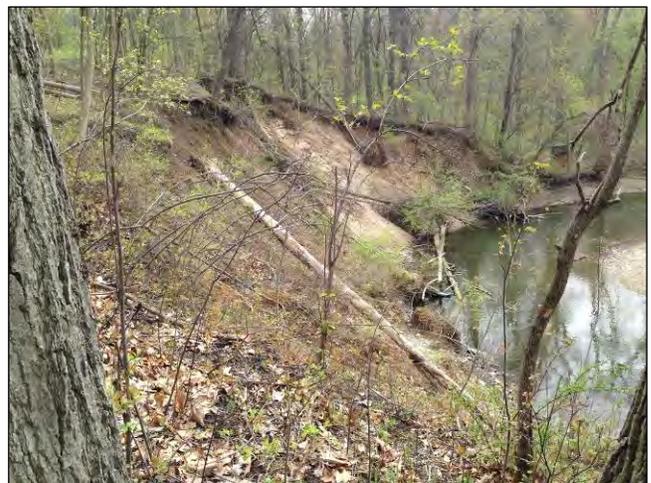
River systems are dynamic, with ever changing patterns, flow rates, and profiles. Under natural circumstances over time, a healthy river can balance a sediment load by effectively transporting it downstream and depositing it in areas that can accept it. In these situations, erosion is typically minimal. In urban areas, however, where humans have altered flow rates through creation of impervious surfaces, commercial and residential development, destruction of vegetated buffers, issues such as bank erosion and sediment deposition can destabilize the natural balance between erosion and deposition causing bank failures and channel migration. This is especially evident in areas with sandy soils (such as Cloverport) that have minimal binding capabilities, allowing small disturbances to become significant problems and resulting in the loss of large portions of the river bank and the eventual formation of sheer cliffs (*above*).

Roughly 180 feet of Clinton River streambank as it flows along the northern and western boundaries of the Cloverport property is failing due to the lateral migration of the stream channel (Figure 5b and Sheets 1 and 2; Appendix B). Unfortunately, this location has significant topographic relief and the channel migration has formed a 30+ feet sheer cliff that is causing massive failure of the entire hillside with the recent loss of several large mature trees. Bank and hillside stabilization techniques (a combination of brush layers and straw wattles; see example photo *right*) as well as installation of instream structures are necessary to reduce stream velocities and to reduce the bank stress while increasing the structural integrity of this bank and hillside. Although the size of the bank and hillside failure is significant, careful planning using natural channel design techniques can stop the channel migration by removing the erosion forces from the sandy hillside and directing the erosive flows back to the middle of the stream channel. Using natural channel design techniques, we would reduce bank slopes, stabilize the bank using natural materials, and install in-stream structures to divert flow to the middle of the

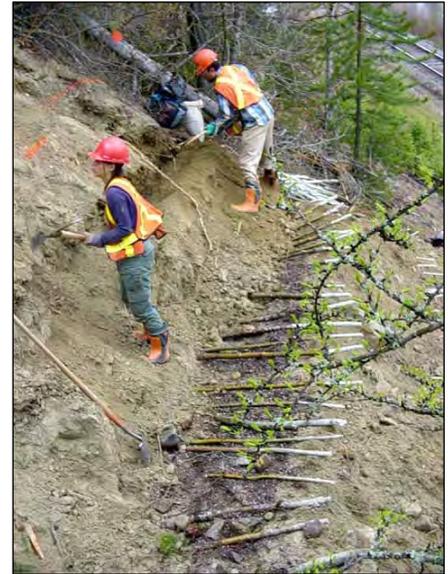
Steep slope stabilization techniques include brush layering and the use of wattles

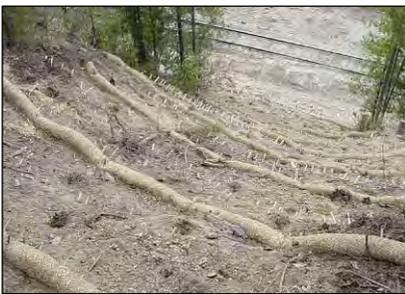
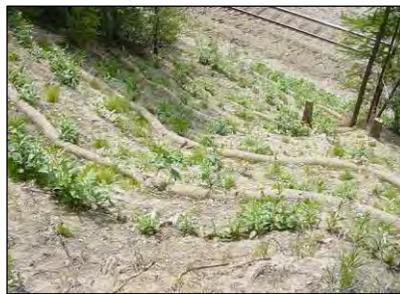
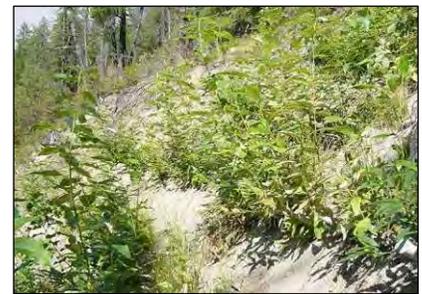
Steep slope stabilization in Canada, similar to conditions present at Cloverport. Severely steeped banks are cut back and terraced (left). Terraced landings are seeded and installed with live brush layers and wattles. Within several months, the slopes begin to vegetate (middle). Within 2 years, it is expected that the banks will be vegetated and stable (right).

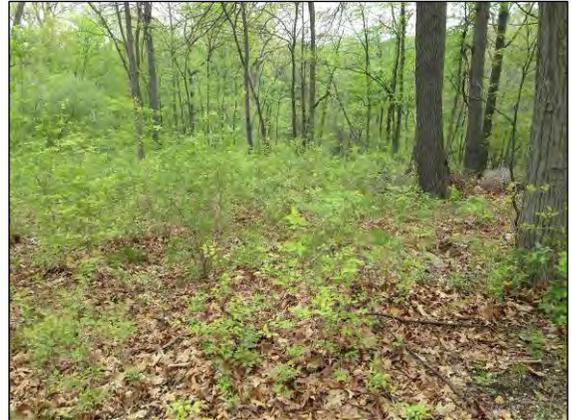
Invasive honeysuckle is relatively common in certain areas of the Cloverport property

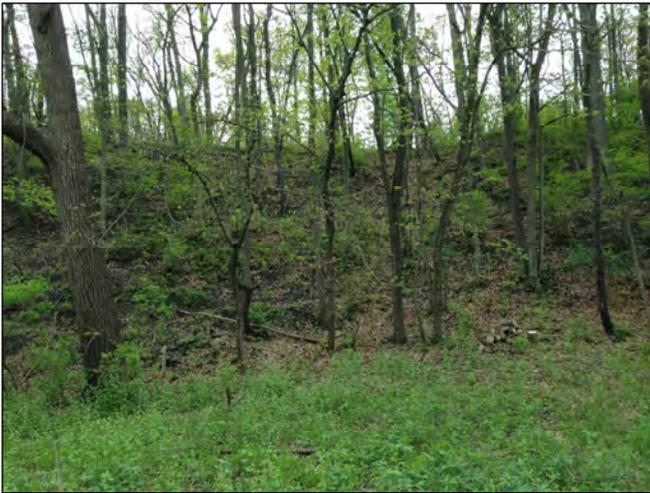
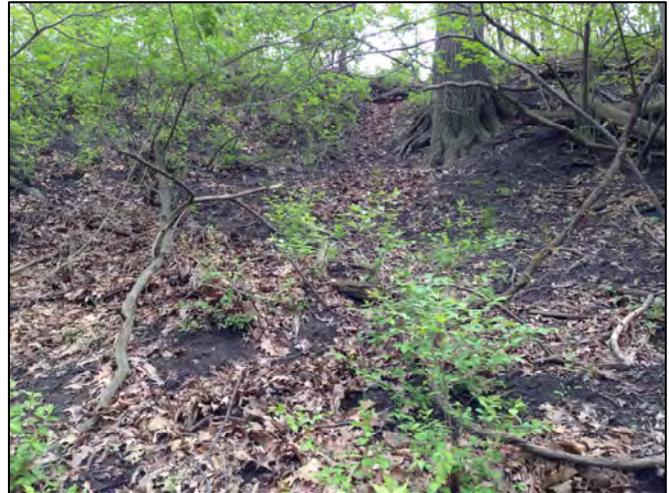
Steep slopes are common throughout the wooded Childress property

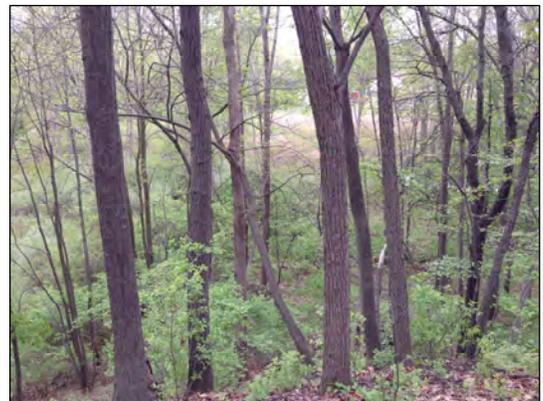
The Childress site is dominated by maple, oak, cherry, walnut, and basswood.

Mature hardwood trees such as maple, walnut, hop hornbeam, cherry, oak and basswood dominate the canopy on the upland slopes of the Childress site, while woody species such as musclemwood, witch hazel, cherry and young hornbeam are common in the understory. Although there are large areas where very little vegetation is present, as is often the case in more mature woodlands, the herbaceous understory vegetation is fairly diverse. Spring wildflowers such as wood anemone, trout lily, Cananda mayflower, mayapple, and wild geranium are present in considerable quantities, especially in the lower elevations. The southwestern portion of the site, which is relatively flat, is dense in areas and of moderately low quality due to the abundance of non-native forbs and shrubs such as garlic mustard, honeysuckle, common privet, barberry, Oriental bittersweet, and common buckthorn. These species reproduce rapidly and in many cases will form dense monocultures. Several higher quality plant species such as flowering dogwood, Indian grass, bloodroot, and early meadow rue are also present on site.

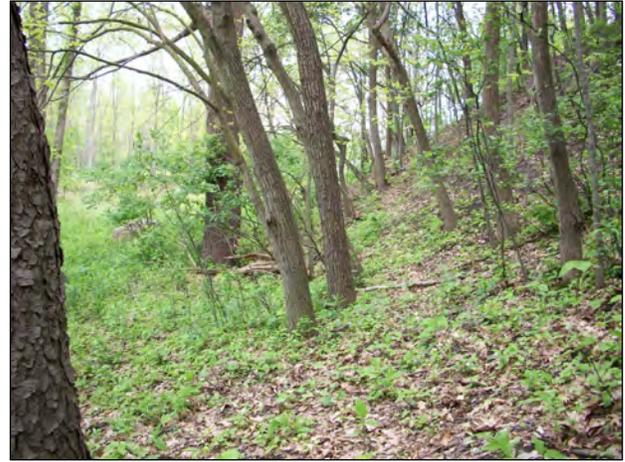
Forested wetland is present between the toe-of-slope and the adjacent Clinton River

The small forested wetland located at the toe-of-slope contains primarily wetland forbs and sedges, but extends beyond the property limits where it becomes a significant natural feature as it buffers the Clinton River. Species such as box elder, maple, elm, agrimony, jewelweed, avens, goldenrod, and sedges are common within the on-site portions of the wetland.

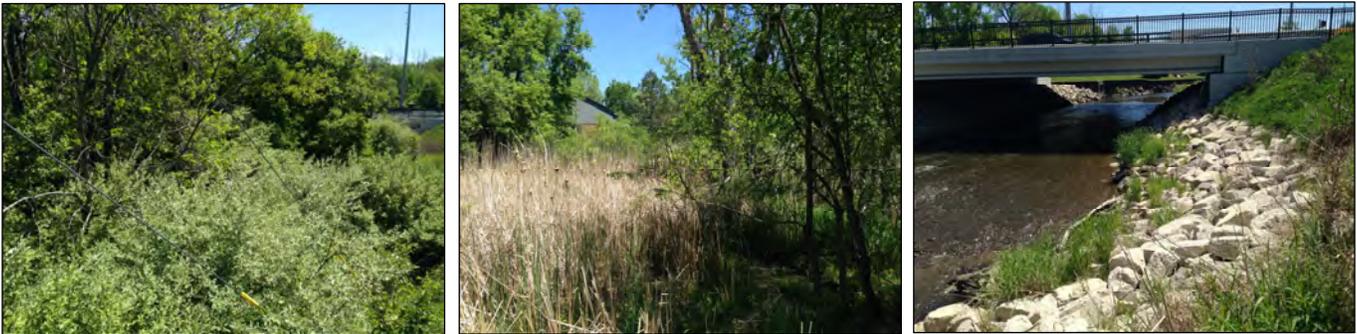
Autumn olive growing in upland old field, cattail marsh, and hard armory leading under the Avon Road Bridge.

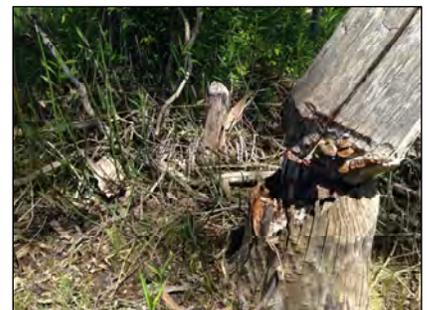
Beaver activity in the northern portion of the Rivercrest site.

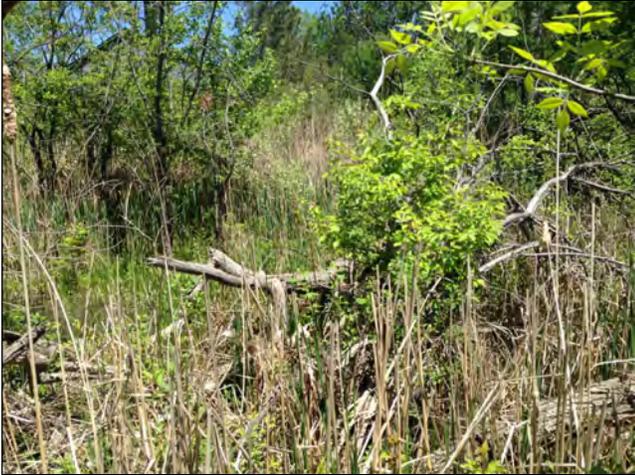
Scrub-shrub wetland

Although the on-site wetland is characterized as scrub-shrub, it does include mature trees, an emergent opening, and pockets of standing water. The wetland is moderately high quality, and is an important natural feature in terms of the functions and values it provides. Unlike many urbanized wetlands that become degraded by surrounding development practices, this area is very diverse for its size and features a variety of quality wetland species such as sedge, joe-pye weed, marsh marigold, tamarack, swamp aster, swamp rose, and burreed.

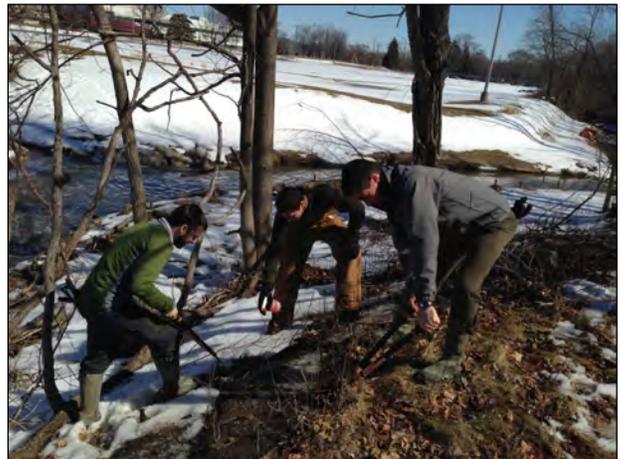
Cut-stump treatment to remove woody invasive shrubs such as buckthorn

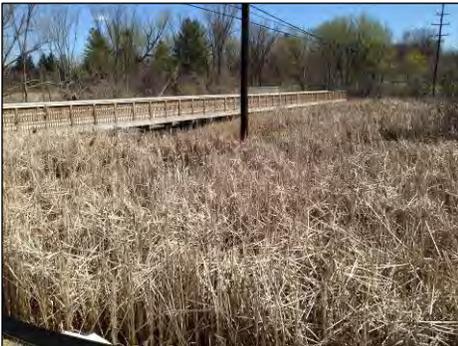
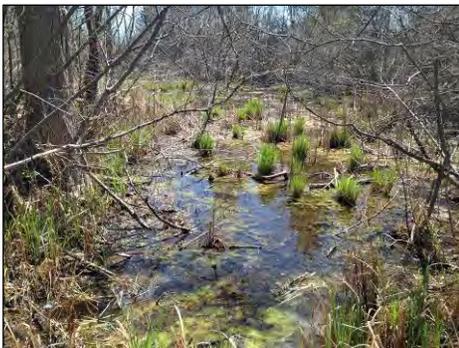
Marsh habitat in the northern portion of the Clear Creek site, south of Mead Road

Each of the four parcels contain wetland ecosystems, and all offer a significant natural buffer to Clear Creek in addition to excellent wildlife habitat, flood retention, groundwater recharge, and sediment and pollutant filtering which is crucial in maintaining the high quality of nearby Stony Creek. A small marsh is present on the south side of Mead Road in the northern portion of the site (*left*), which was likely historically connected to a larger emergent wetland system located on the north side of the road in Oakland Township. Portions along the road and boardwalk are dominated by cattail and contain patches of Phragmites, but other areas of this wetland contain higher quality species such as lakebank sedge, tussock sedge, rice cutgrass, skunk cabbage, swamp milkweed, sensitive fern, and iris (*below*). This wetland appears to be permanently inundated, and provides excellent breeding habitat for amphibians and insects, which in turn provide a valuable food source for predators.

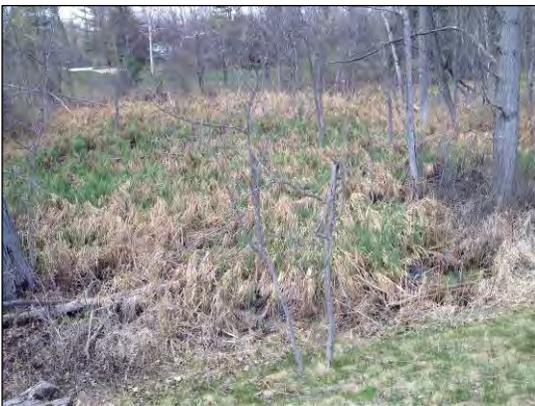
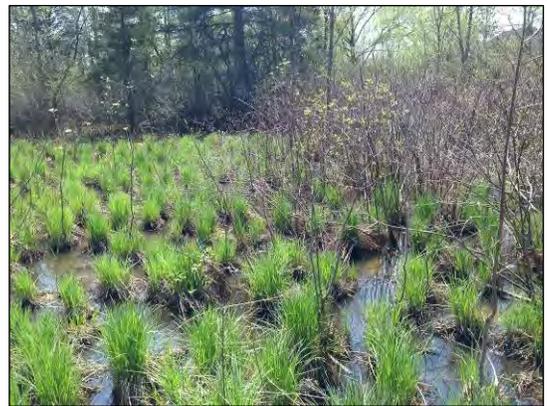
Two sedge meadows are located within the Clear Creek property. Sedge meadows are often dominated by tussock sedge, which is the most abundant species found in each of these wetland areas.

Two high quality southern wet meadows are found on the Clear Creek site as well; one near the curve on Traceky Drive, and another along the south side of this road. Southern wet meadows, otherwise known as sedge meadows, typically form a transition zone between aquatic communities and uplands. These groundwater-fed ecosystems are increasingly rare in developed communities and are particularly important for the water quality functions they provide, including the trapping of sediments, the assimilation of nutrients, and the retention of floodwater.

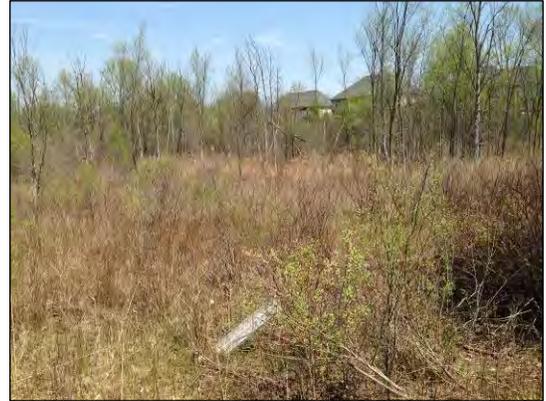
A scrub-shrub wetland north of Clear Creek Drive is under threat from buckthorn

Several moderately high quality scrub-shrub wetlands are also present on the Clear Creek site, but are under immediate threat from invasive honeysuckle and glossy buckthorn. These diverse wetlands contain emergent species such as sedge, cattail, fern, water hemlock, rice cutgrass, and skunk cabbage, but also contain numerous woody species such as willow, dogwood, elm, meadowsweet, viburnum, and ninebark. Clear Creek flows through these scrub-shrub wetlands, making them essential buffers in maintaining the quality of this watercourse. Unfortunately, these wetlands are surrounded by woodlands and scrubland, dominated by invasive glossy buckthorn

and honeysuckle. Glossy buckthorn in particular has the capability to survive in saturated conditions, so it is imperative that these species be removed to prevent further encroachment into these valuable wetland resources. The scrub-shrub wetland along Sheldon Road, between Placid Court and Clear Creek Drive, is of particular importance but is under immediate threat from glossy buckthorn.

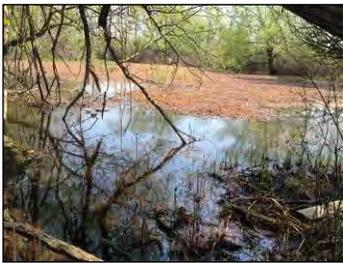
A small pond sits within a woodland along Sheldon Road

Finally, an open-water wetland is located in the western portion of the Clear Creek site, along Sheldon Road, north of Placid Court. This wetland is located in a wooded area that is dominated by invasive shrubs, and an area of Phragmites is present to the east. The pond itself appears to be shallow and mucky, with a perimeter of sedge, willow, and buckthorn. Water smartweed is present in large amounts, extending beyond the top of the water. This area is home to ducks, turtles, and frogs, but no fish were observed.

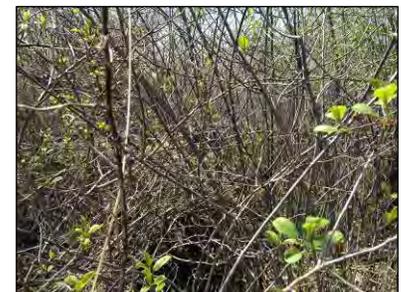
Glossy buckthorn dominates much of the Clear Creek site

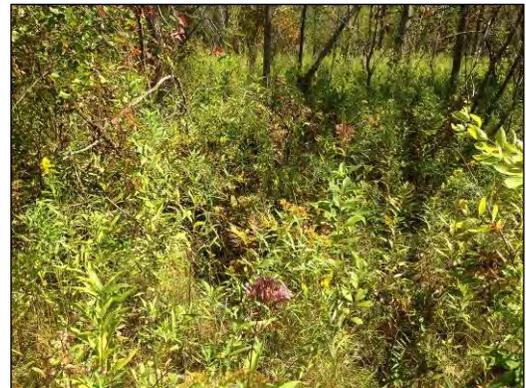
Portions of the scrub-shrub wetland exhibit wet prairie species

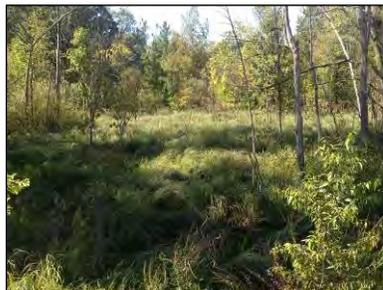
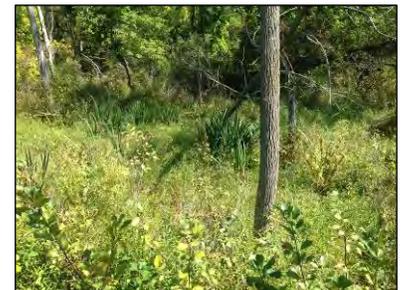
Open sedge meadow and scrub-shrub wetland areas on the Clear Creek property

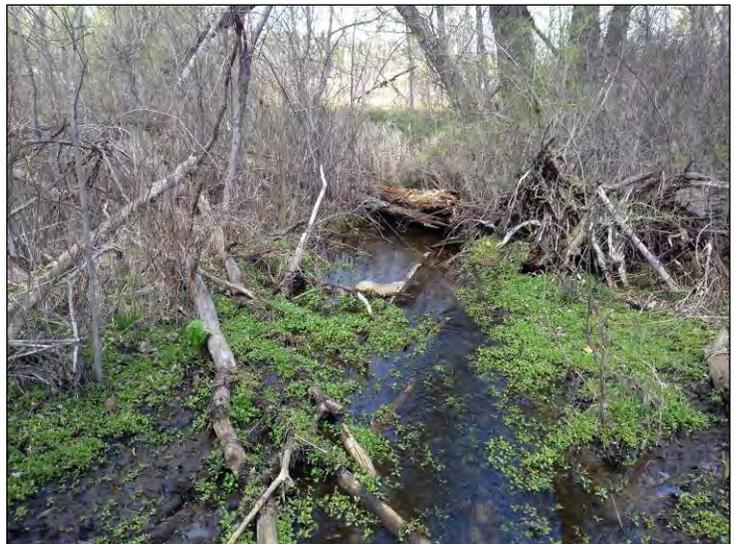
*A dense thicket of buckthorn and honeysuckle surround
Clear Creek*

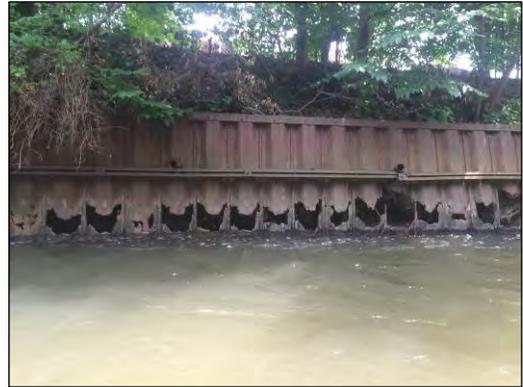
Failing hard armory along the banks of the Clinton River

In addition, removing hard armoring (e.g., vertical steel seawall and concrete slabs) and restoring the shorelines using natural materials (e.g., natural field stone, native plantings, and bio-degradable materials) to restore the natural function of the stream will continue to improve the stream function and water quality.
