Rochester Hills Natural Features Stewardship Program Long-Term Management Plan

**NISWANDER**
ENVIRONMENTAL

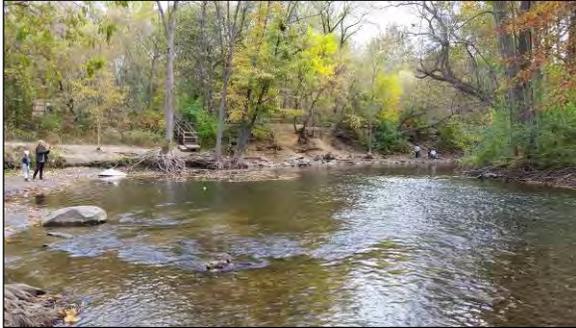
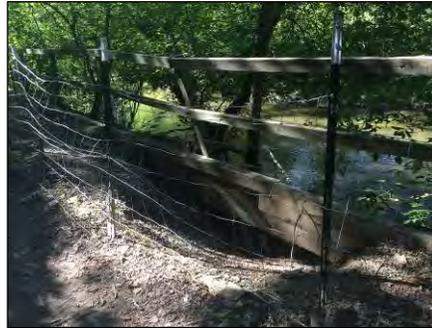
Sedimentation and erosion are significant issues facing the Clinton River on the Yates Cider Mill Property. With significant use by the public and uncontrolled public access and historic manipulation of the stream channel, approximately 1,000 feet of streambank has some level of erosion and the channel has migrated and is causing significant loss of land, threatening the public trail way that extends from the Cider Mill.

Significant bank erosion at the Yates Cider Mill property has led to portions of the trail being closed until restoration activities can repair the river

Several efforts to patch the erosion issues at the Yates property have occurred with the placement of rocks and boulders. These piecemeal approaches on a river of this size are almost always

prone to failure, or these efforts simply transfer the problem by moving the erosion issue upstream or downstream (which appears to be the case in this section of the river). A properly designed and implemented natural channel design project will address the ongoing erosion and bring long-term stability to the river on this property. The new channel design will result in locating the river away from severely eroding banks and eliminating artificially abrupt and sharp turns in the river channel along this reach.

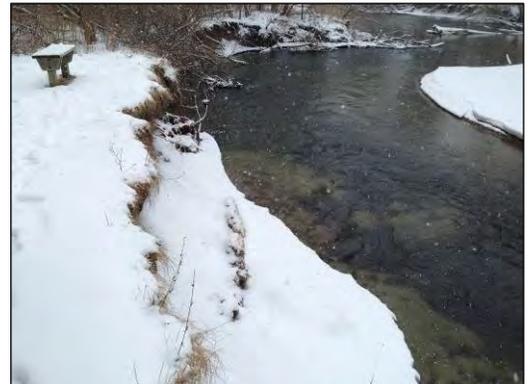
The banks of the Clinton River in portions of the Avon Nature Study Area are eroding near trails and overlook areas

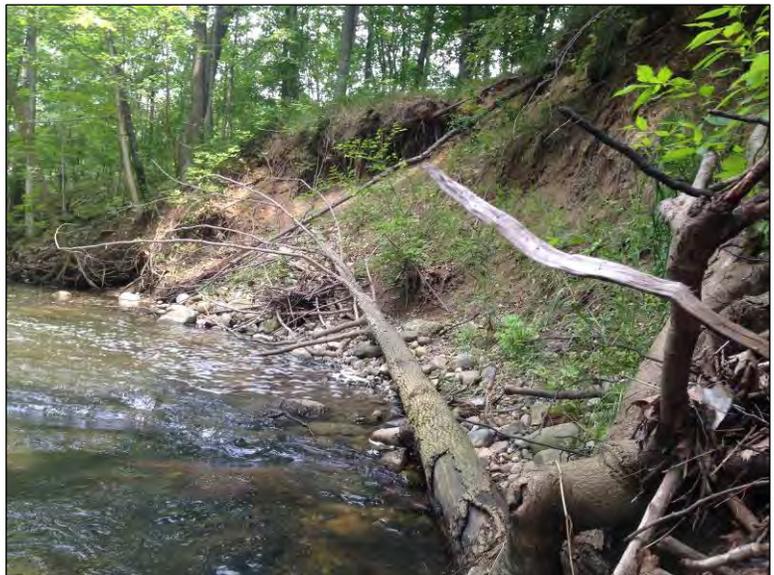
High banks along Riverbend Park are failing, leading to woody debris and sedimentation

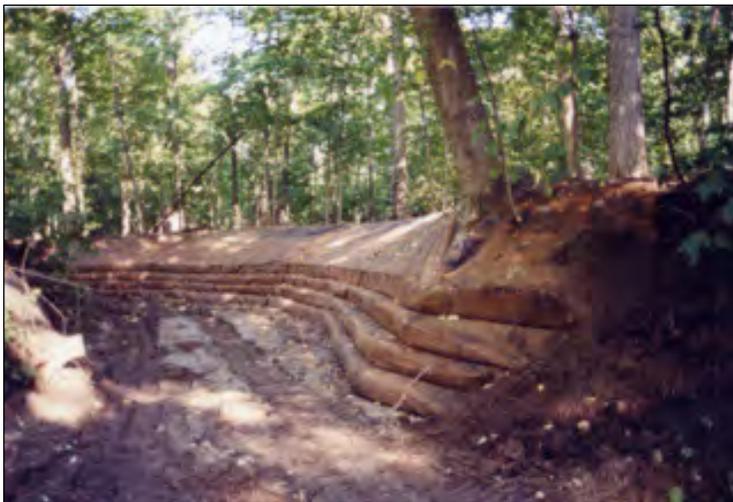
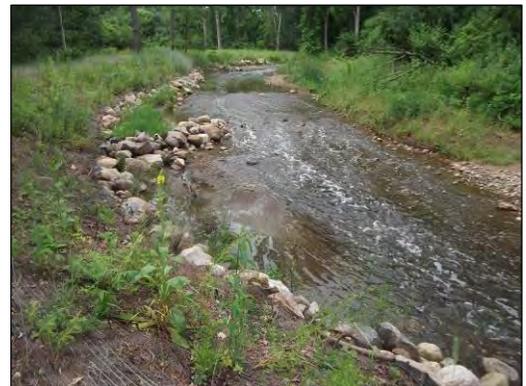
Examples of bank terracing (left) to repair a steep eroding bank, and vane arm (above) to redirect water back to the center of the channel

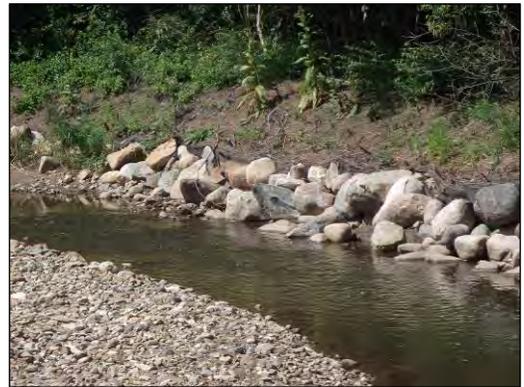
Example of toe rock along restored streambank in Ann Arbor

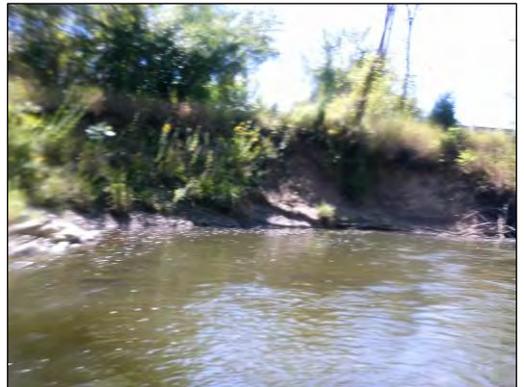
The scoured banks along Bloomer Park will require toe rock and the creation of a bankfull shelf to prevent further erosion
