PRELIMINARY HISTORIC DISTRICT STUDY COMMITTEE REPORT 920 SOUTH BOULEVARD ROCHESTER HILLS, MICHIGAN

3. DESCRIPITON OF THE HISTORICAL DISTRICT STUDIED:

920 South Boulevard is located in Section 34 and consists of a home and storage shed/barn on approximately 2.4 acres (see map).

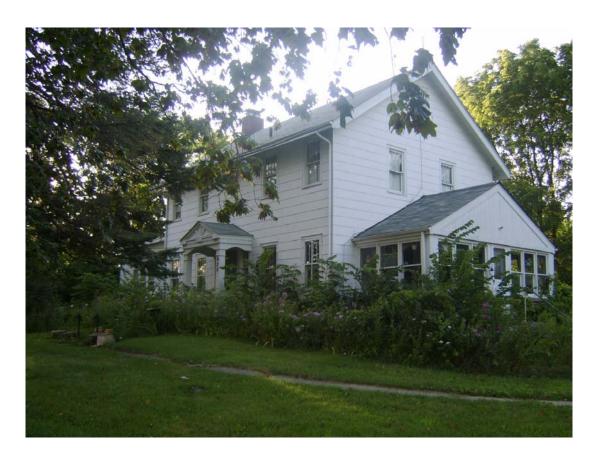
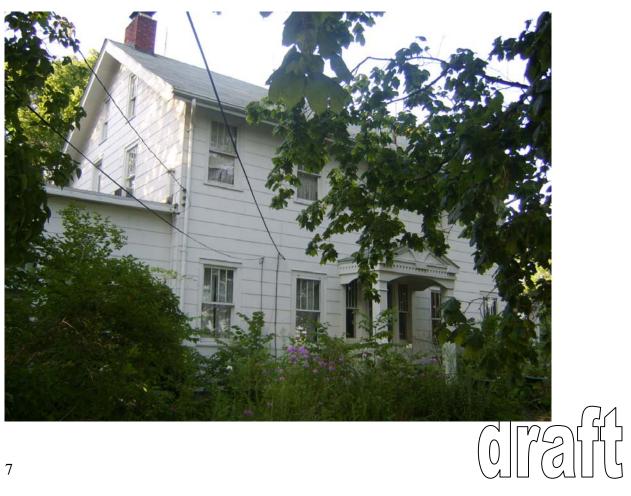
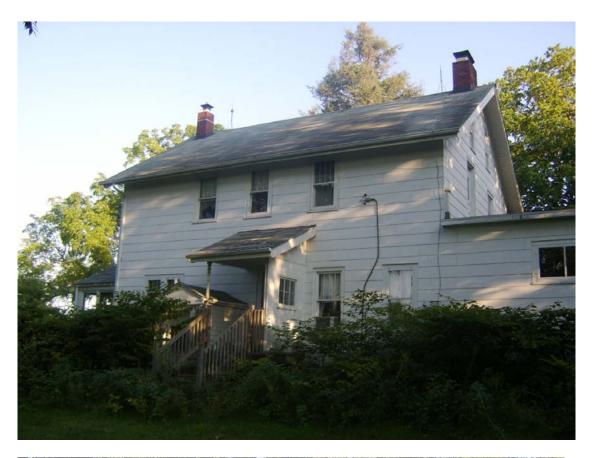
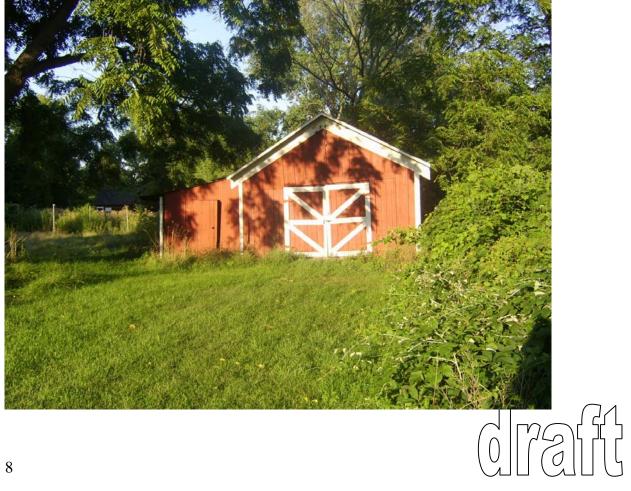
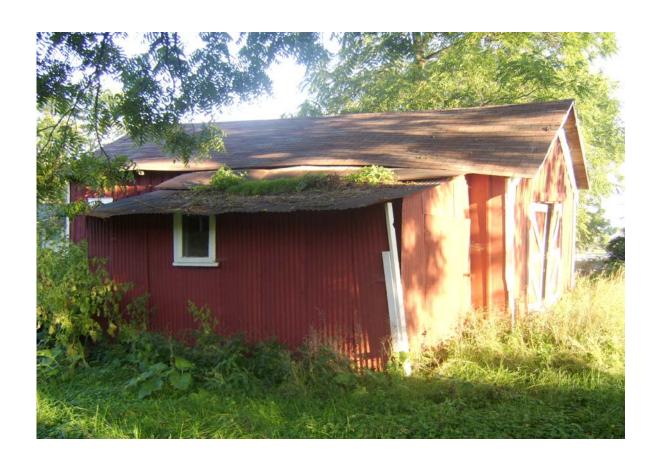
Reviewer's Opinion: This building is a very good example of the Colonial Revival style. It appears to be in very good condition. I agree with the Inspection Report performed by the RH Building Department. The so-called barn is basically a storage building and not worth saving unless the whole site is restored. The siding on this home is probably not original, but I would need to do additional research to verify this. This building should not be dismissed off hand. It is probably one of the last homes of this era and style still remaining in the city. The problem is always where to draw the line and what battles are we all willing to fight for. Is this house worth the effort? I believe it might be and we should consider working with the new owners to see if it can be appropriately incorporated into their development.

Two-story side gabled house. One story west wing with square bay, and a one story east side enclosed porch addition with brick lower walls. Asbestos siding (or a similar looking artificial siding). 4/1 windows. Two brick chimneys. Pedimented entrance porch. Front door with sidelights.

The site currently contains a one-story barn/storage building with an attached shed. The structure has swing doors, and board and batten siding. The barn/storage building is not a contributing resource, and is deemed to be structurally unsound.
